Overview of Groundwater and Surface Water Investigations – Town of Patagonia Flood and Flow Committee

May 13, 2021

Hermosa hydrogeological investigations

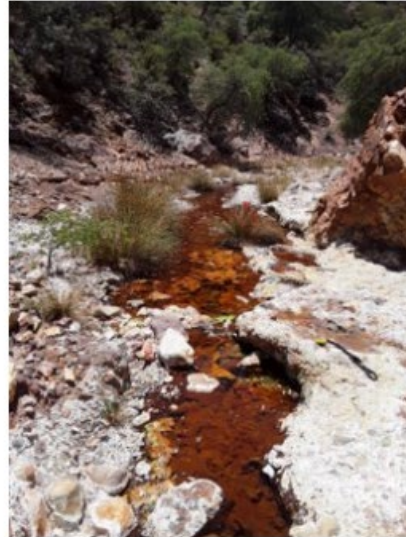
Spring and Seep Catalog update

Spring and Seep Catalog

Hermosa Project Area

- Water quality results extended through June sampling in 2020
- Addition of 50 new sites within the Patagonia Mts.
- Site summary pages all include potential impacts to groundwater contributions at the spring/seep from early dewatering
- Site descriptions include date visited, measured flows (when flowing), pH, temperature, and conductance
- Vegetation and wildlife encountered are detailed for each site
- Photographs of wet and dry season conditions are provided for most sites

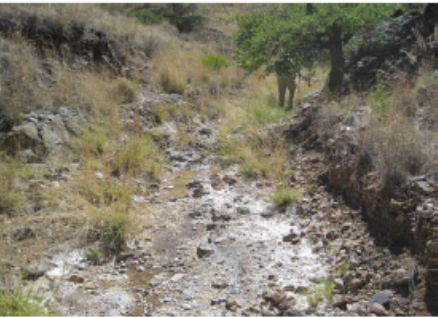
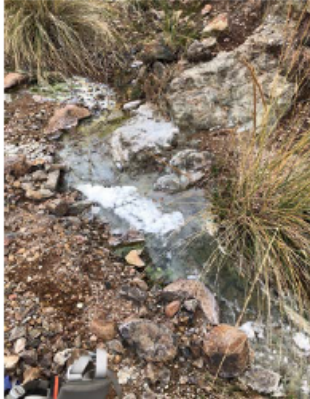
| Site ID | F6-01 | | Interpretation of Groundwater Age: Mixed source of modern water and deep groundwater. | | | | | | |
|--|---|---|--|---|---|---|---|---|---|
| Dry Season Photo (5/30/2018) | | | | | Wet Season Photo (11/29/2018) | | | | |

| Site ID | F6-01 | | Interpretation of Groundwater Age: Mixed source of modern water and deep groundwater. | | | | | | |
|--|---|---|--|---|---|---|---|---|---|
| <p>Aquatic and Vegetation Survey Findings: This site is located in rocky and cobbly section of Flux Canyon with exposed bedrock. Generally, water is present in shallow pools. Bullgrass (<i>Muhlenbergia emersleyi</i>) and riparian obligate rushes (<i>Juncus</i> spp.) are dominate perimeter vegetation along the drainage bottom. Hopbush (<i>Dodonaea viscosa</i>) and Texas bluestem (<i>Schizachyrium cirratum</i>) occur on the adjacent hillsides. Although there is no overstory canopy at the site, overstory trees along the drainage are dominated by Emory oak (<i>Quercus emoryi</i>). Non-native annual rabbitsfoot grass (<i>Polypogon monspeliensis</i>) and invasive plants, Lehmann lovegrass (<i>Eragrostis lehmanniana</i>) and Johnson grass (<i>Sorghum halepense</i>), have been observed. Aquatic invertebrates previously noted within the Flux Canyon drainage including beetles, boatmen, backswimmers, dragonflies, and damselflies. No aquatic vertebrates have been observed.</p> | | | | | | | | | |

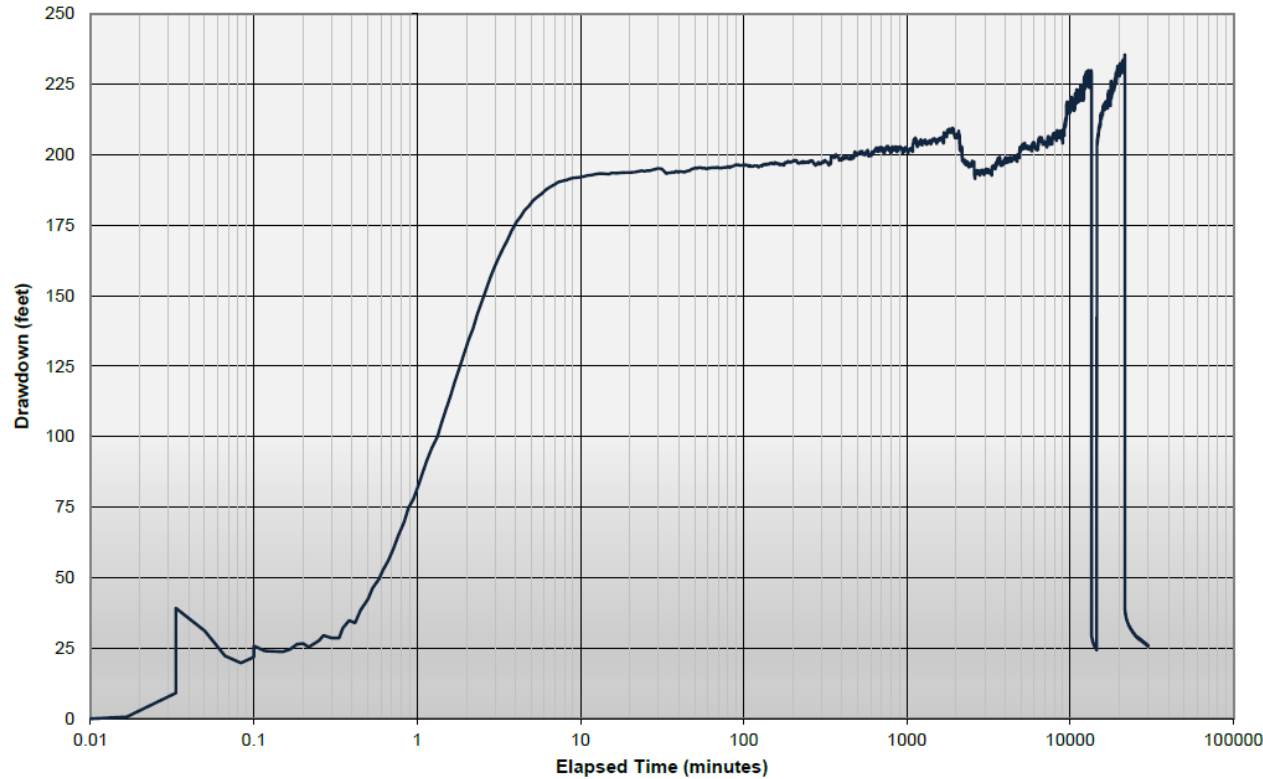
Pumping Well WW-1

- A total of 11 different aquifer tests have been conducted on various wells at Hermosa conducted from 2017 through 2019
- Aquifer testing has been used to understand the range in permeability of the differing geologic materials (volcanic and sedimentary aquifer units)
- Some tests lasted only a few hours with less than 1 gpm
- The largest of the aquifer tests was at well WW-1, extending for approximately 15 days at 1,950 gpm
