# Hermosa Spring and Seep Catalog

Hermosa Project Area

## SPRING AND SEEP CATALOG Hermosa Project Area

### INTRODUCTION

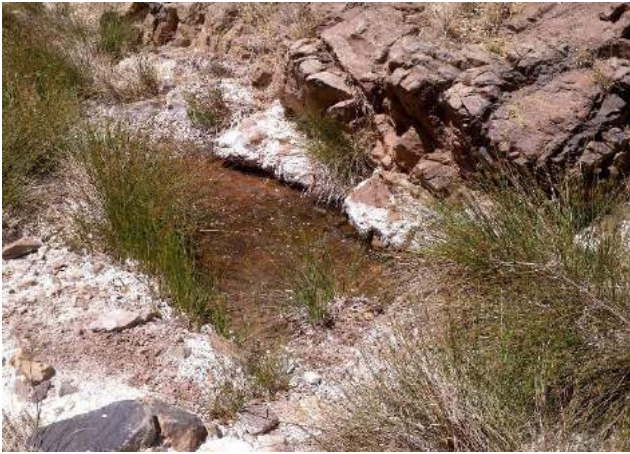
**Dry Season Photo (5/24/2018)**

**Aquatic and Vegetation Survey Findings:** Site is located in cobbly and rocky section of Alum Gulch with exposed bedrock. Generally, water is present in shallow pools and runs. Aquatic beetles and boatmen have been observed. No aquatic vertebrates have been observed. Overstory tree coverage is sparse within the drainage dominated by oak (*Quercus* spp.). Perimeter vegetation is dominated by riparian obligate rushes (*Juncus* spp.). Hillsides of drainage dominated by oak (*Quercus* spp.).

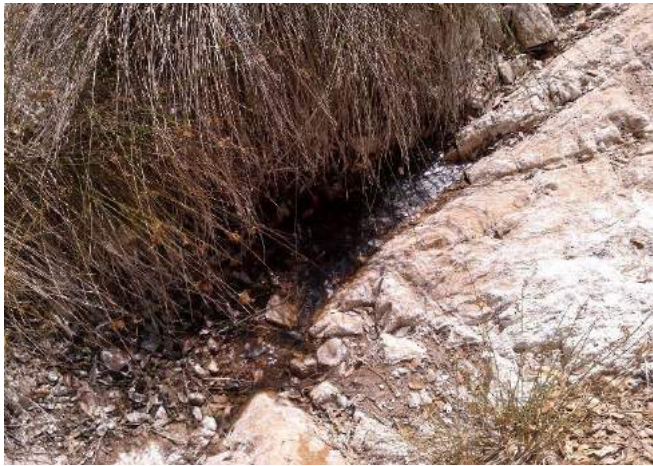
**Dry Season Photo (5/25/2018)**

**Aquatic and Vegetation Survey Findings:** Site is located in exposed bedrock section of Alum Gulch. Generally, water is present in shallow pools. Aquatic beetles and boatmen have been observed. No aquatic vertebrates have been observed. Deer tracks have been noted at this site. No overstory tree coverage is present and perimeter vegetation is dominated by *Juncus balticus*. Hillsides of drainage dominated by oak (*Quercus* spp.). Invasive plant species observed are Lehmann lovegrass (*Eragrostis lehmanniana*) and Bermudagrass (*Cynodon dactylon*).

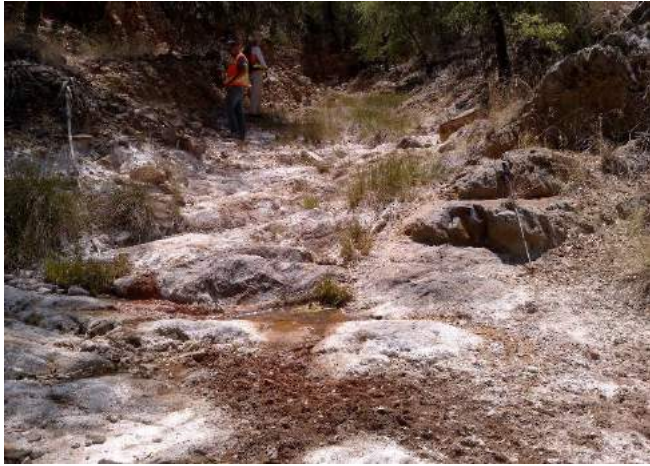
**Dry Season Photo (5/25/2018)**

**Aquatic and Vegetation Survey Findings:** Site is located in exposed bedrock section of Alum Gulch. Generally, water is present in shallow pools. Aquatic beetles and boatmen have been observed. No aquatic vertebrates have been observed. Deer tracks and bear scat have been noted at this site. Overstory tree coverage is dominated by an individual Fremont cottonwood (*Populus fremontii*) and also includes oak (*Quercus* spp.) and mesquite (*Prosopis velutina*). Perimeter vegetation is dominated by riparian obligate rushes (*Juncus* spp.), deergrass (*Muhlenbergia rigens*), and cane bluestem (*Bothriochloa barbinodis*). Hillsides of drainage dominated by oak (*Quercus* spp.). Invasive plant species observed are Lehmann lovegrass (*Eragrostis lehmanniana*) and Bermudagrass (*Cynodon dactylon*).

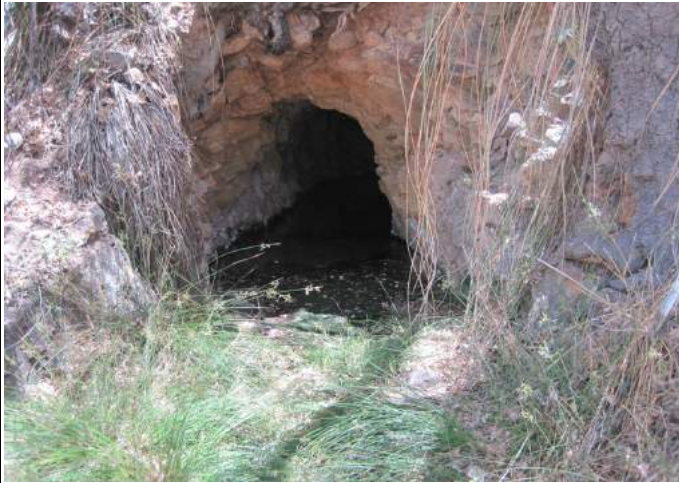
**Dry Season Photo (5/28/2018)**

**Aquatic and Vegetation Survey Findings:** This site is located at an adit with a concrete spring box that retains water at the adit entrance within Alum Gulch. Rushes (*Juncus* spp.), a riparian obligate genus, and deergrass (*Muhlenbergia rigens*) are present at the adit opening. Overstory cover dominated by oak (*Quercus* spp.) with individual Fremont cottonwood (*Populus fremontii*), and Mexican pinyon (*Pinus cembroides*) present. Invasive plants observed include Bermudagrass (*Cynodon dactylon*) and horehound (*Marrubium vulgare*). Aquatic beetles have been observed. No aquatic vertebrates have been observed.

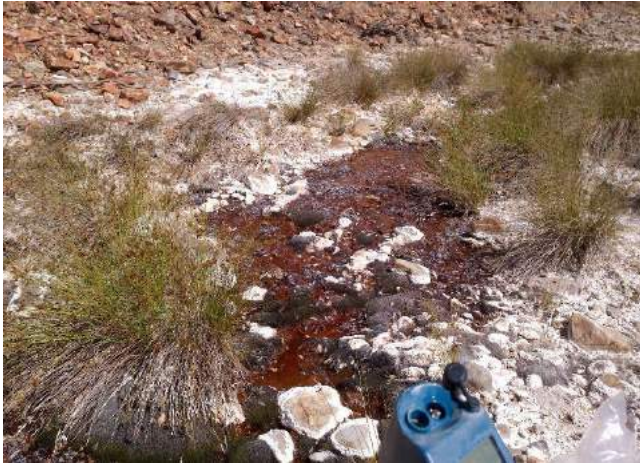
**Dry Season Photo (5/29/2018)**

**Aquatic and Vegetation Survey Findings:** Site is located in exposed bedrock section of Alum Gulch. Generally, water is present in shallow pools. No overstory tree coverage is present within the drainage at this site. Perimeter vegetation is dominated by riparian obligate *Juncus balticus*. Hillsides of drainage dominated by oaks (*Quercus* spp.). Invasive plant species observed are Lehmann lovegrass (*Eragrostis lehmanniana*).

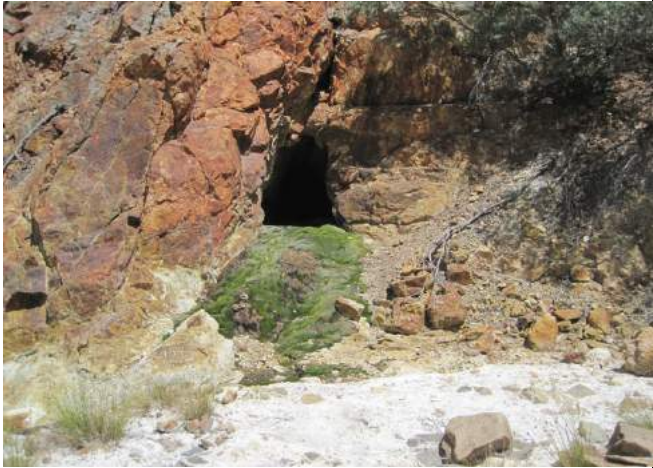
**Dry Season Photo (5/29/2018)**

**Aquatic and Vegetation Survey Findings:** This site is located at an adit within a rocky section of Alum Gulch. Water is present in the adit and discharges into the drainage. A large moss mat and some riparian obligate rushes (*Juncus* spp.) are present at the adit entrance. Although there is no overstory canopy at the site, overstory tree species along the drainage are dominated by oak (*Quercus* spp.) and Chihuahuan pine (*Pinus leiophylla*). Aquatic invertebrates observed include damselflies, beetles, boatmen, and backswimmers. No aquatic vertebrates have been observed.

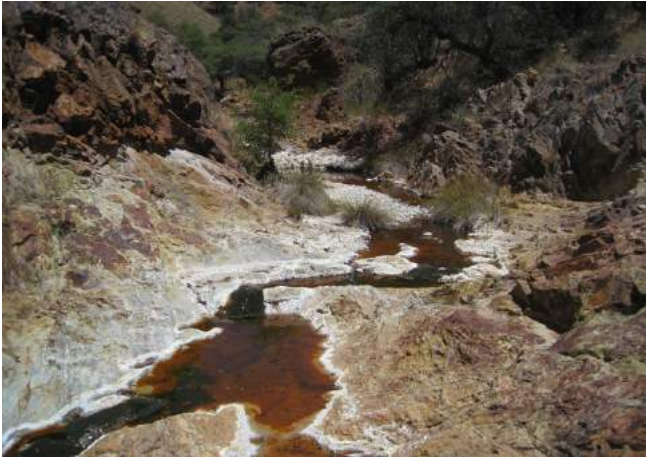
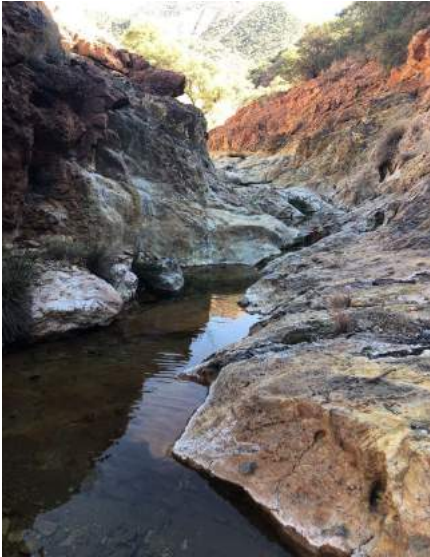
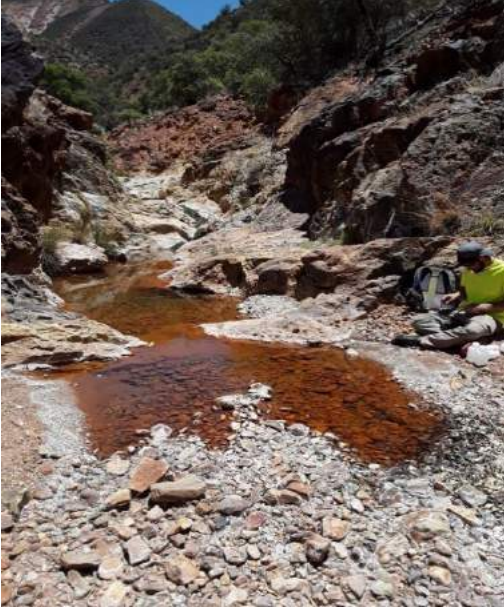
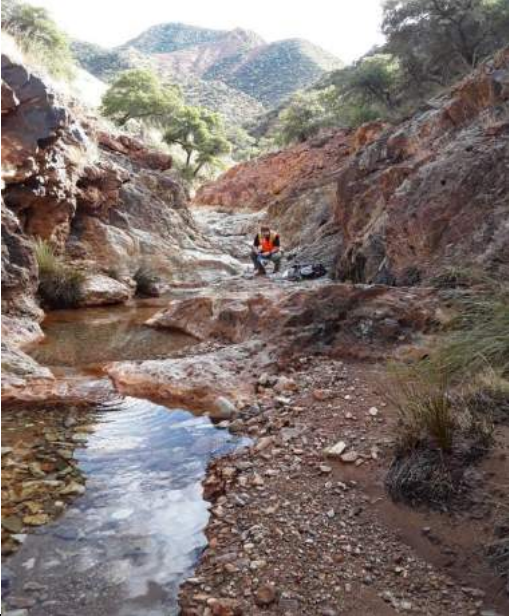
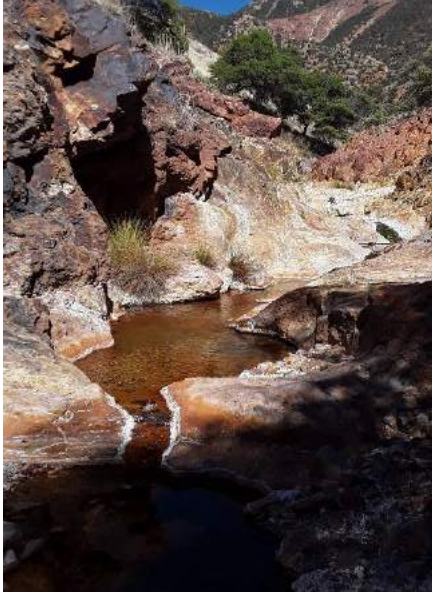
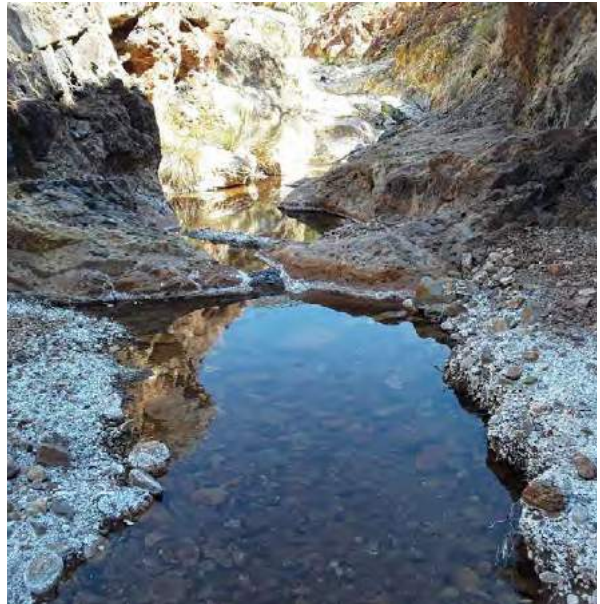
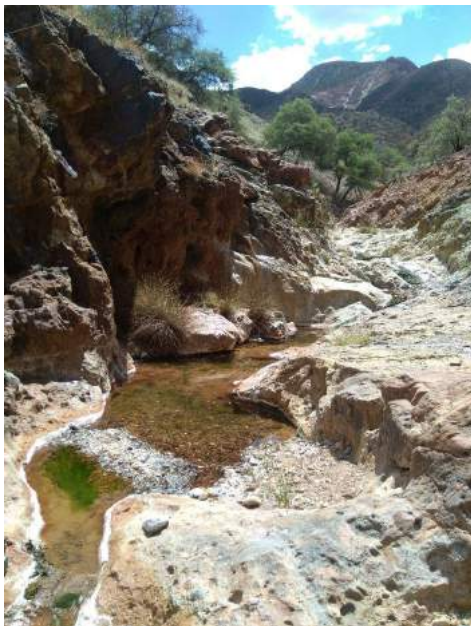
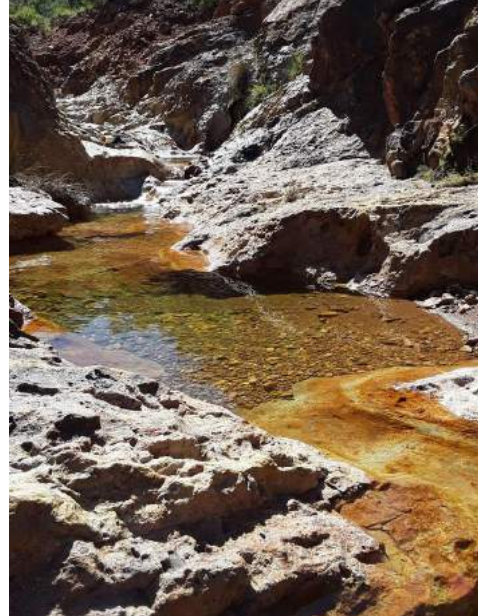
**Aquatic and Vegetation Survey Findings:** This site is located in a bedrock section near downstream extent of Alum Gulch. Water is present in series of pools and runs. The site supports very little vegetation, but where pockets of soil exist in the bedrock, Baltic rush (*Juncus balticus*), a riparian obligate species, beargrass (*Nolina macrocarpa*), and moss occur sparingly. Although there is no overstory canopy at the site, overstory trees along the drainage are dominated by oak (*Quercus* spp.). Non-native annual rabbitsfoot grass (*Polypogon monspeliensis*) and invasive Lehmann lovegrass (*Eragrostis lehmanniana*) have been observed. Aquatic invertebrates observed within the Alum Gulch drainage include beetles, boatmen, and backswimmers. No aquatic vertebrates have been observed.

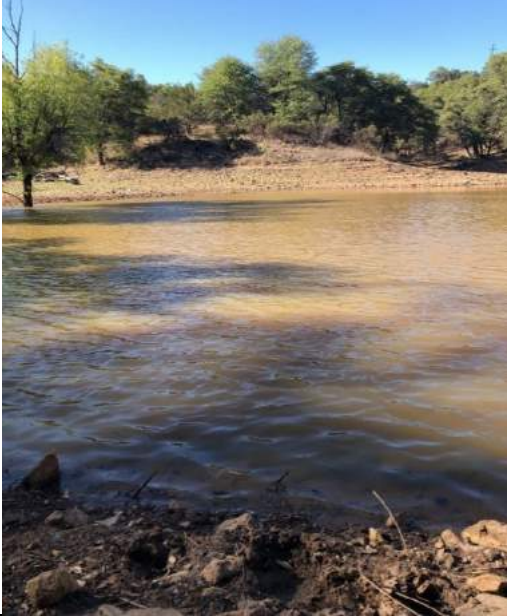
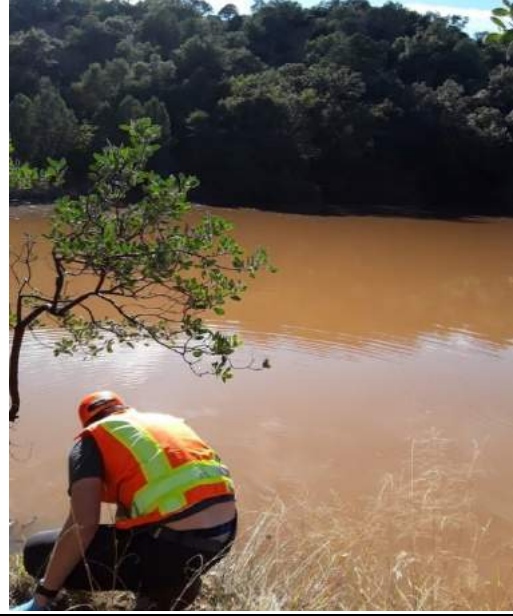
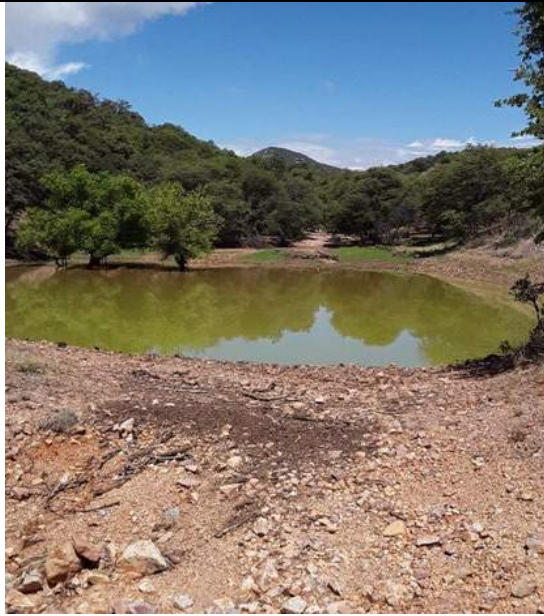
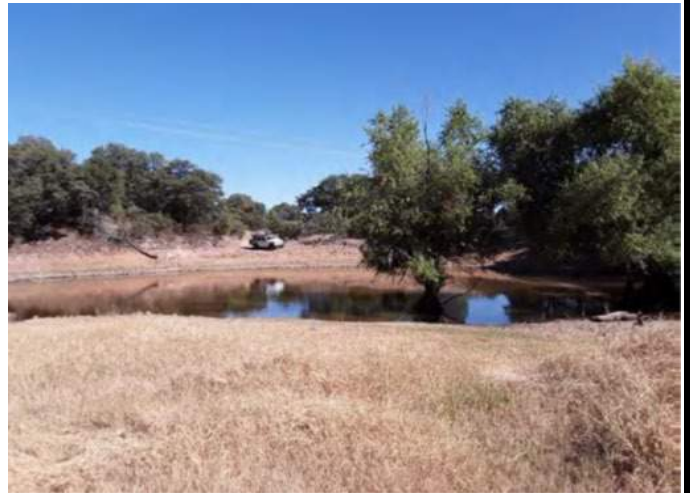
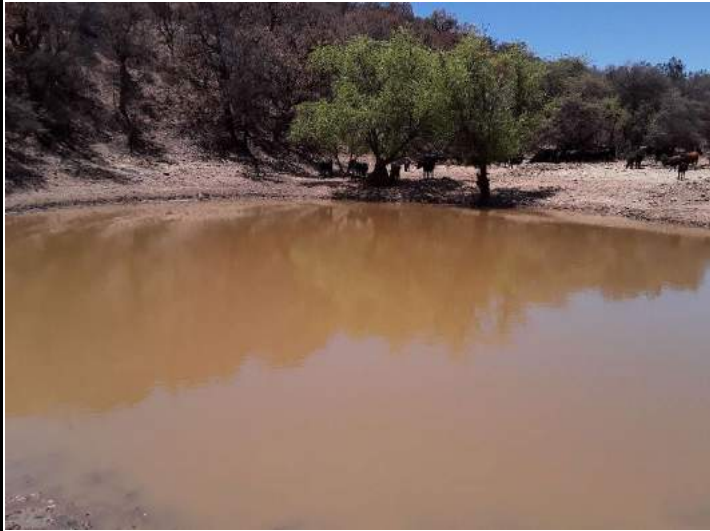
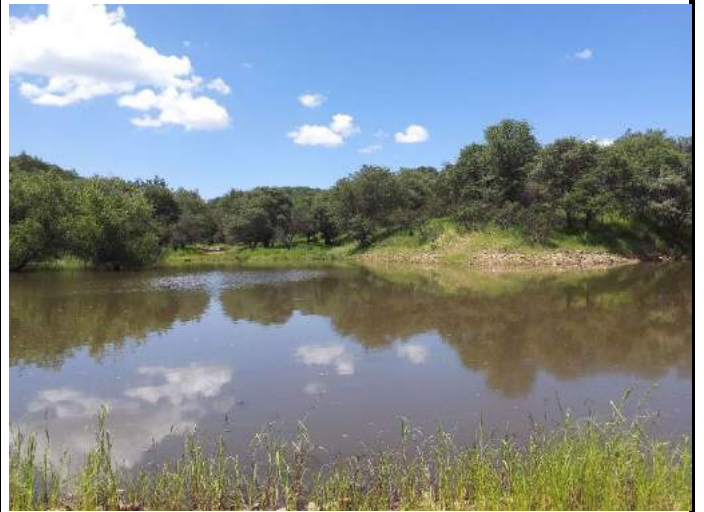
7/2/2020	Iron, lead				10/2/2020	Wet season 2020 samples were not collected due to Covid-19 restrictions			
1/20/2021	No exceedances				11/17/2021	No exceedances			
5/17/2021	Lead								
<b>Aquatic and Vegetation Survey Findings:</b> This site is a large earthen stock tank located within Adams Canyon drainage. Two willow trees ( <i>Salix</i> sp.) occur as emergent and canopy vegetation for the tank. Perimeter vegetation is dominated by non-native barnyard grass ( <i>Echinochloa crus-galli</i> ) and riparian obligate spikerush ( <i>Eleocharis</i> sp.). The upland overstory vegetation is dominated by Emory oak ( <i>Quercus emoryi</i> ). Invasive Bermudagrass ( <i>Cynodon dactylon</i> ) and American bullfrogs ( <i>Lithobates catesbeianus</i> ) have been observed at this site.

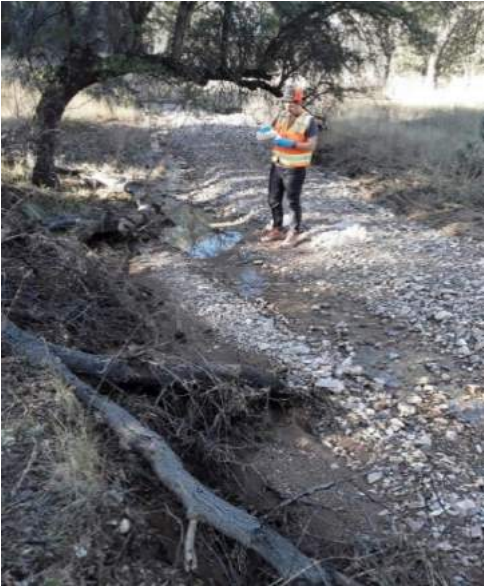
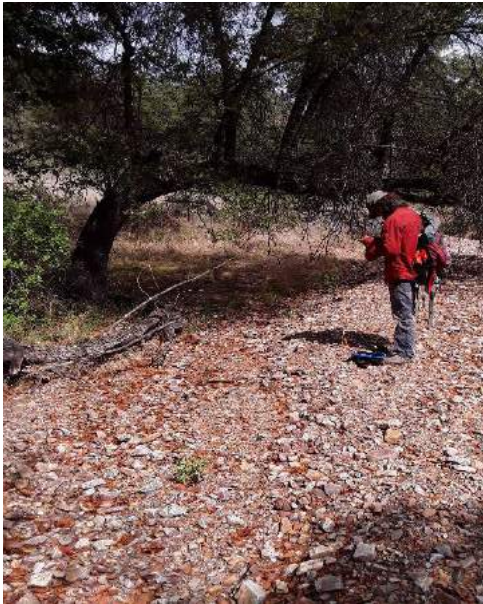
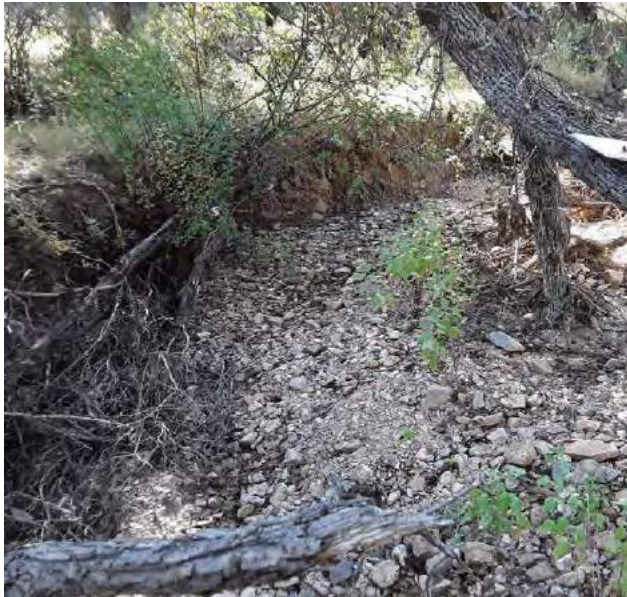
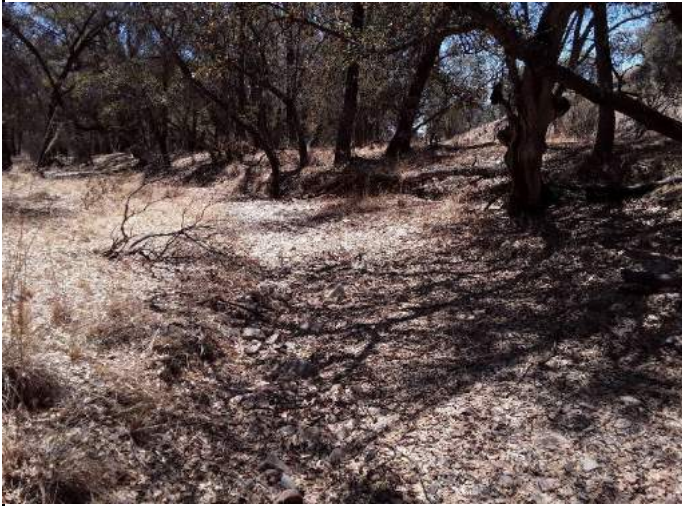
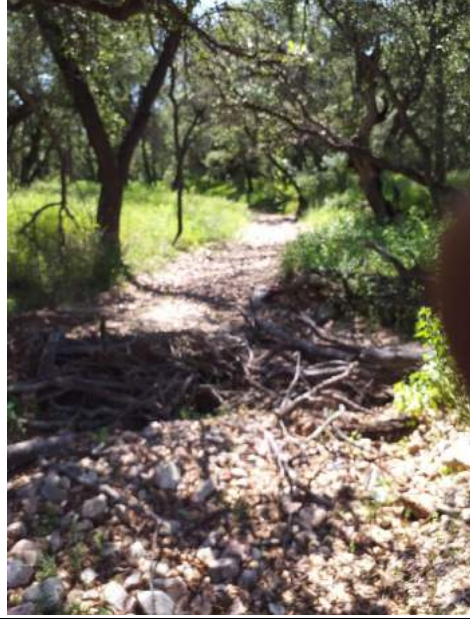
**Aquatic and Vegetation Survey Findings:** This site is located in a rocky, gravelly section of Adams Canyon drainage. This site was dry during one visit in 2019 and another in 2020. The overstory is dominated by oak (*Quercus* spp.) with some alligator juniper (*Juniperus deppeana*) and Arizona walnut (*Juglans major*) present. Dominant understory vegetation includes poison ivy (*Toxicodendron radicans*), grasses (*Aristida* sp.), pinyon ricegrass (*Piptochaetium fimbriatum*), and bullgrass (*Muhlenbergia emersleyi*). Invasive weeping lovegrass (*Eragrostis curvula*) has been observed. No aquatic invertebrates or vertebrates have been observed. Heavy grazing occurs at this site.

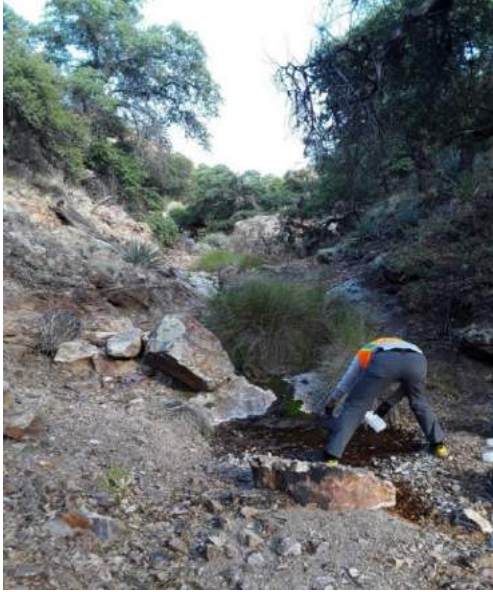
**Dry Season Photo (5/27/2019)**

**Aquatic and Vegetation Survey Findings:** This feature is a seep located within a section of exposed bedrock in Blue Eagle Canyon. Water is present in small pools. Herbaceous ground cover is dominated by riparian obligate Baltic rush (*Juncus balticus*). Also present is rockloving spikemoss (*Selaginella rupincola*) and sotol (*Dasylirion wheeleri*). Overstory vegetation is dominated by oaks (*Quercus* spp.). Aquatic invertebrates observed include backswimmers. No aquatic vertebrates have been observed.

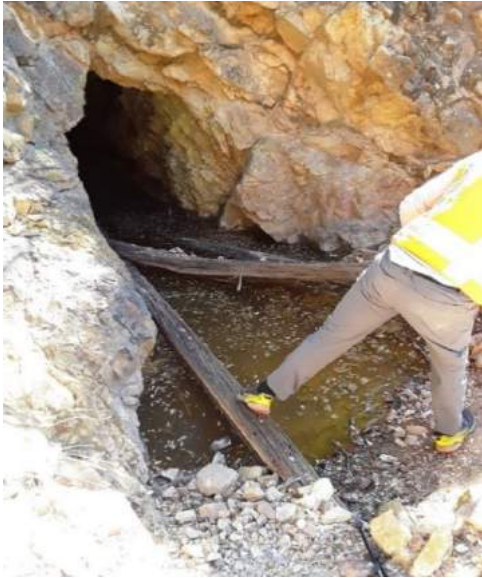
**Dry Season Photo (5/27/2019)**

**Aquatic and Vegetation Survey Findings:** This site is located at an adit within Blue Eagle Canyon with a rocky berm that dams water at the adit entrance. The site does not support emergent or perimeter vegetation. Oaks (*Quercus* spp.) dominate the overstory within the adjacent drainage. Rockloving spikemoss (*Selaginella rupicola*), hopbush (*Dodonaea viscosa*), and bullgrass (*Muhlenbergia emersleyi*) were also noted near the site. Aquatic invertebrates observed include beetles, boatmen, and backswimmers. No aquatic vertebrates have been observed.

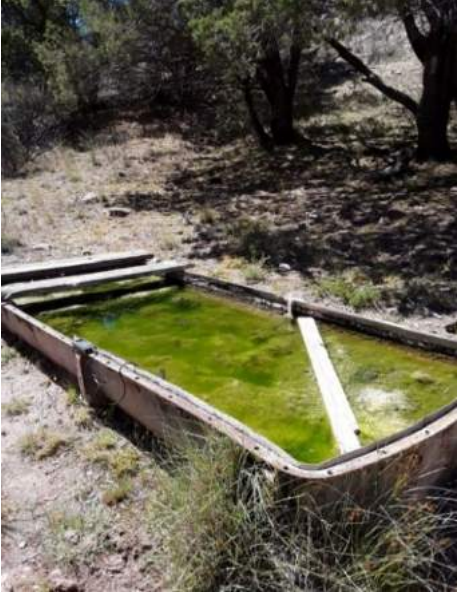
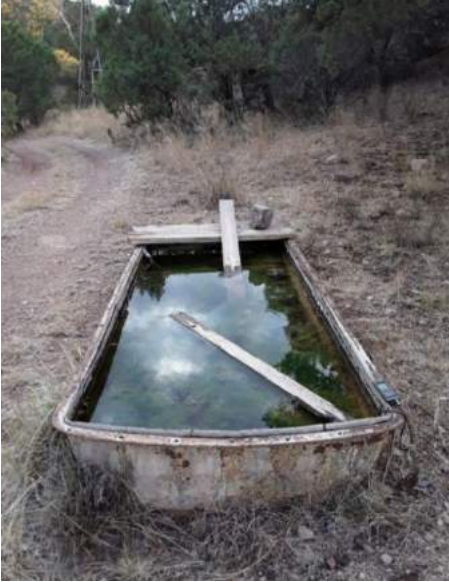
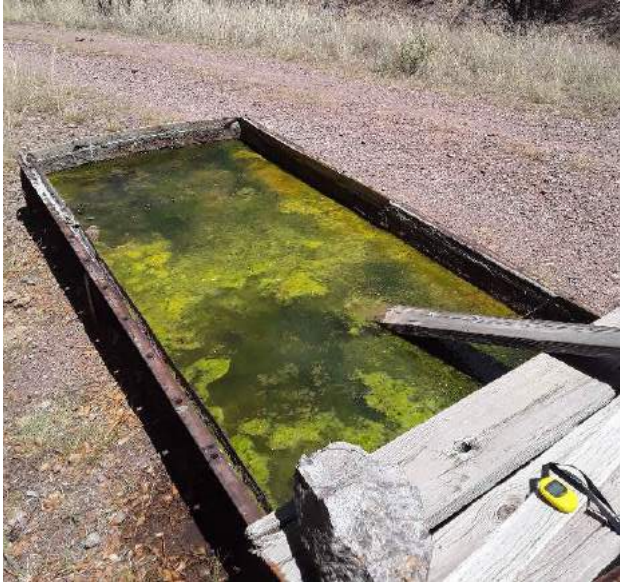
**Aquatic and Vegetation Survey Findings:** This site is an above ground, metal, rectangular stock drinker (approx. 3m x 1m) fed by an adjacent windmill and well system in Corral Canyon. Submerged algae and *Chara* sp. have been observed within the drinker. The site supports no emergent vegetation and only limited perimeter vegetation in the form of cane bluestem (*Bothriochloa barbinodis*) and some Rocky Mountain rush (*Juncus saximontanus*). Upland vegetation surrounding the site is dominated by alligator juniper (*Juniperus deppeana*) and catclaw mimosa (*Mimosa aculeaticarpa* var. *biuncifera*). Aquatic beetles, water boatmen, backswimmers, snails, water striders, and dragonfly larvae have been observed. Invasive American bullfrog (*Lithobates catesbeianus*) and black-necked gartersnake (*Thamnophis cyrtopsis*) have been observed at this drinker.

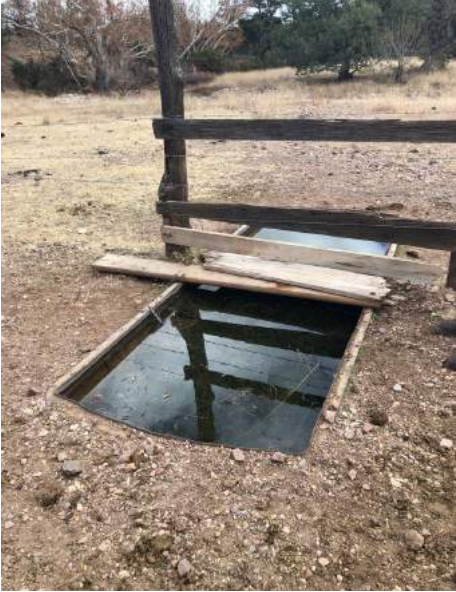
<p style="text-align: center;"><b>Dry Season Photo</b></p> <p style="text-align: center;">No photo taken.</p>	<p style="text-align: center;"><b>Wet Season Photo (12/02/2018)</b></p>

**Aquatic and Vegetation Survey Findings:** This site is a metal, rectangular stock drinker (approx. 3.8m x 1m) sunk at ground-level, located in Corral Canyon. Submerged algae and *Chara* sp. have been observed within the drinker. Vegetation at the site is predominated by invasive Bermudagrass (*Cynodon dactylon*) and southwestern prickly poppy (*Argemone pleiacantha*). Cows have been noted at the site. Aquatic invertebrates observed include backswimmers, beetles, boatmen, dragonflies, and leeches. Invasive American bullfrogs (*Lithobates catesbeianus*) have been observed in recent years at this site.

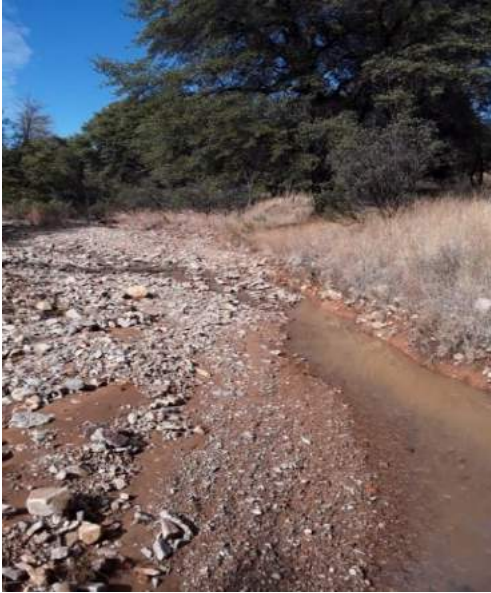
Dry Season Photo	Wet Season Photo (12/6/2019)
<p data-bbox="363 478 553 506">No photo taken</p>

**Aquatic and Vegetation Survey Findings:** This site is a metal open-topped cistern, fed from an adjacent solar well in Chino Draw. This cistern has two attached side drinkers. Water is present within the cistern and the side drinkers as well as an adjacent wetted area as spillover. The overstory vegetation is dominated by Emory oak (*Quercus emoryi*). Understory vegetation is dominated by grasses (*Bouteloua* sp. and *Aristida* sp.), weakleaf bur ragweed (*Ambrosia confertiflora*), and riparian obligate spikerush (*Elocharis* sp.). Invasive vegetation observed includes Bermudagrass (*Cynodon dactylon*). Aquatic invertebrates observed include beetles and boatmen. No aquatic vertebrates have been observed.

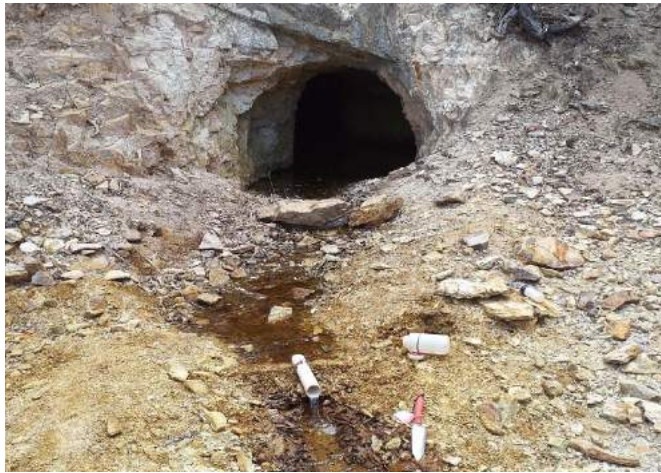
**Dry Season Photo (06/01/2021)**

**Aquatic and Vegetation Survey Findings:** Water flows from an adit on the eastern side of the canyon in upper Cox Gulch, staining the ground surface yellow-orange at the adit entrance. The adit entrance is mostly bare of vegetation; however, water present at entrance supports algae. The overstory cover is dominated by Emory oak (*Quercus emoryi*) in the immediate surrounding area. Aquatic beetles have been present at the adit entrance, but no aquatic vertebrates have been observed. Vertebrate wildlife or sign observed included Mearn's quail (*Cyrtonyx montezumae*) and deer.

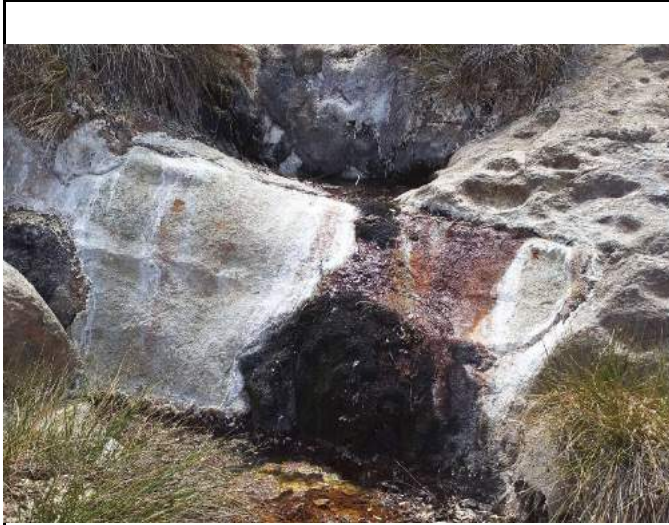
**Dry Season Photo (06/01/2021)**

**Aquatic and Vegetation Survey Findings:** Water seeps from granite joints and flows atop bedrock outcrop in Cox Gulch. Steep and terraced channel with several tinajas. Vegetation is predominantly rushes (*Juncus balticus*) and mosses, with an overstory of Emory oak (*Quercus emoyi*). Invasive Lehmann lovegrass occurs (*Eragrostis lehmanniana*). Aquatic beetles and backswimmers have been present. During the site visit on 06/01/2021, Mexican jays (*Aphelocoma wollweberi*) and Dusky-capped flycatchers (*Myiarchus tuberculifer*) were observed in the vicinity.

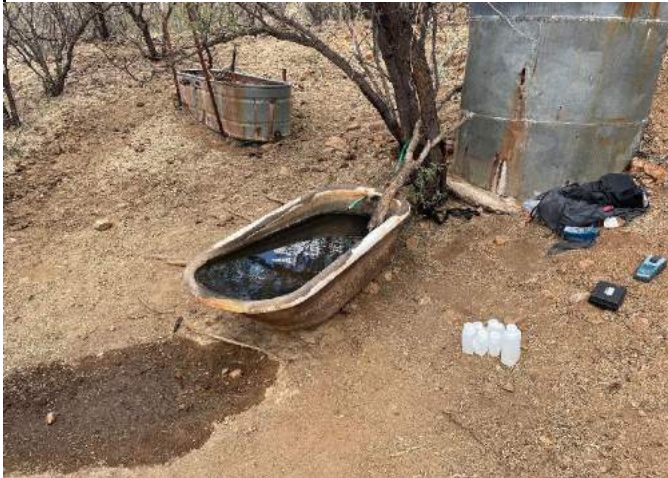
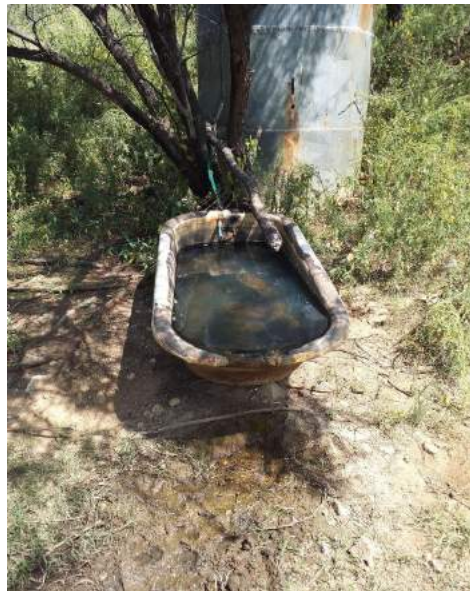
**Dry Season Photo (06/01/2021)**

**Aquatic and Vegetation Survey Findings:** Water flowing into a bathtub fed by an artesian well. During visits, overflow from the bathtub results in wetted stretch of soil typically extending approximately 6 feet. No aquatic invertebrates or herpetofauna have been observed; evidence of cattle, deer, and coyotes have been observed.

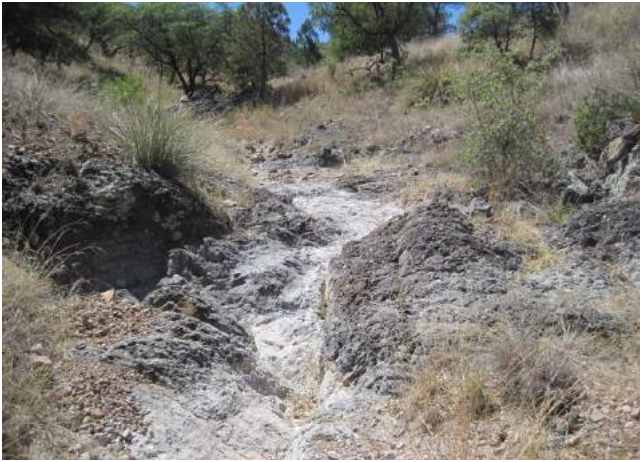
**Dry Season Photo (5/30/2018)**

**Aquatic and Vegetation Survey Findings:** This site is located in cobbly and gravelly section of Flux Canyon with some exposed bedrock. Generally, water is present in shallow, isolated pools near bedrock. Rocky Mountain rush (*Juncus saximontanus*), a riparian obligate species, plains lovegrass (*Eragrostis intermedia*), and bullgrass (*Muhlenbergia emersleyi*) are dominate perimeter vegetation along the drainage bottom. Seep monkeyflower (*Mimulus guttatus*), a wetland associated plant, was noted at this site. Green sprangletop (*Leptochloa dubia*) and other grasses dominate the adjacent hillsides. Arizona white oak (*Quercus arizonica*) provides the limited amount of overstory tree coverage at this site. Invasive plant species observed includes Lehmann lovegrass (*Eragrostis lehmanniana*). Aquatic invertebrates previously noted within the Flux Canyon drainage including beetles, boatmen, backswimmers, dragonflies, and damselflies. No aquatic vertebrates have been observed.

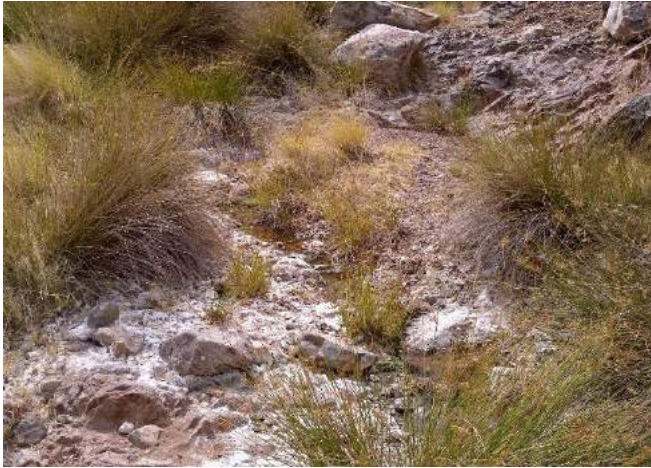
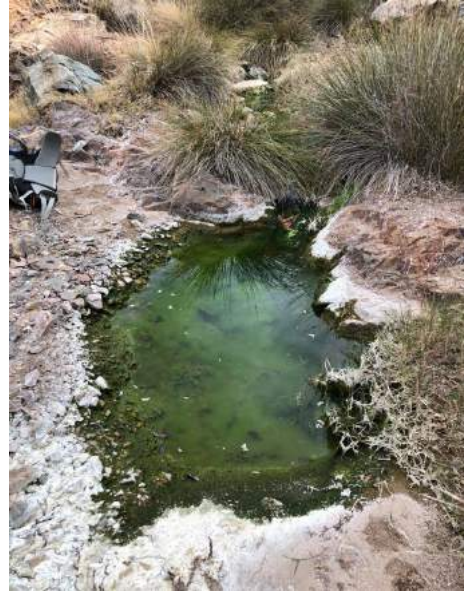
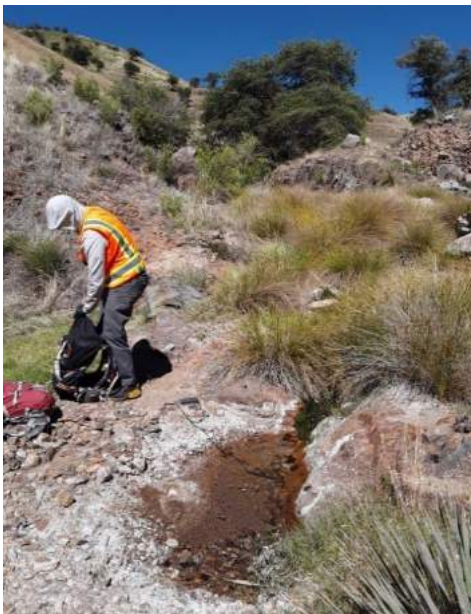
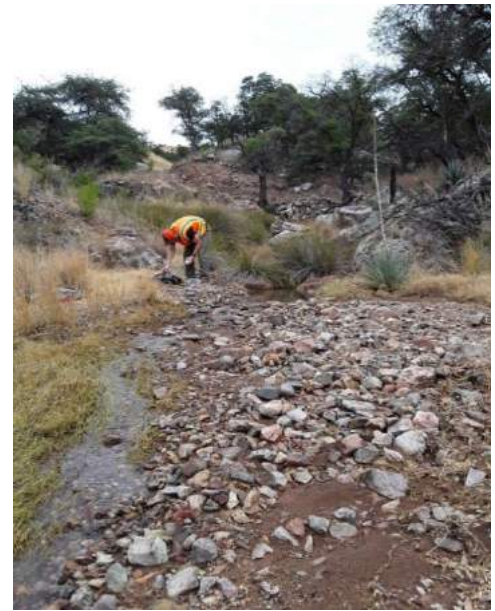
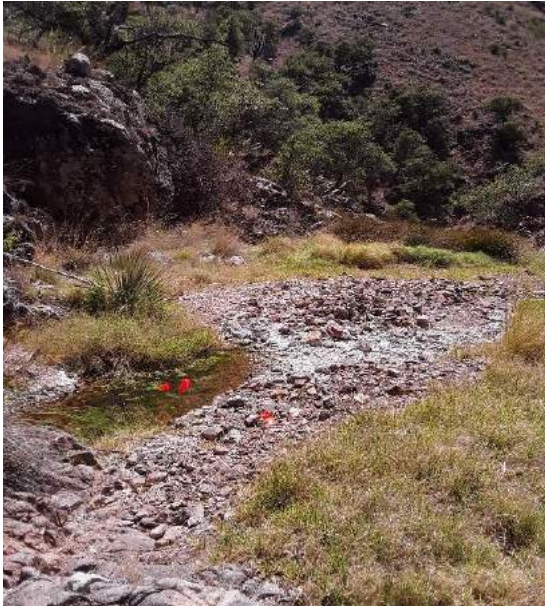
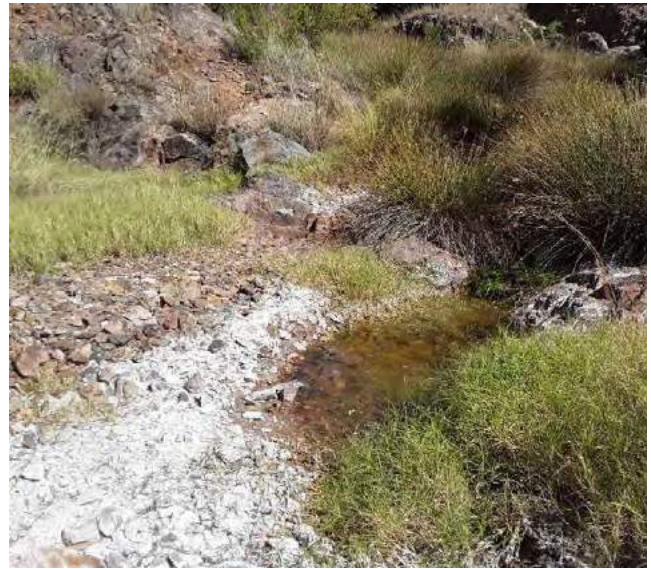
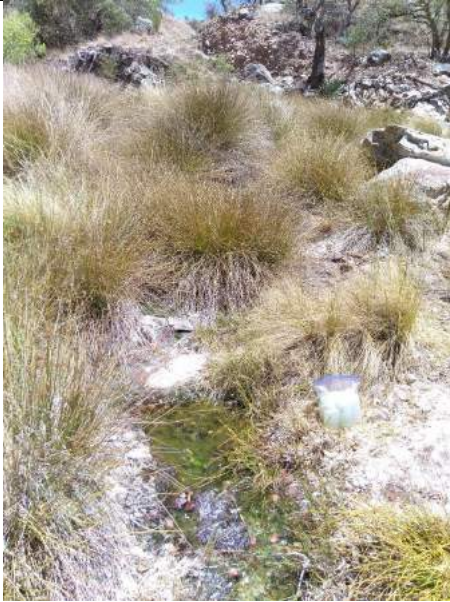
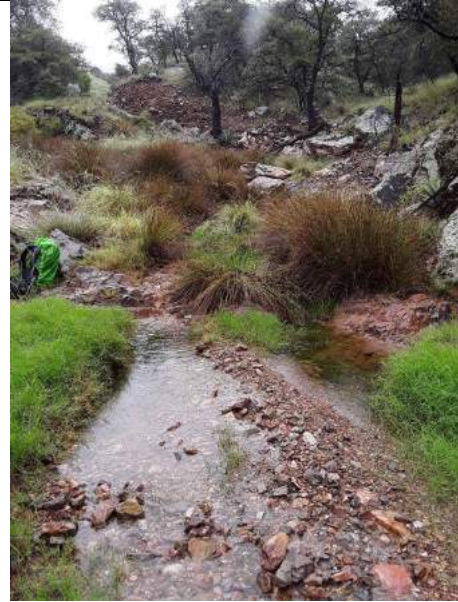
**Aquatic and Vegetation Survey Findings:** Site is located in rocky and cobbly section of Flux Canyon with exposed bedrock. Generally, water is present in shallow pools. Aquatic invertebrates including beetles, boatmen, and damselflies observed. No aquatic vertebrates have been observed. Livestock (scat) and deer (tracks) sign present. Little to no overstory tree coverage is present within the drainage. Emergent and perimeter vegetation is dominated by riparian obligate rushes (*Juncus* spp.), Bermudagrass (*Cynodon dactylon*), and bullgrass (*Muhlenbergia emersleyi*). Drainage lacks riparian vegetation. North-facing slopes are dominated by upland tree and shrub species (oaks [*Quercus* spp.], junipers [*Juniperus* spp.], and hopbush [*Dodonaea viscosa*]), while south-facing slopes are dominated by grasses with sotol (*Dasyliirion wheeleri*) and Palmer agave (*Agave palmeri*) present. Invasive plant species observed are Bermudagrass (*Cynodon dactylon*).

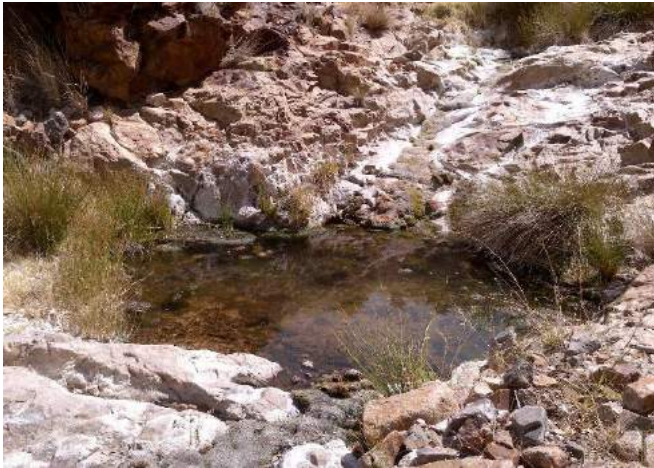
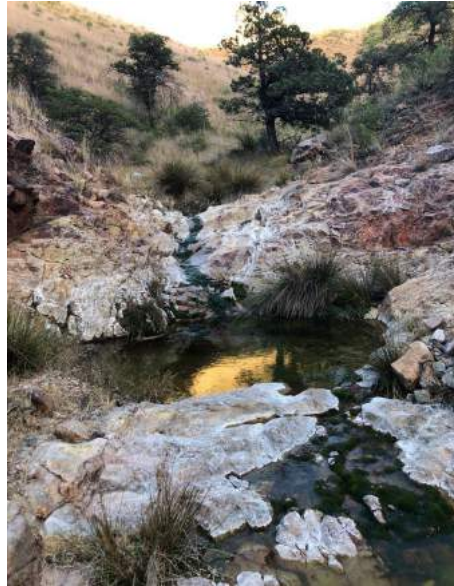
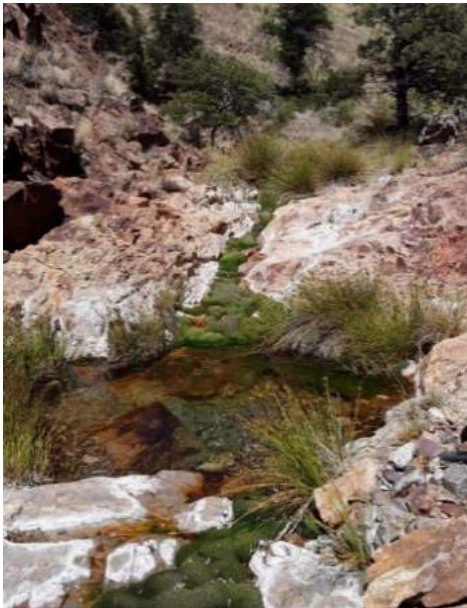
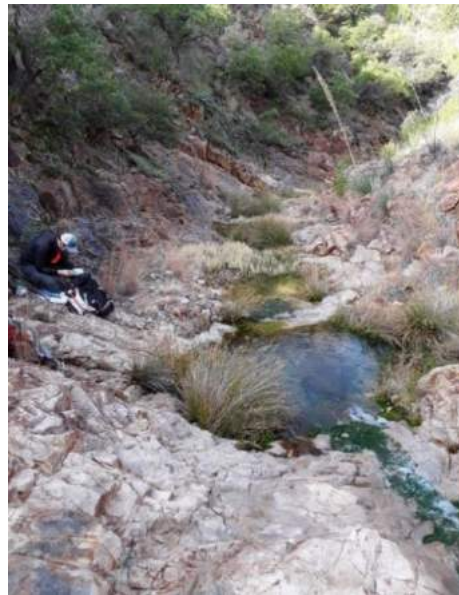
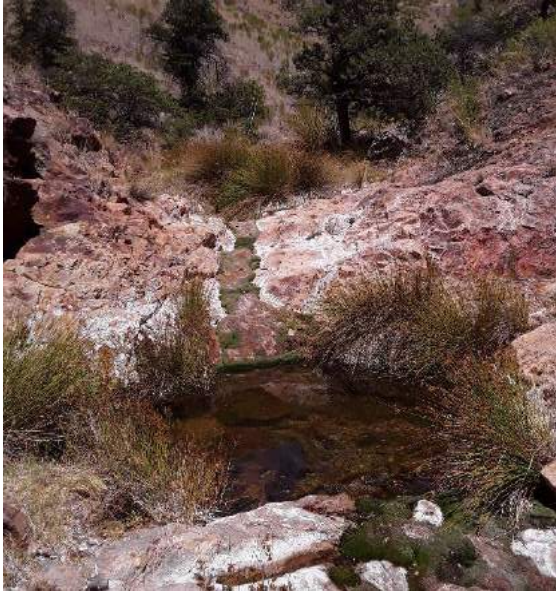
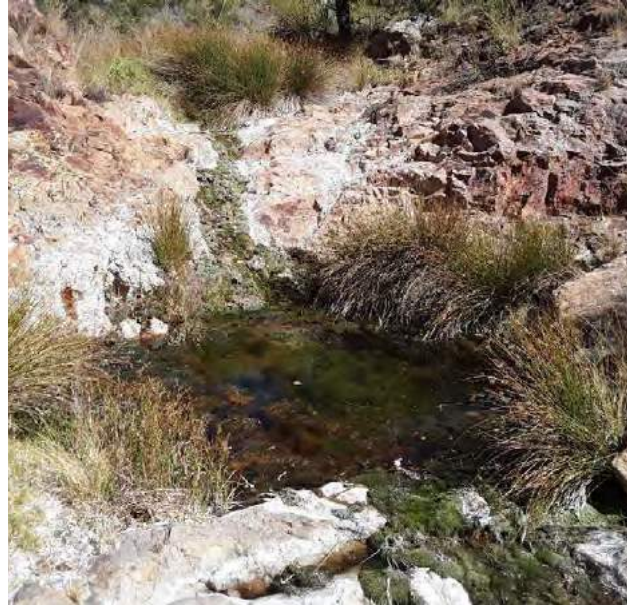
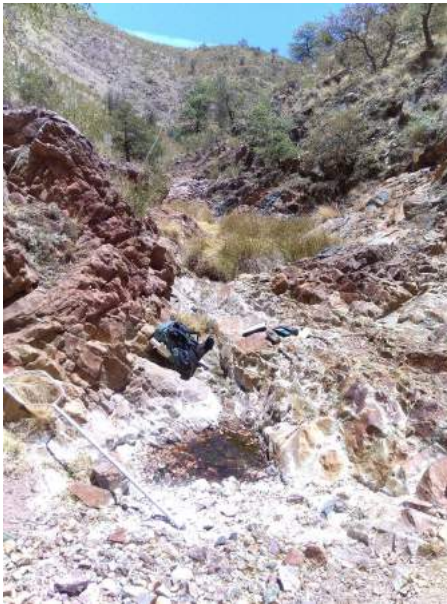
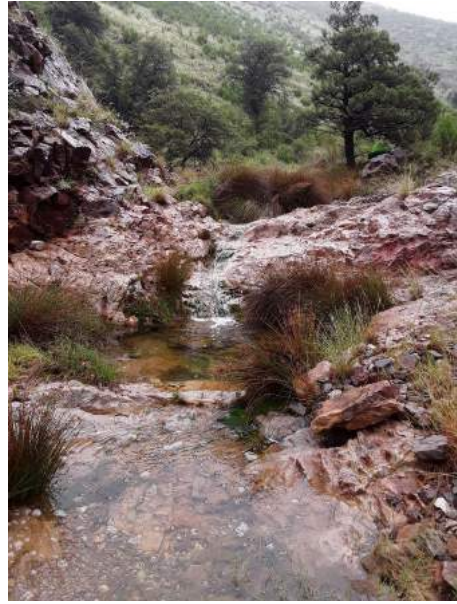
**Aquatic and Vegetation Survey Findings:** Site is located in bedrock bottom section of Flux Canyon. Generally, water is present in shallow pools. Aquatic beetles and boatmen have been observed. No aquatic vertebrates observed have been observed. Deer tracks have been noted at this site. No overstory tree coverage is present at this site in the drainage. Emergent and perimeter vegetation is dominated by riparian obligate *Juncus* spp., Bermudagrass (*Cynodon dactylon*), and bullgrass (*Muhlenbergia emersleyi*). Drainage lacks riparian tree vegetation. North-facing slopes are dominated by Emory oak (*Quercus emoryii*) and hopbush (*Dodonaea viscosa*), while south-facing slopes are dominated by grasses with sotol (*Dasylirion wheeleri*) and Palmer agave (*Agave palmeri*) present. Invasive plant species observed includes Bermudagrass (*Cynodon dactylon*).

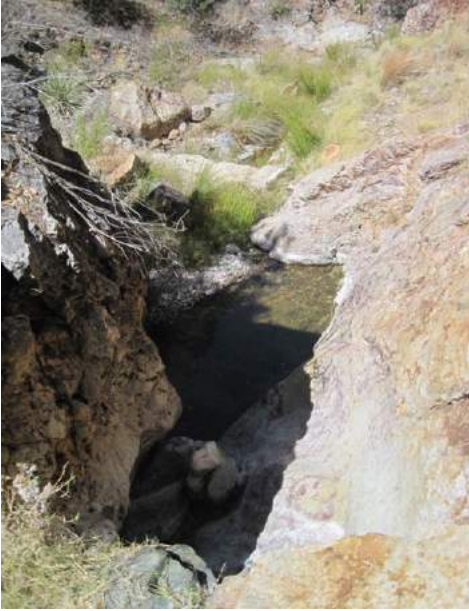
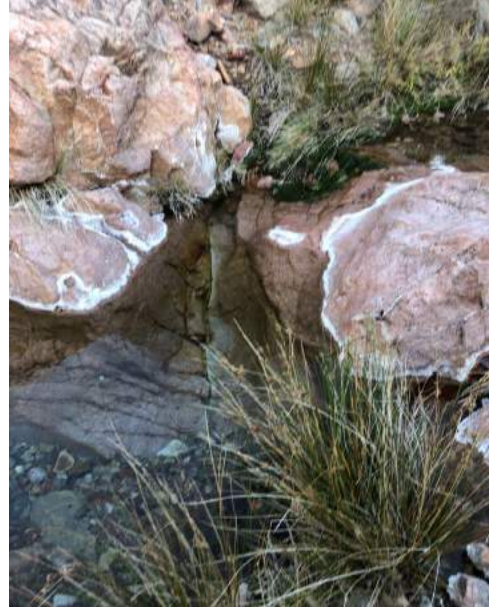
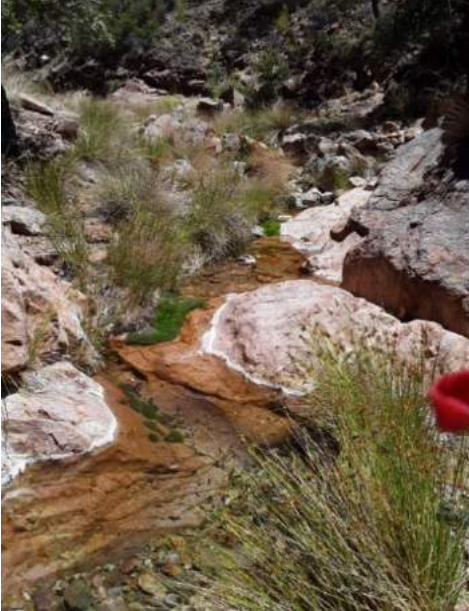
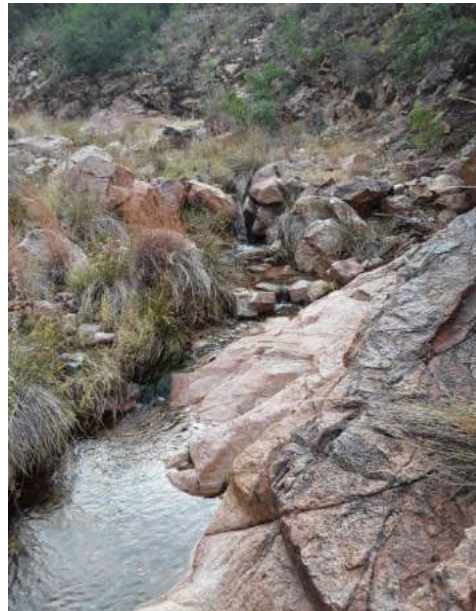
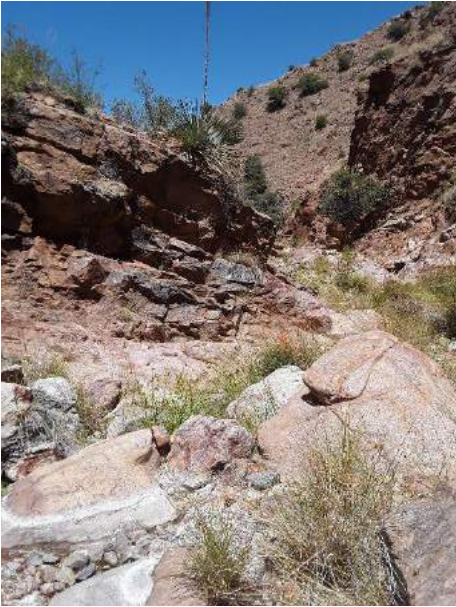
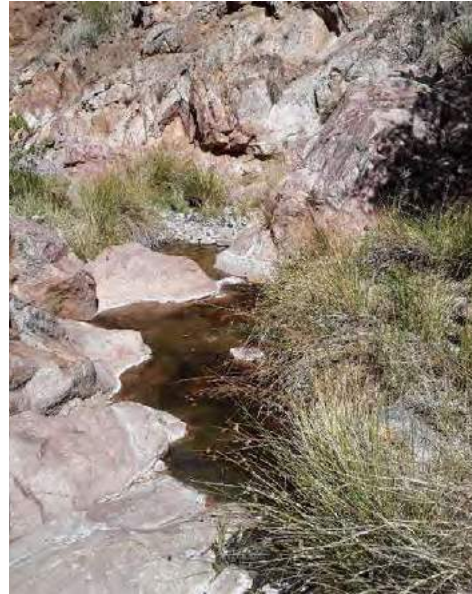
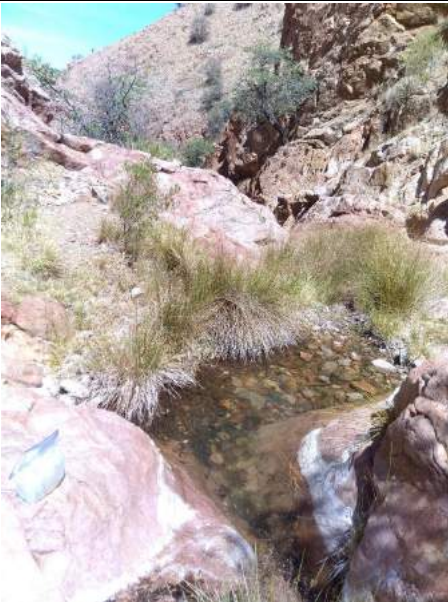
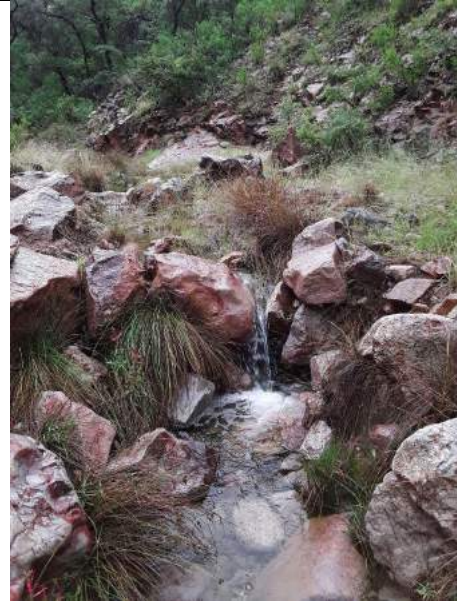
**Aquatic and Vegetation Survey Findings:** Site is located in rocky and bouldery section of lower Flux Canyon. Generally, water is present in shallow pools. Aquatic beetles and boatmen have been observed. No aquatic vertebrates observed have been observed. Deer tracks have been noted at this site. No overstory tree coverage is present at this site within the drainage. Emergent and perimeter vegetation is dominated by riparian obligate *Juncus* spp., Bermudagrass (*Cynodon dactylon*), bullgrass (*Muhlenbergia emersleyi*), and deergrass (*Muhlenbergia rigens*). Drainage lacks riparian tree vegetation. North-facing slopes are dominated by Emory oak (*Quercus emoryi*) and hopbush (*Dodonaea viscosa*), while south-facing slopes are dominated by grasses. Invasive plant species observed are Lehmann lovegrass (*Eragrostis lehmanniana*) and Bermudagrass (*Cynodon dactylon*).
