# Hermosa Spring and Seep Catalog

Hermosa Project Area

## SPRING AND SEEP CATALOG Hermosa Project Area

### INTRODUCTION

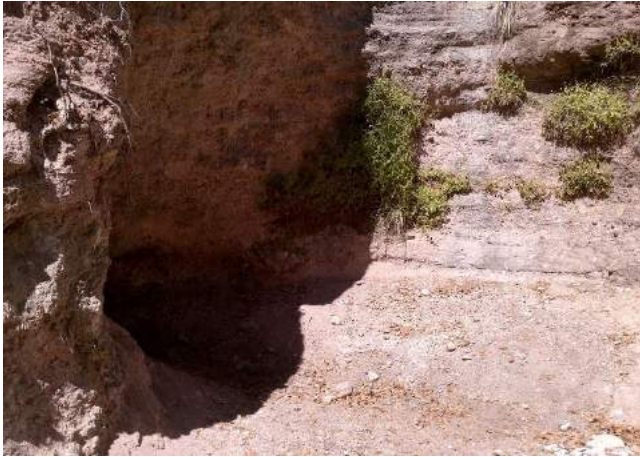
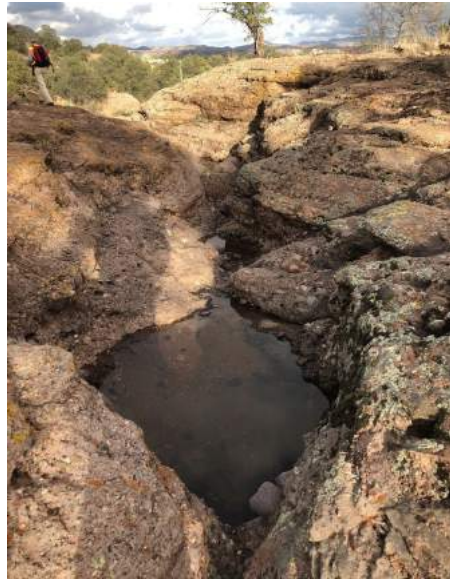
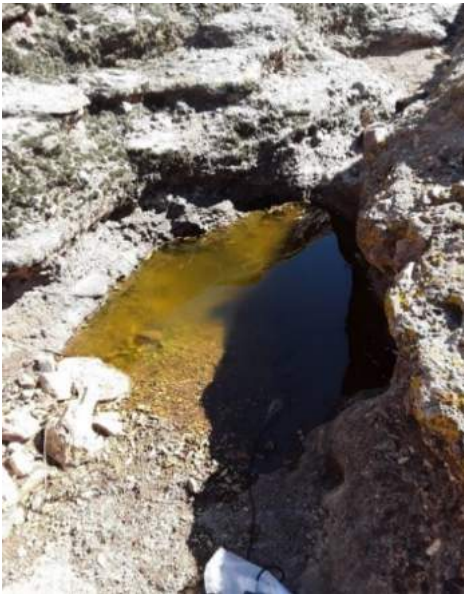
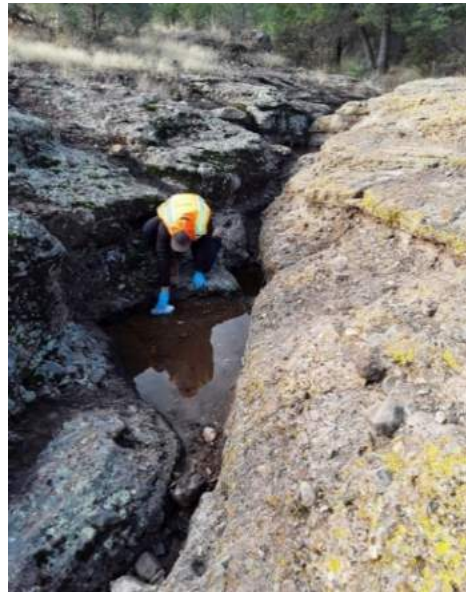
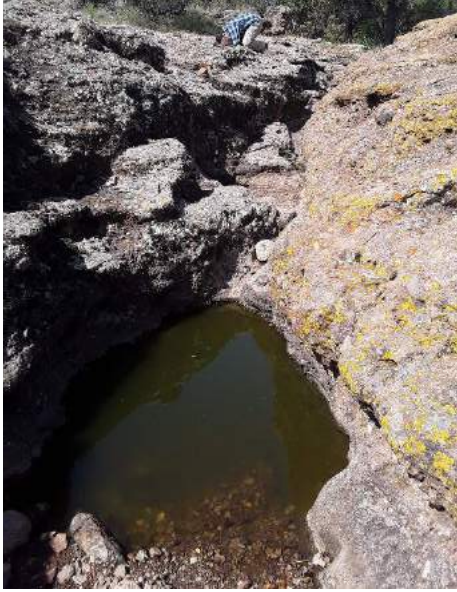
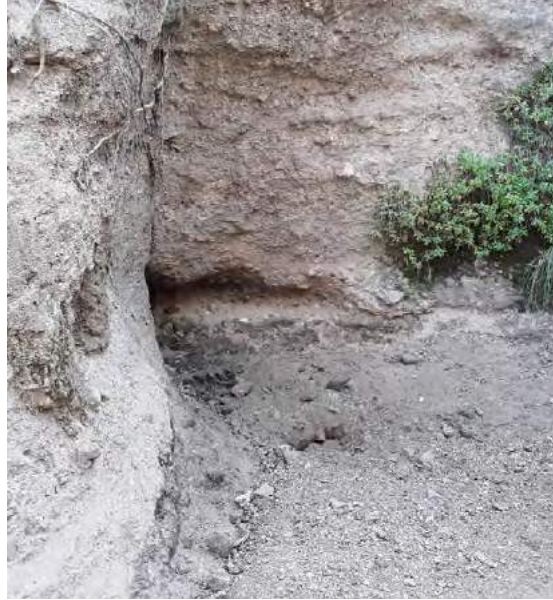
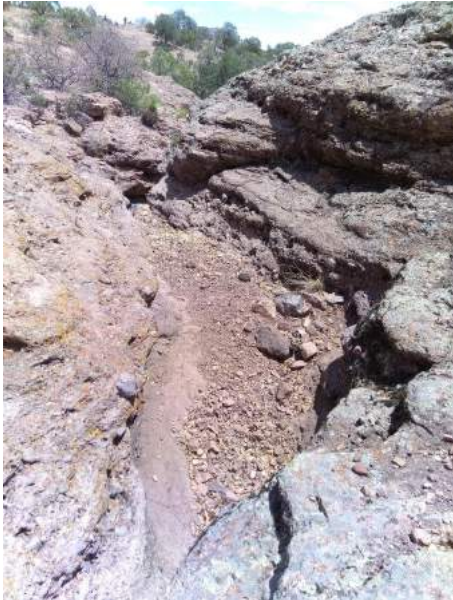
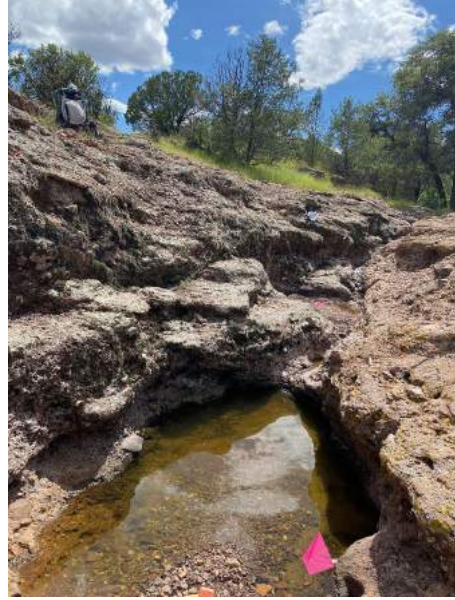
**Aquatic and Vegetation Survey Findings:** This site is located within exposed bedrock in Goldblau Canyon. Water is present in series of small tinajas. This site does not support any emergent or perimeter vegetation. No overstory tree species occur at this site. Trace vegetation noted nearby include Ipomopsis (*Ipomopsis* sp.) and deergrass (*Muhlenbergia rigens*). Canyon treefrog (*Hyla arenicolor*) have been observed at this site.

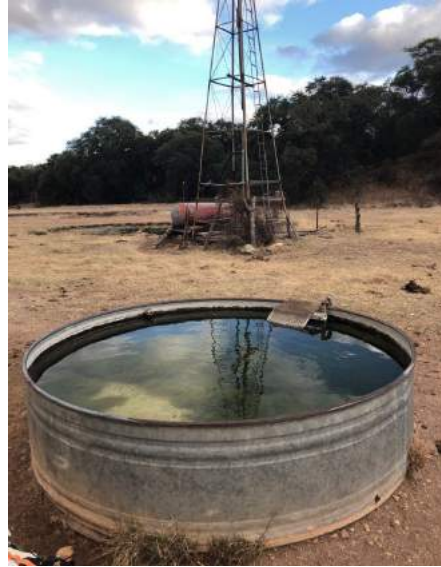
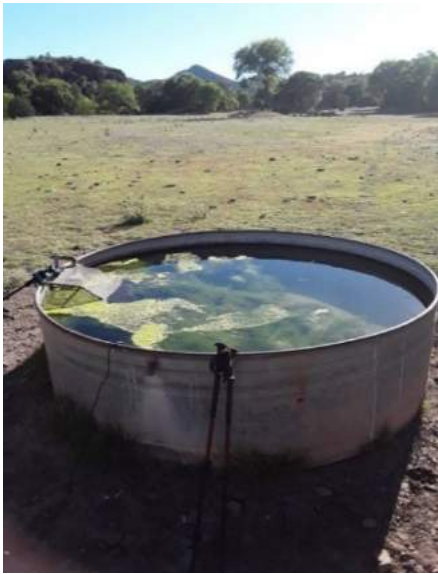
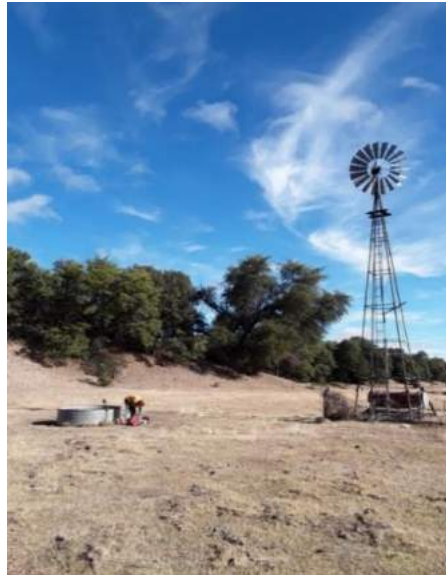
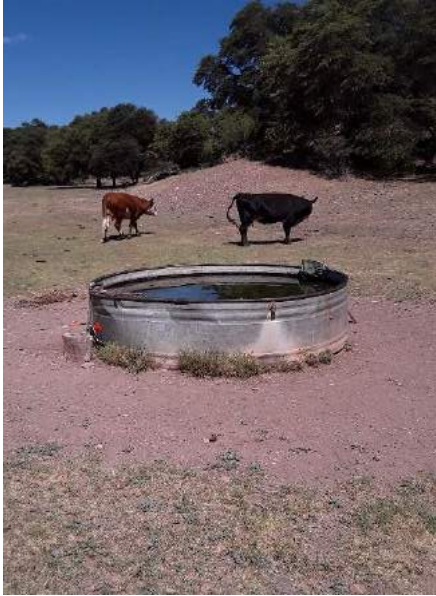
**Aquatic and Vegetation Survey Findings:** This site consists of a metal, circular stock drinker (approx. 1.8m in diameter) located in Goldbaum Canyon. The drinker is fed by an adjacent windmill and well. There is some accumulated silt along the bottom of the drinker. Submerged algae (*Chara* sp.) is typically present in this drinker. No overstory vegetation is present. Invasive Bermudagrass (*Cynodon dactylon*) occurs around the base of the drinker. Aquatic invertebrates observed include beetles, backswimmers, boatmen, dragonflies, water scorpion, leeches, and snails. No aquatic vertebrates or herpetofauna have been observed. Livestock has been observed around the stock tank and the site is heavily grazed.

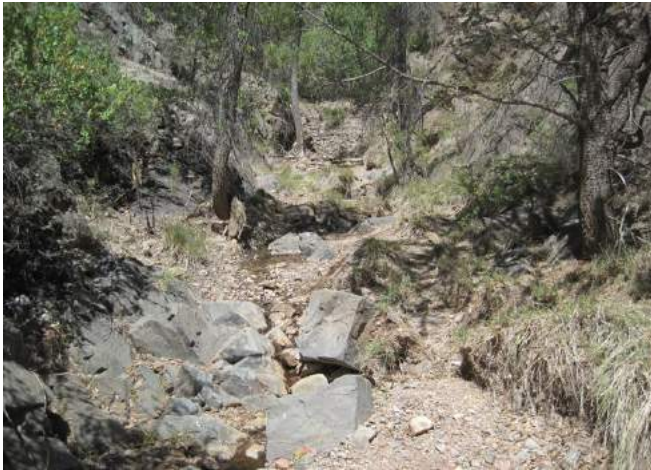
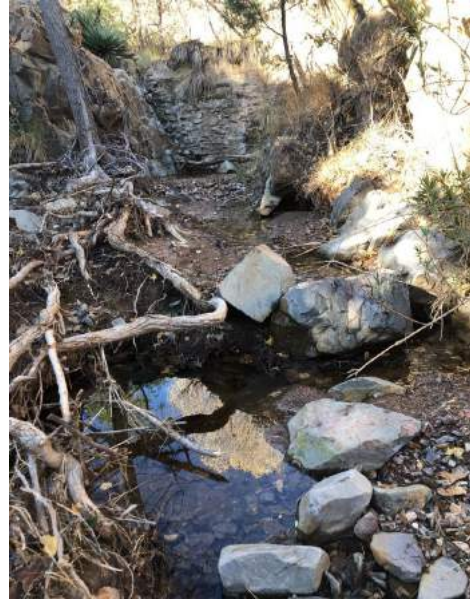
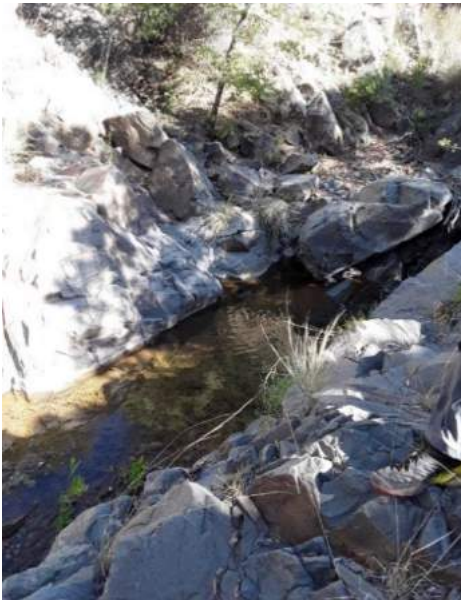
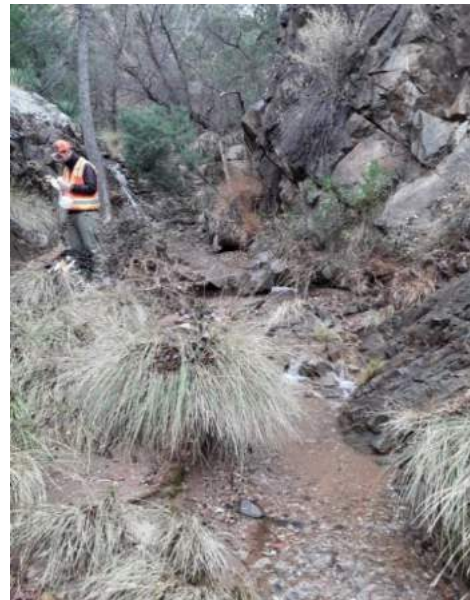
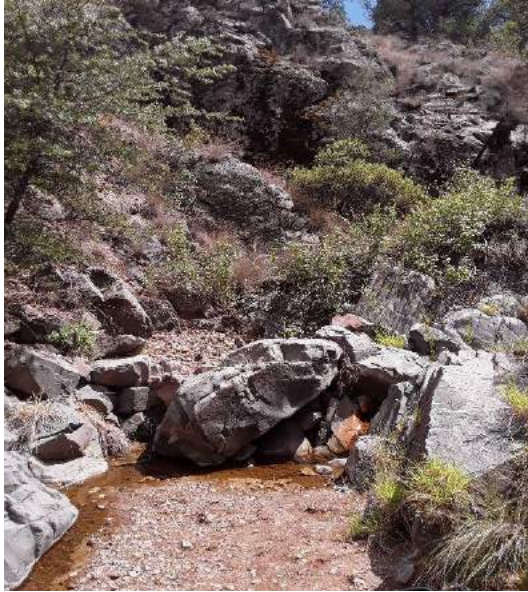
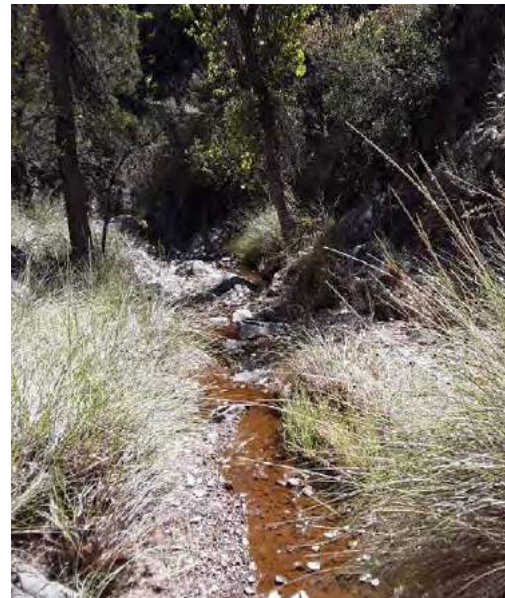
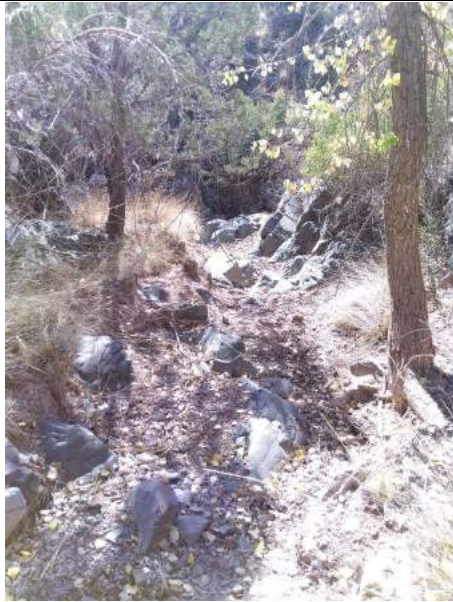
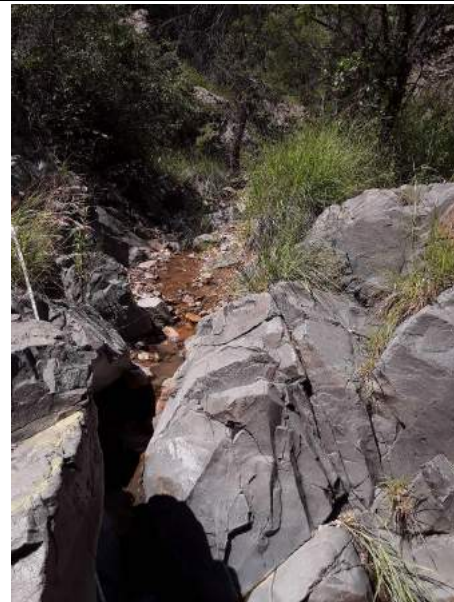
**Aquatic and Vegetation Survey Findings:** Feature consists of a relic dam that has silted in along Harshaw Creek. A pipe driven into the bottom of the dam allows for the passage of water within the alluvium behind the dam to the downstream drainage. During monsoons, flowing water is consistently present below the dam. Aquatic invertebrates but no aquatic vertebrates have been observed. Drainage substrate is mix of bedrock, boulders, gravel, and sand. Arizona white oak (*Quercus arizonica*), alligator juniper (*Juniperus deppeana*), and Fremont cottonwood (*Populus fremontii*) dominate the overstory. Understory vegetation includes deergrass (*Muhlenbergia rigens*), silktassel (*Garrya wrightii*), Arizona grape (*Vitis arizonica*), seepwillow (*Baccharis salicifolia*), and skunkbush sumac (*Rhus trilobata*).

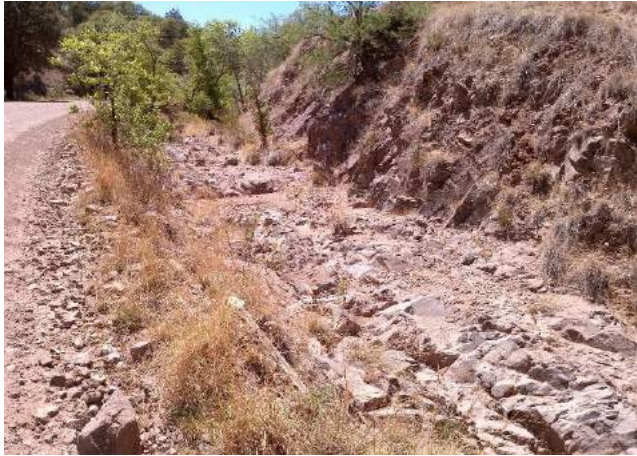
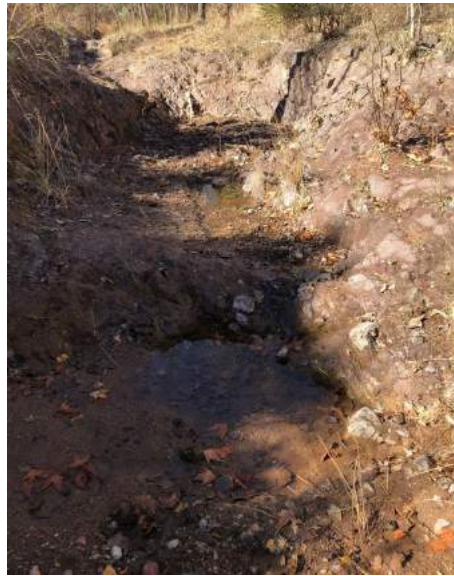
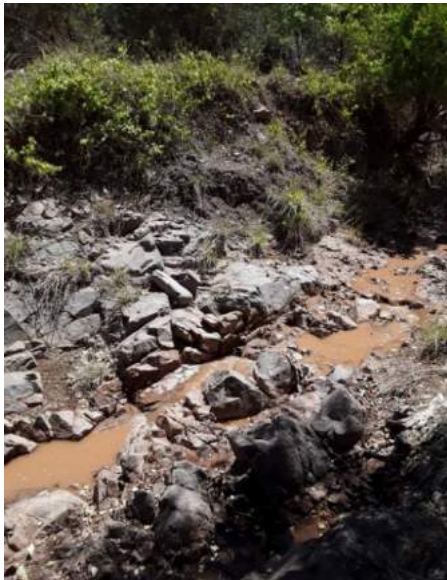
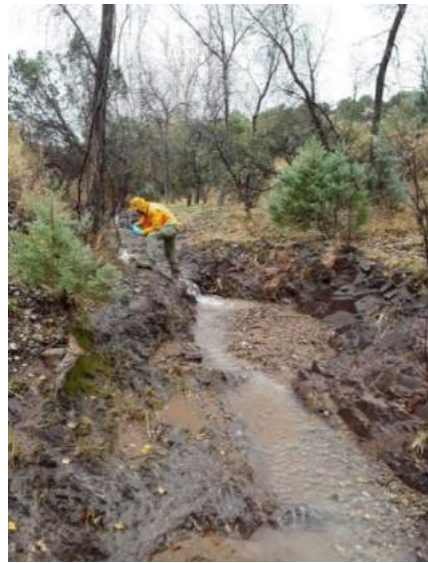
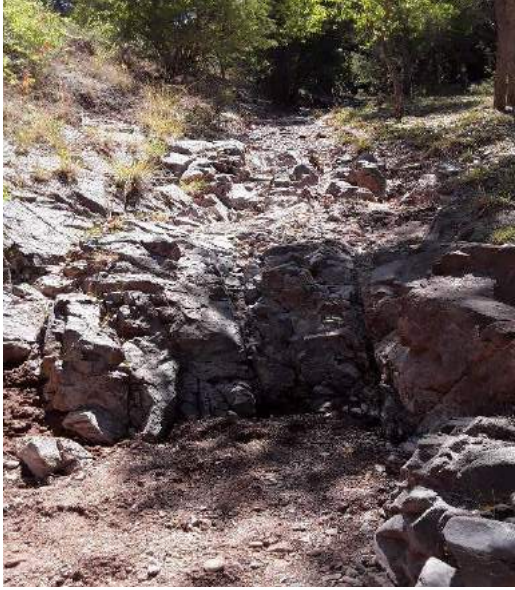
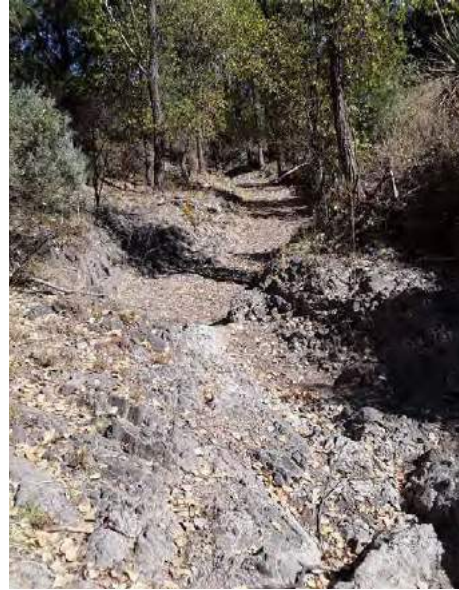
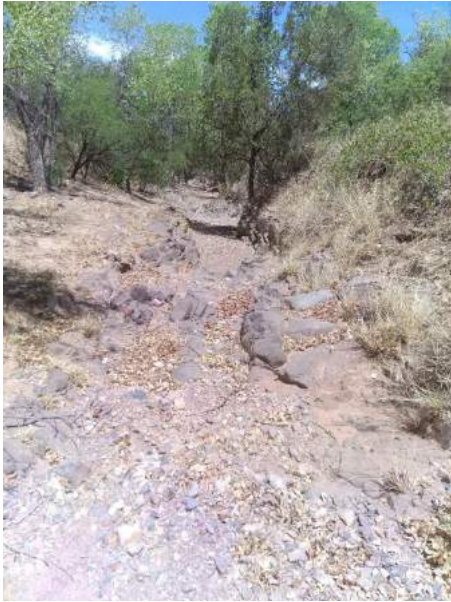
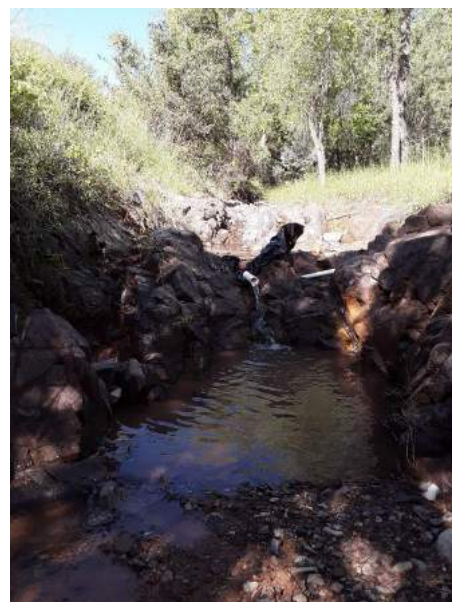
**Aquatic and Vegetation Survey Findings:** This site is located in a section of Harshaw Creek with gravely, sandy substrate and bedrock constrictions. When water is present, it is typically available in shallow pools. Limited herbaceous vegetation cover is dominated by deergrass (*Muhlenbergia rigens*) and other perennial grasses (*Poaceae* family). Riparian overstory tree cover is dominated by Fremont cottonwood (*Populus fremontii*) and Arizona sycamore (*Platanus wrightii*). Velvet mesquite (*Prosopis velutina*) and alligator juniper (*Juniperus deppeana*) are also present in the midstory. Non-native annual rabbitsfoot grass (*Polypogon monspeliensis*) has been observed. Aquatic invertebrates along this section of the drainage generally include boatmen, damselflies, beetles and water striders. No aquatic vertebrates have been observed.

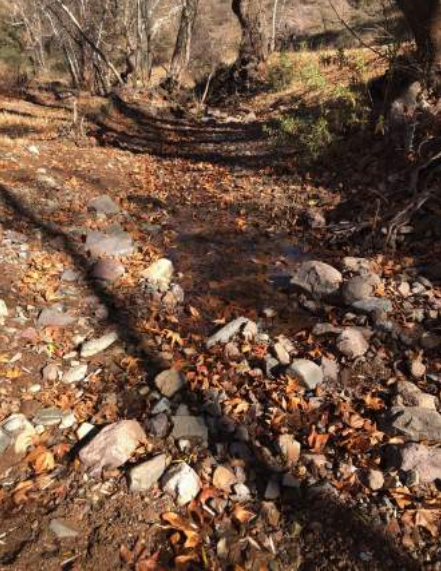
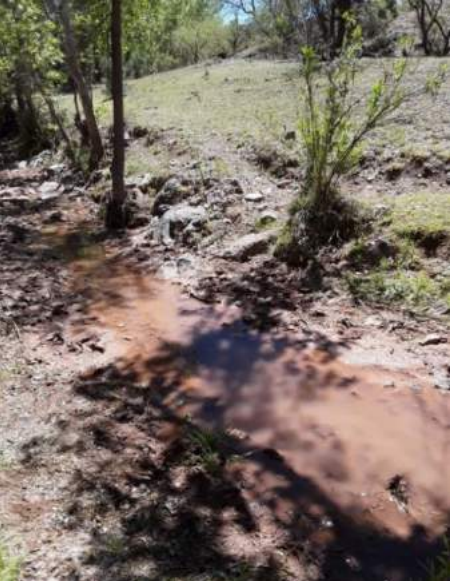
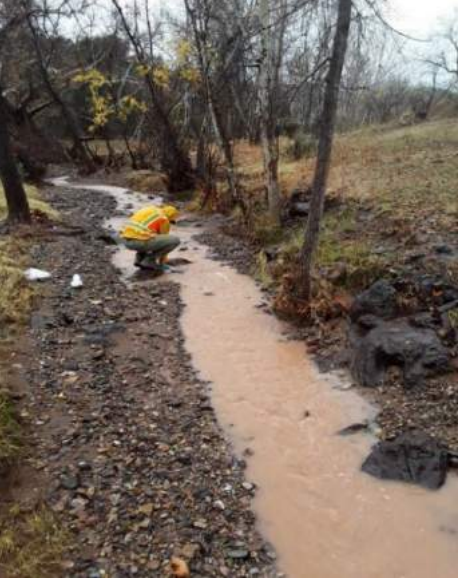
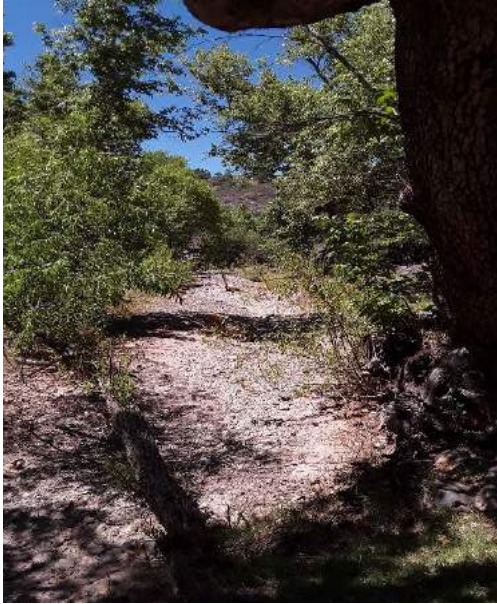
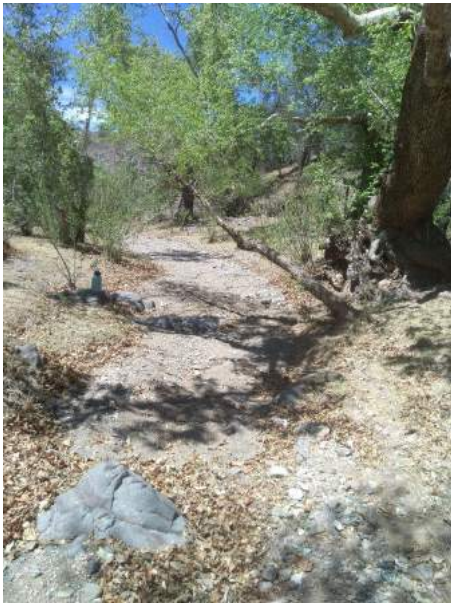
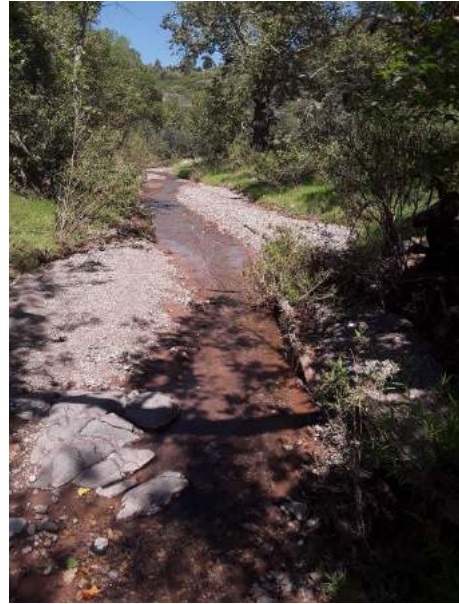
**Aquatic and Vegetation Survey Findings:** This site is located in a rocky, gravelly, and sandy section of Harshaw Creek with some bedrock constrictions. Riparian tree species including Fremont cottonwood (*Populus fremontii*) and Arizona sycamore (*Platanus wrightii*) dominate the overstory vegetation. Bonpland willow (*Salix bonplandiana*) is also present. Understory vegetation includes deergrass (*Muhlenbergia rigens*), Arizona grape (*Vitis arizonica*), and narrowleaf willow (*Salix exigua*). Non-native annual rabbitsfoot grass (*Polypogon monspeliensis*) and beardless rabbitsfoot grass (*Polypogon viridis*) have been observed along with invasive Bermudagrass (*Cynodon dactylon*). No aquatic invertebrates or vertebrates have been observed.

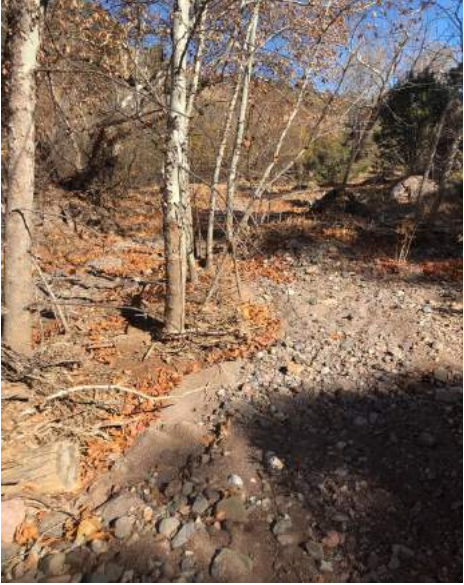
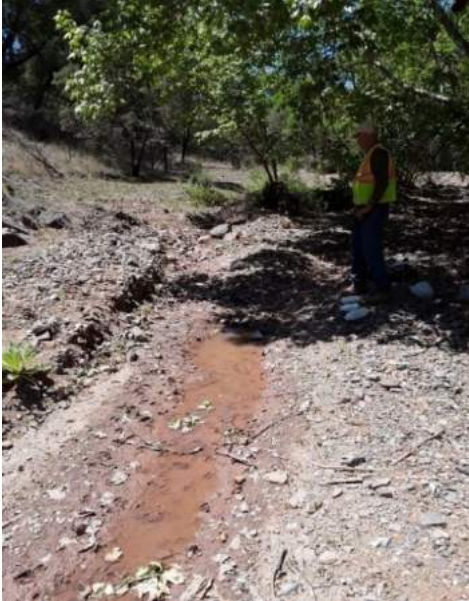
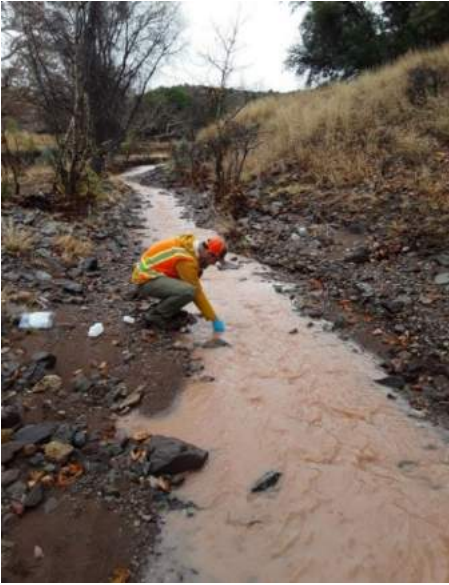
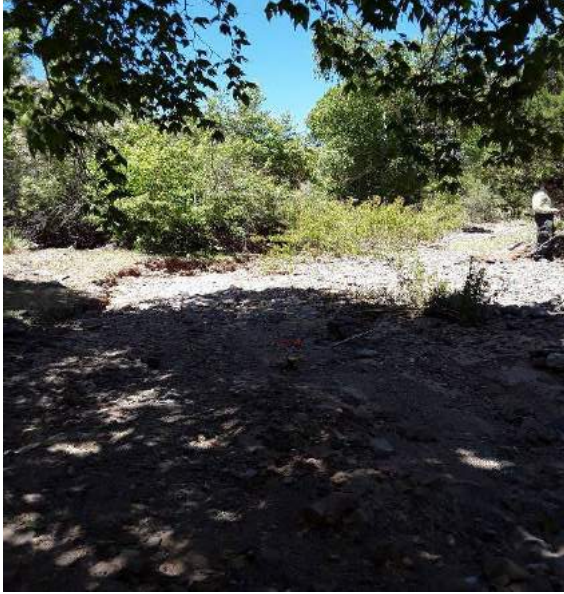
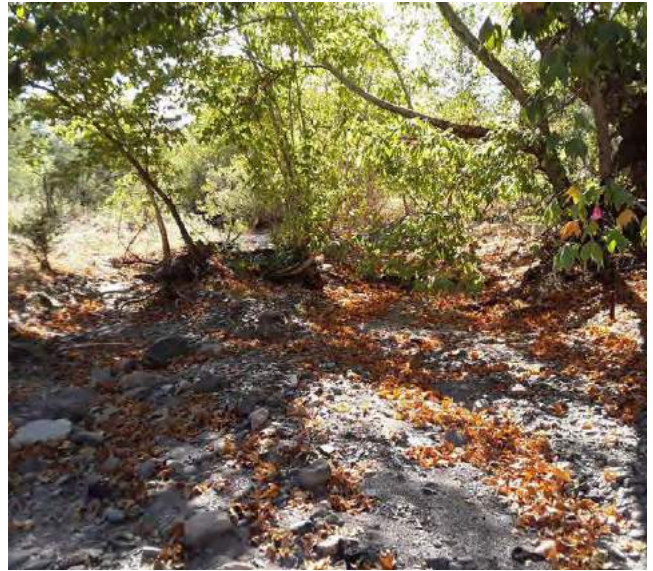
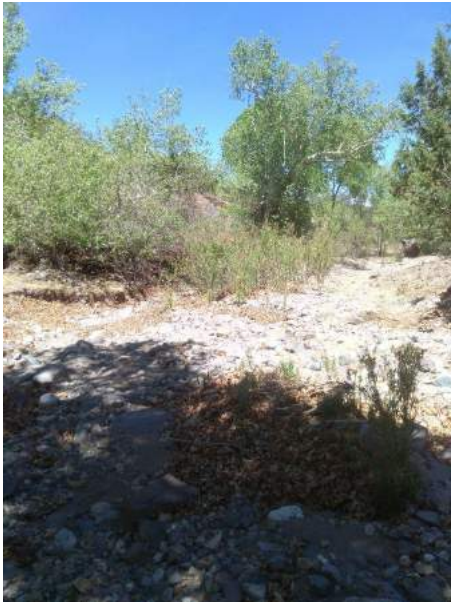
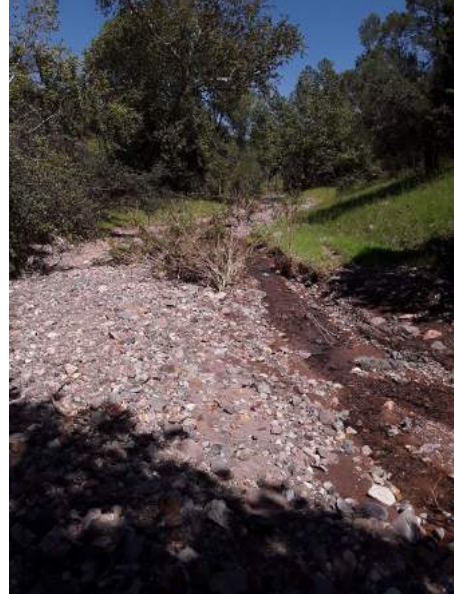
**Aquatic and Vegetation Survey Findings:** This site is located in a rocky, gravelly, and sandy section of Harshaw Creek. This site was dry during both pre-monsoon and monsoon visits in 2020. Arizona sycamore (*Platanus wrightii*), a preferential riparian tree species, dominates the overstory tree canopy with alligator juniper (*Juniperus deppeana*) also present. Understory vegetation is limited and includes Arizona grape (*Vitis arizonica*) and seepwillow (*Baccharis salicifolia*). Invasive plant species observed include Bermudagrass (*Cynodon dactylon*) and common mullein (*Verbascum thapsus*). No aquatic vertebrates have been observed.

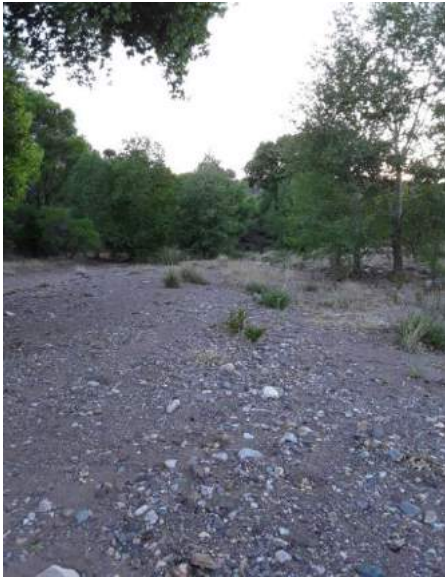
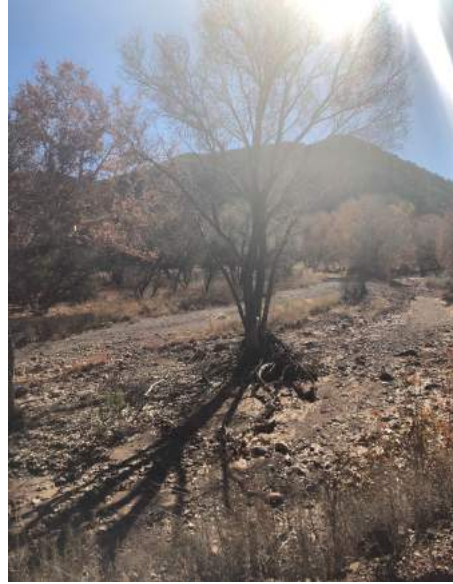
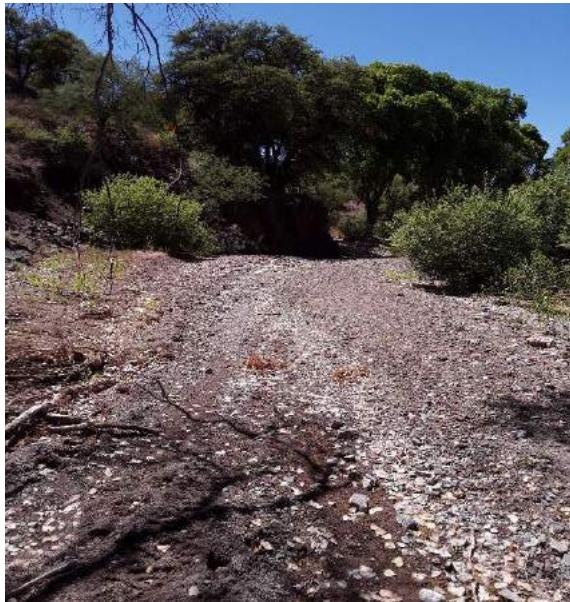
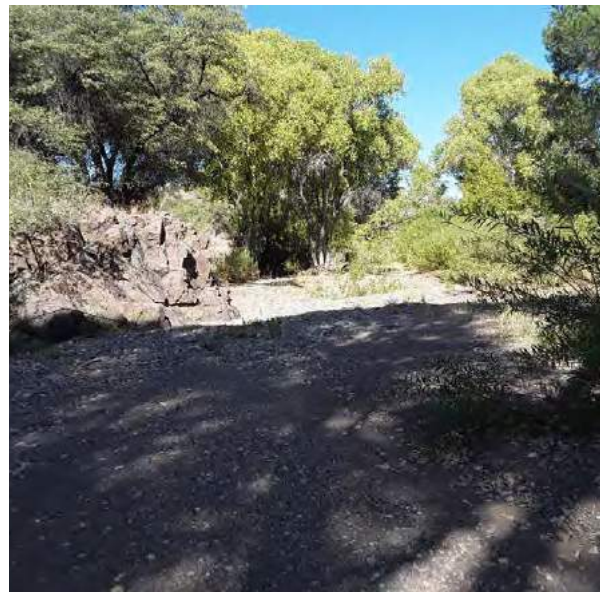
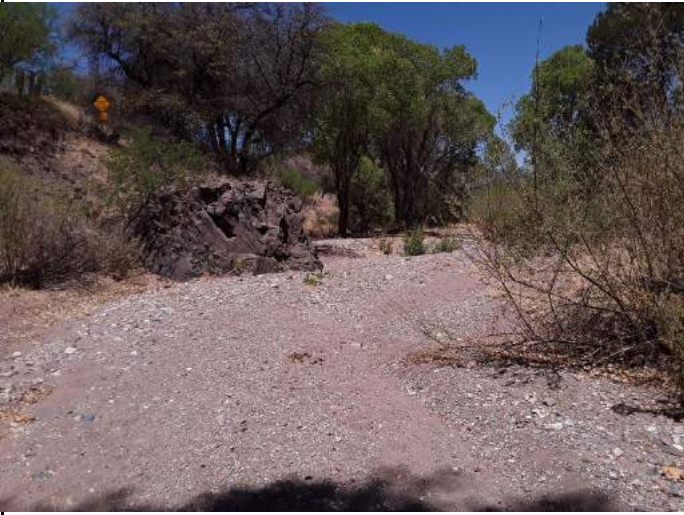
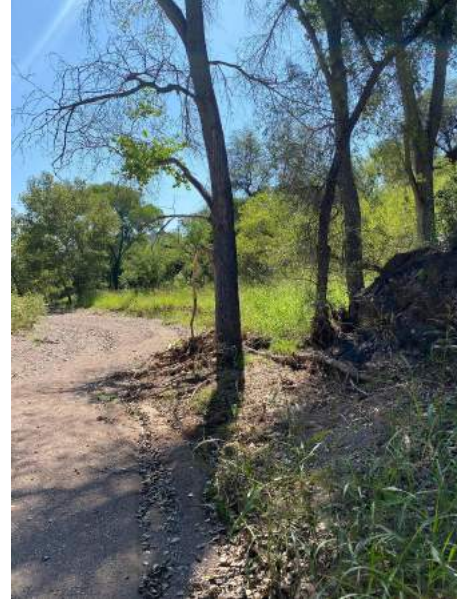
**Aquatic and Vegetation Survey Findings:** This site is located in a wide, sandy and gravelly section of Harshaw Creek. The overstory tree canopy is dominated by riparian trees including Fremont cottonwood (*Populus fremontii*) and Goodding's willow (*Salix gooddingii*). Seepwillow (*Baccharis salicifolia*) occurs sparingly at the channel edges. Seep monkeyflower (*Mimulus guttatus*), a wetland associated plant, was noted at this site. Non-native annual rabbitsfoot grass (*Polypogon monspeliensis*) and invasive plants, common mullein (*Verbascum thapsus*), Johnson grass (*Sorghum halepense*), and Lehmann lovegrass (*Eragrostis lehmanniana*), have been observed.

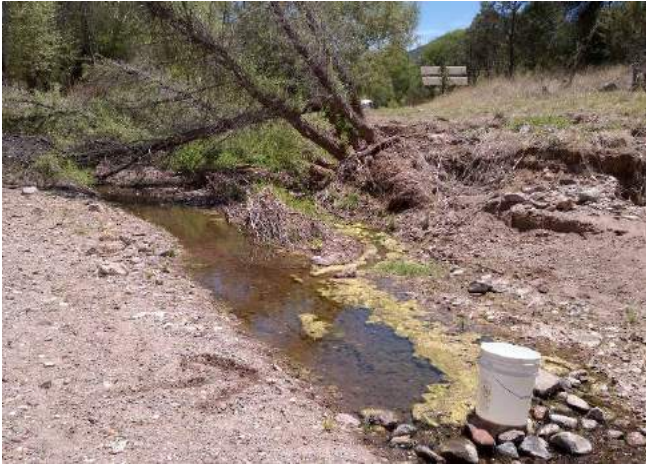
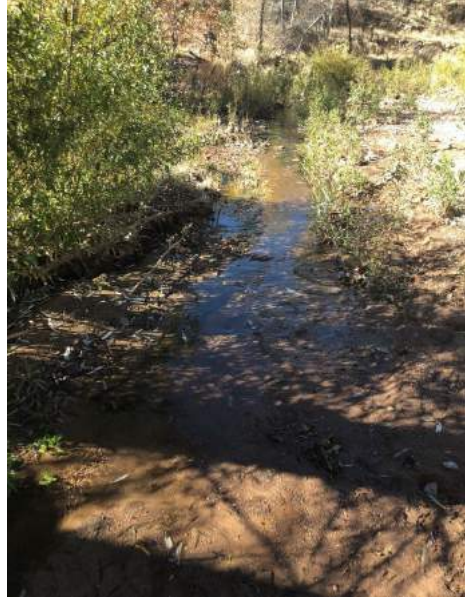
Water is present during pre-monsoon and monsoon surveys. Longfin dace (*Agosia chrysogaster*), canyon tree frog (*Hyla arenicolor*) tadpoles, and black-necked gartersnakes (*Thamnophis cyrtopsis*) have been observed along this wetted stretch of Harshaw. Aquatic beetles, boatmen, backswimmers, dragonflies, damselflies, mayflies, waterscorpions, belostomatids, and snails have been observed. Invasive plants noted include Johnsongrass (*Sorghum halepense*), common mullein (*Verbascum thapsus*), Bermudagrass (*Cynodon dactylon*), gummy lovegrass (*Eragrostis curtipedicellata*), Lehmann lovegrass (*Eragrostis lehmanniana*), cocksbur grass (*Echinochloa* spp.), yellow bluestem (*Bothriochloa ischaemum*), Sahara mustard (*Brassica tournefortii*), and saltcedar (*Tamarisk* spp.).

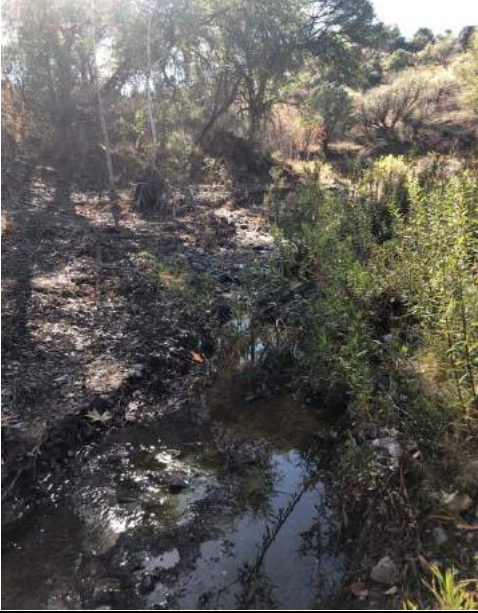
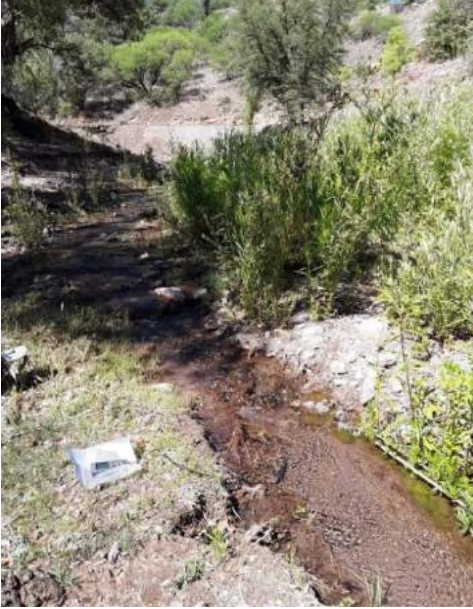
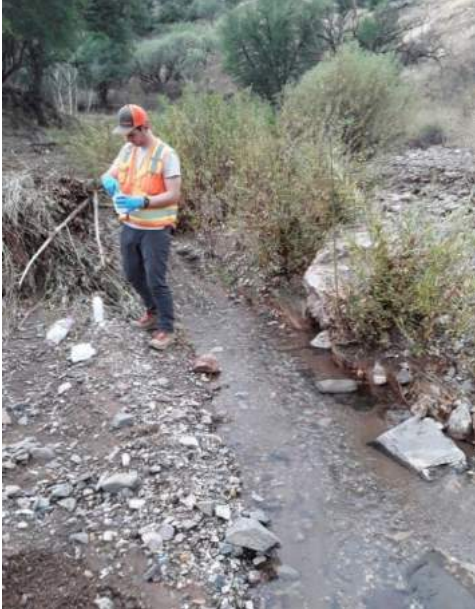
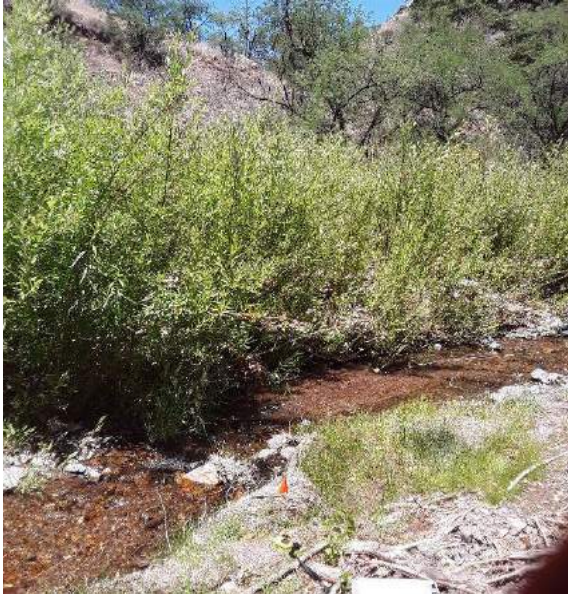
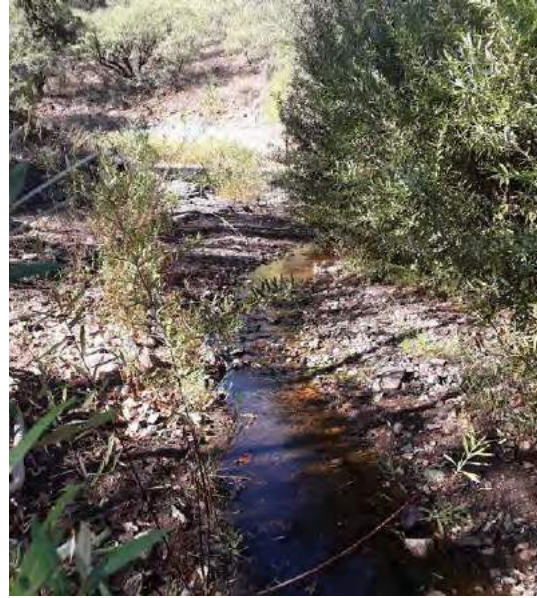
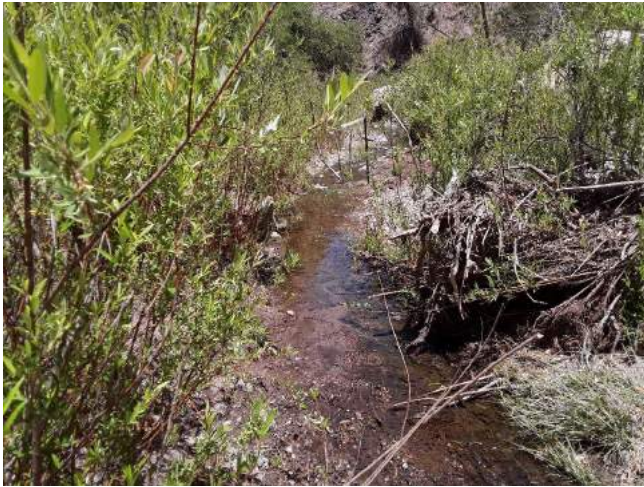
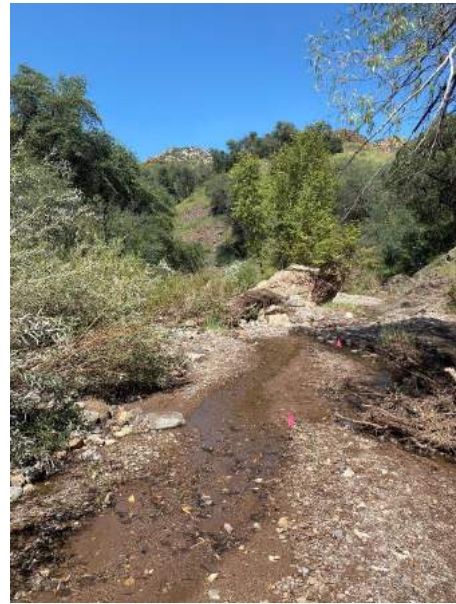
**Aquatic and Vegetation Survey Findings:** This site is located in a wetted section of Harshaw Creek with gravelly and sandy substrate. Water is available in shallow riffles and runs. Goodding's willow (*Salix gooddingii*) and Fremont cottonwood (*Populus fremontii*) are the dominant riparian overstory tree species while seepwillow (*Baccharis salicifolia*) and riparian obligate spikerush (*Eleocharis* sp.) are dominant emergent vegetation. Wetland associated plants, cattail (*Typha* sp.) and monkeyflower (*Mimulus* sp.), have been observed. Non-native annual rabbitsfoot grass (*Polypogon monspeliensis*) and invasive plants, Johnsongrass (*Sorghum halepense*) and saltcedar (*Tamarix ramossissima*), have been noted. Canyon treefrog (*Hyla arenicolor*), black-necked gartersnake (*Thamnophis cyrtopsis*), and longfin dace (*Agosia chrysogaster*) have been observed in this portion of Harshaw Creek. Aquatic beetles, boatmen, backswimmers, dragonflies, damselflies, mayflies, water scorpions, belostomatids, and snails have been observed.

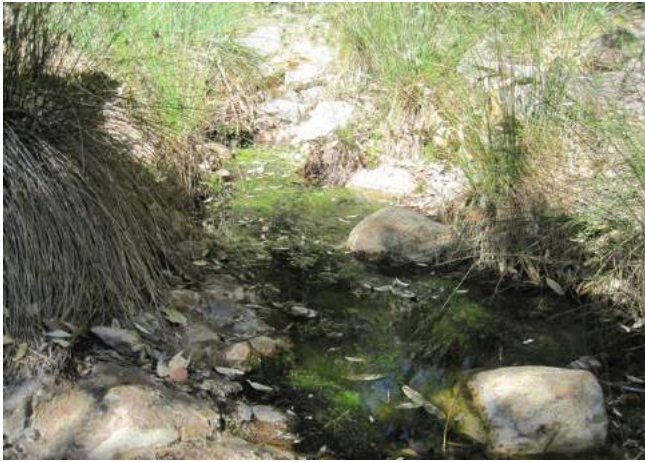
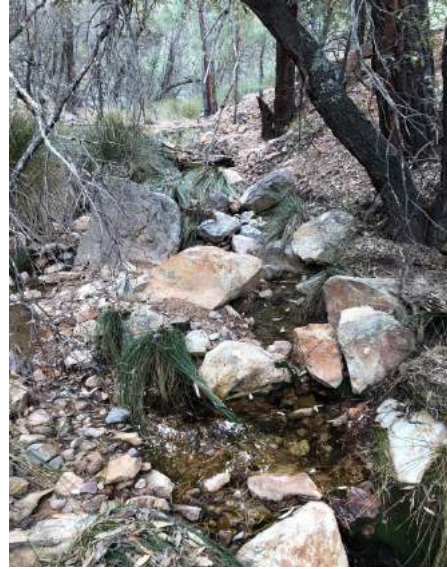
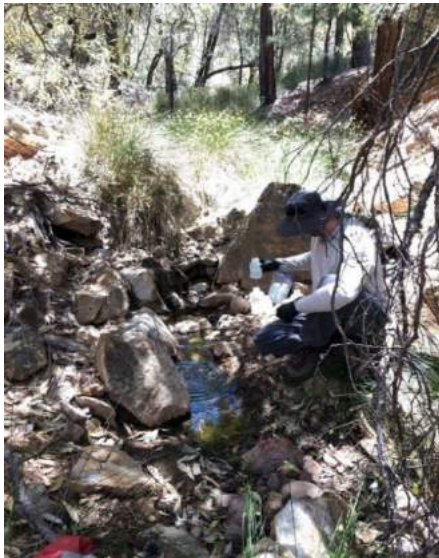
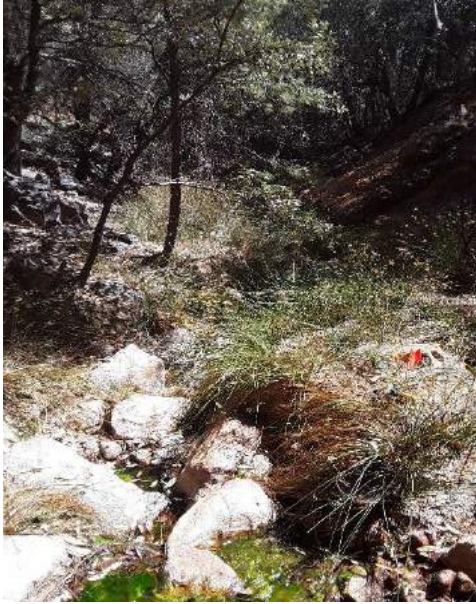
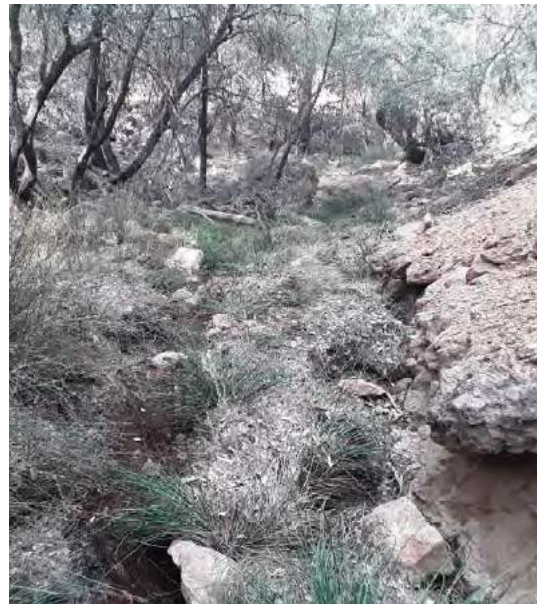
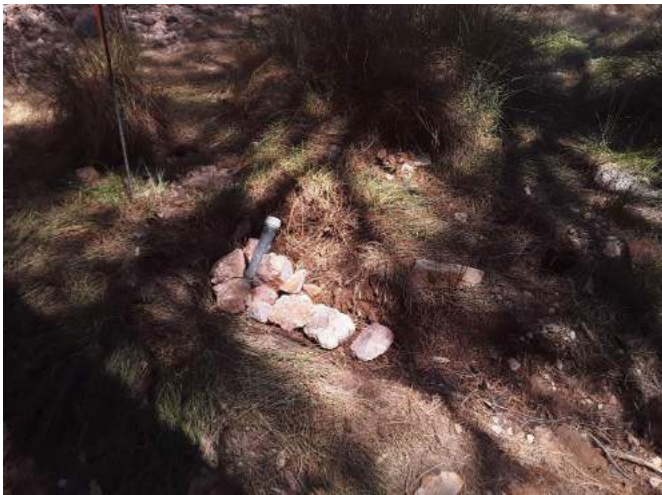
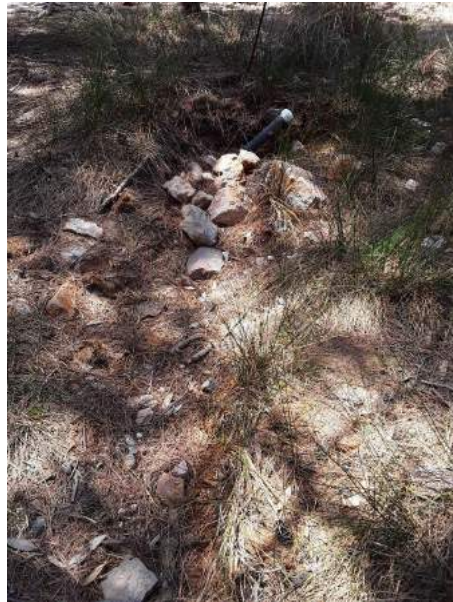
**Aquatic and Vegetation Survey Findings:** This feature is located at a well-head in Humboldt Canyon where seepage results in a shallow surface water in the road and discharges to adjacent drainage. Riparian obligate Baltic rush (*Juncus balticus*), submerged algae, and moss are the predominate vegetation cover at the site. Silverleaf oak (*Quercus hypoleucoides*) and Chihuahuahua pine (*Pinus leiophylla*) provide overstory cover. Non-native annual rabbitsfoot grass (*Polypogon monspeliensis*) has been noted. Aquatic beetles and dragonfly larvae have been observed. No aquatic vertebrates have been observed.

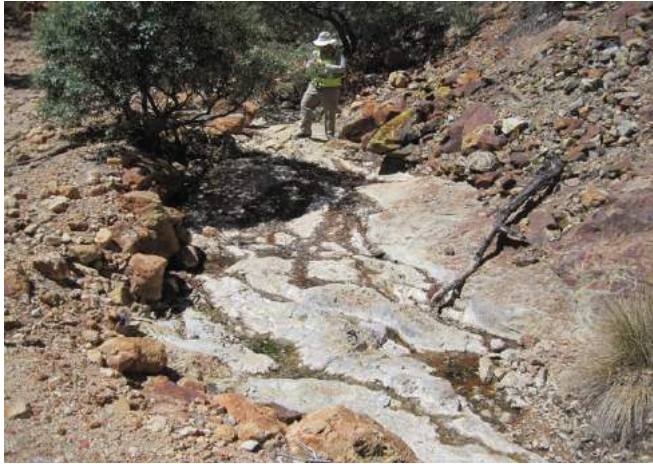
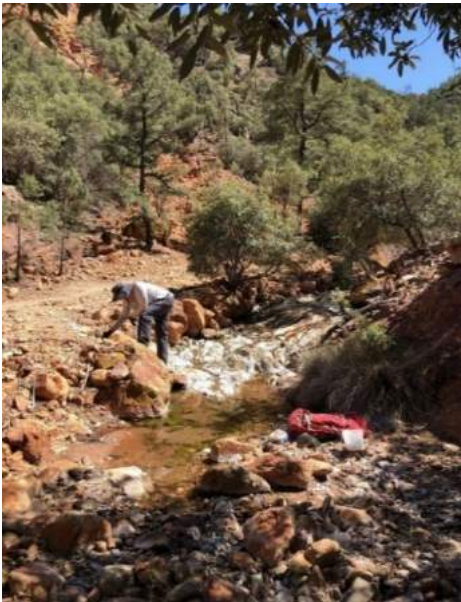
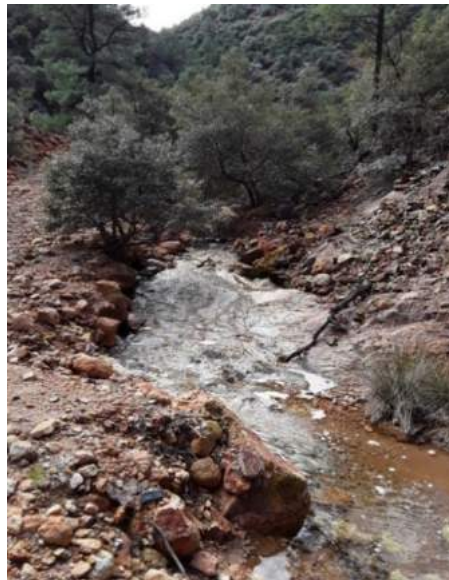
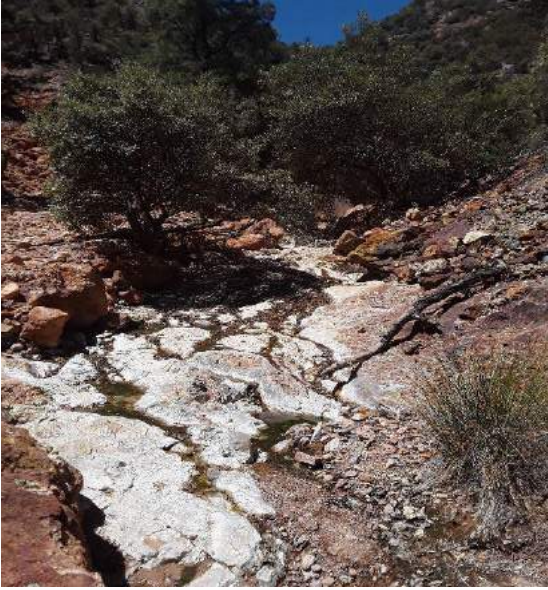
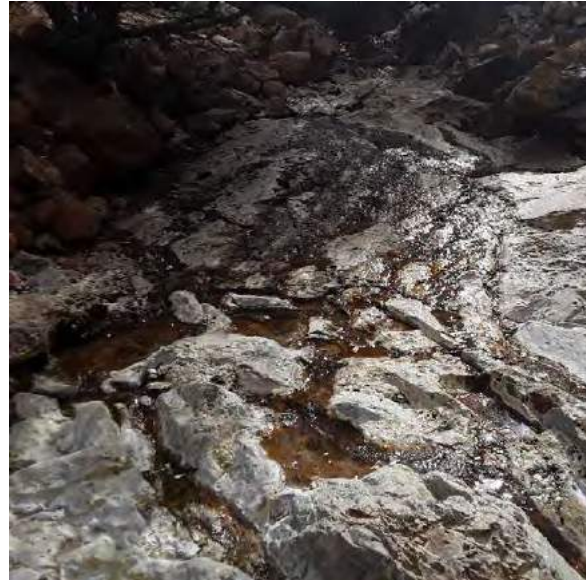
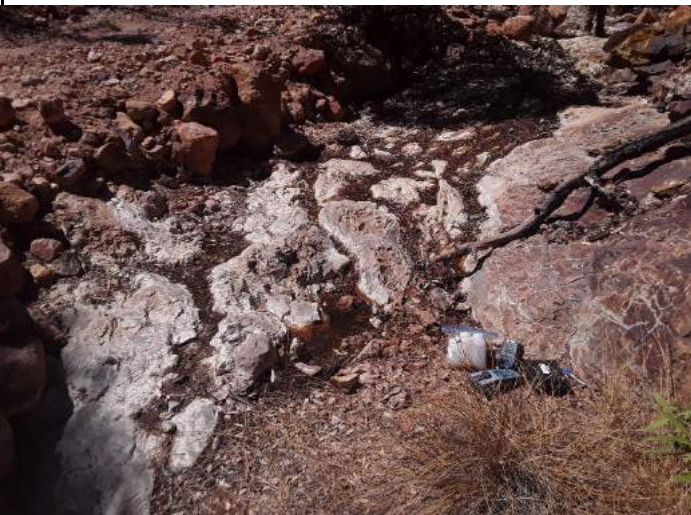
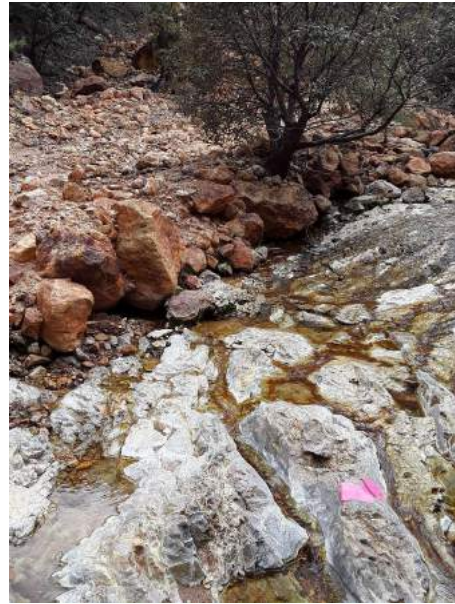
5/24/2021	0.02	2.73	17.4	1366					
Water Quality Exceedances									
Dry Season					Wet Season				
Date	Parameter				Date	Parameter			
4/27/2017	Cadmium, copper, zinc, pH				10/20/2017	Copper, zinc, pH			
5/23/2018	Copper, zinc, pH				11/28/2018	Copper, zinc, pH			
5/28/2019	Copper, zinc, pH				12/3/2019	Copper, zinc, pH			
6/19/2020	Cadmium, copper, zinc				10/15/2020	Wet season 2020 samples were not collected due to Covid-19 restrictions			
1/13/2021	Cadmium, copper, iron, lead, nickel, zinc, pH				11/16/2021	Cadmium, copper, iron, lead, nickel, thallium, zinc, pH, DO			
5/24/2021	Cadmium, copper, iron, lead, nickel, silver, zinc, pH, DO								
<b>Aquatic and Vegetation Survey Findings:</b> This shallow seep is located in a section of exposed bedrock in Humboldt Canyon. Riparian obligate Baltic rush ( <i>Juncus balticus</i> ), algae, and moss are the predominate vegetation cover at the site. Silverleaf oak ( <i>Quercus hypoleucoides</i> ) provides overstory cover at the site. Aquatic invertebrates observed include boatmen and beetles. No aquatic vertebrates have been observed.
