# Hermosa Spring and Seep Catalog

Hermosa Project Area

## SPRING AND SEEP CATALOG Hermosa Project Area

### INTRODUCTION

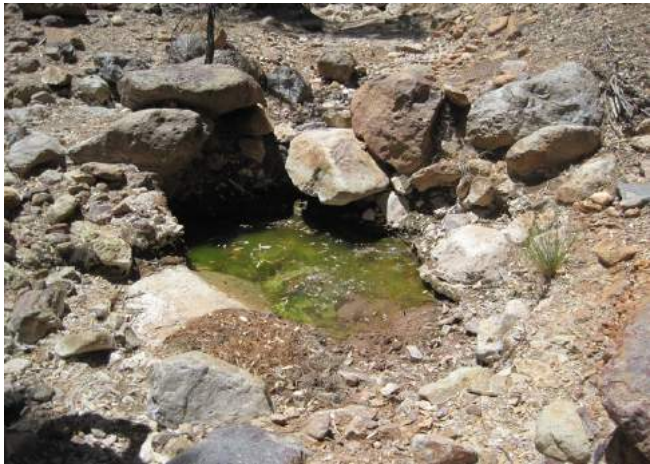
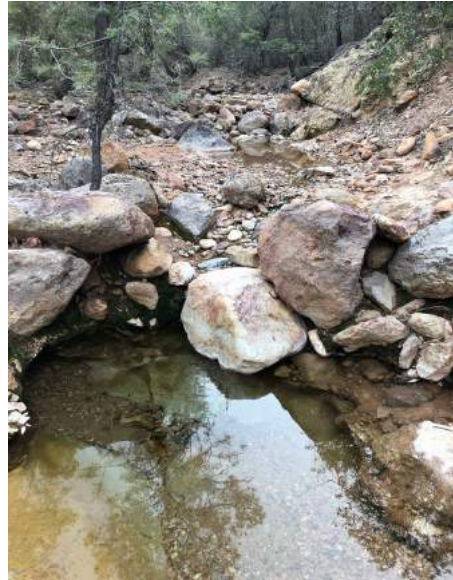
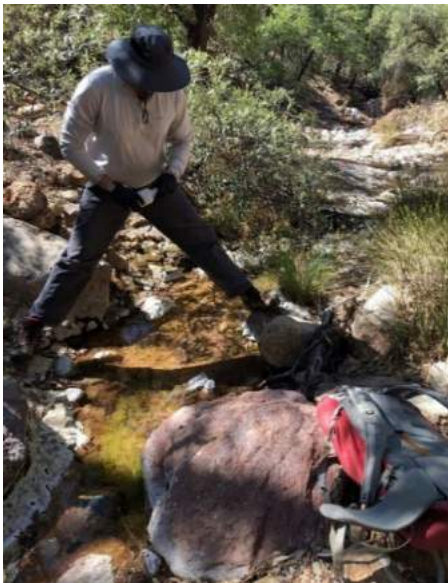
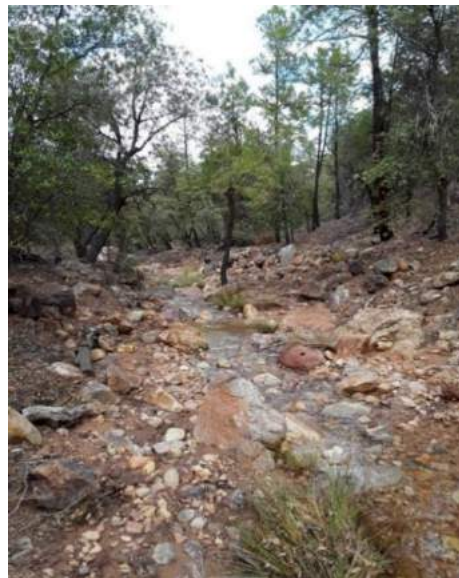
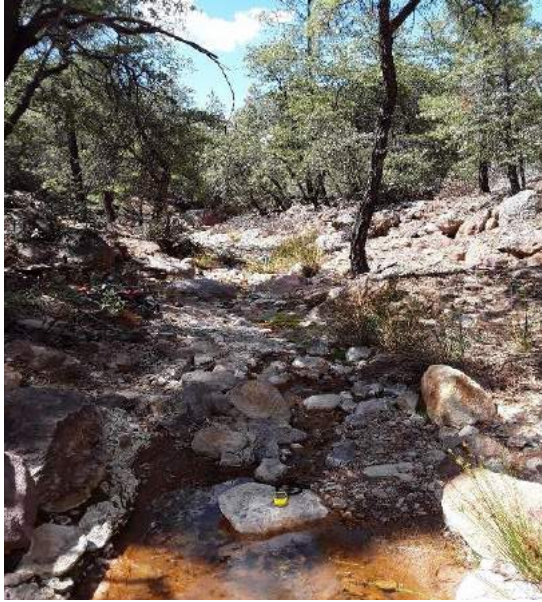
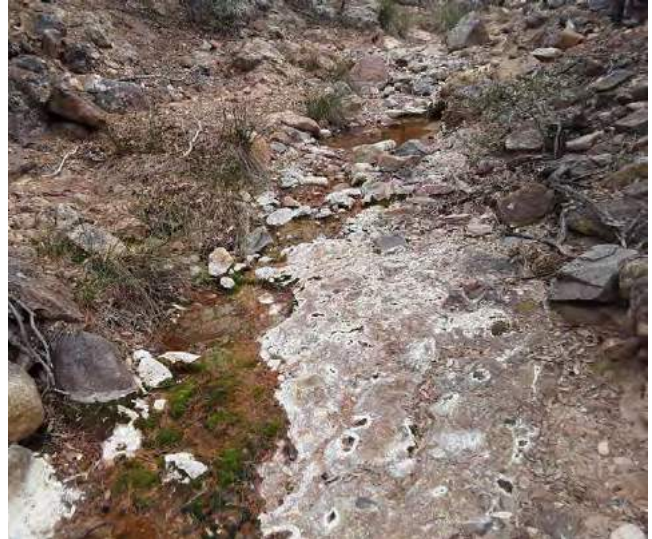
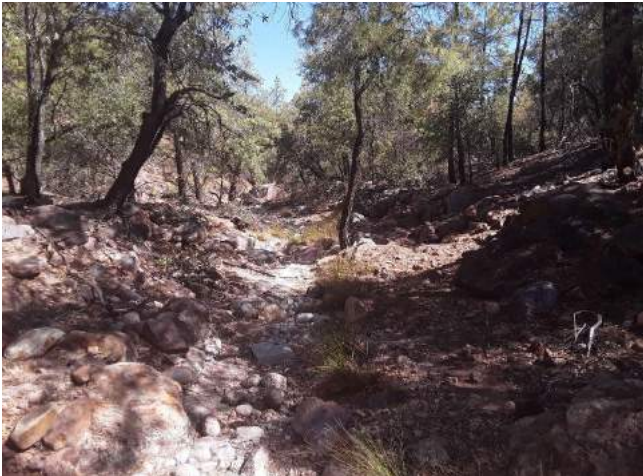
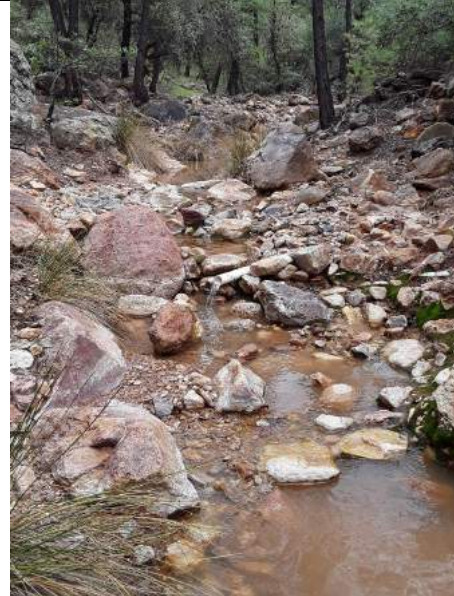
**Aquatic and Vegetation Survey Findings:** This site is located within a rocky and bouldery section of Humboldt Canyon. Water is typically present in shallow runs with small pools in the drainage. Riparian obligate Baltic rush (*Juncus balticus*), algae, and moss are the predominate herbaceous cover at the site. Silverleaf oak (*Quercus hypoleucoides*) and Chihuahua pine (*Pinus leiophylla*) provide overstory cover. Aquatic beetles and backswimmers have been observed along this drainage. No aquatic vertebrates were observed.

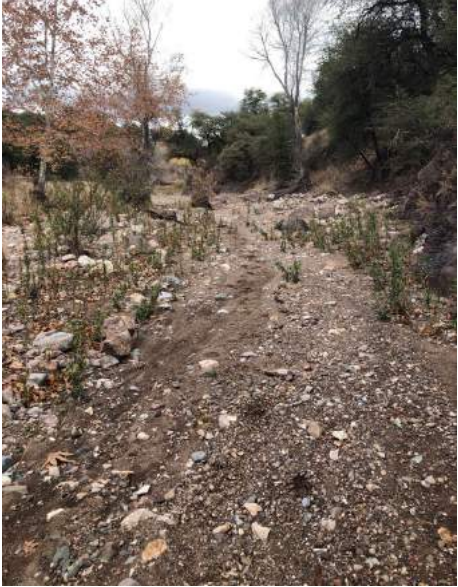
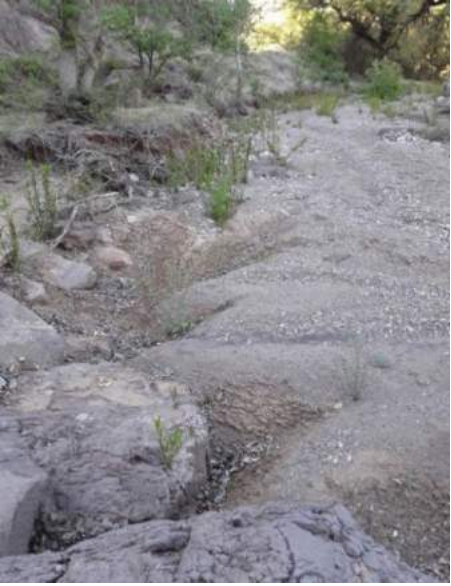
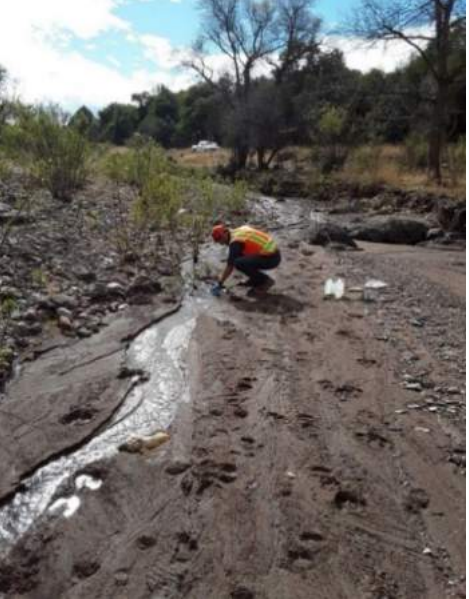
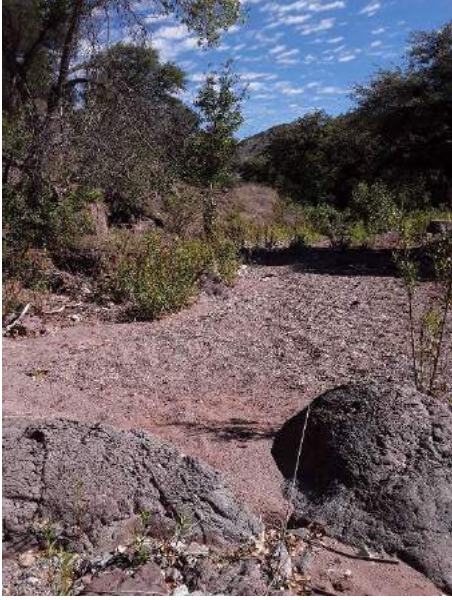
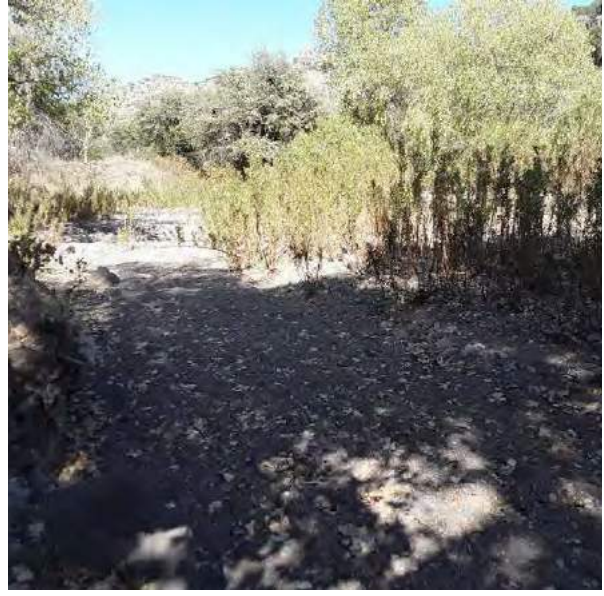
**Aquatic and Vegetation Survey Findings:** This site is located within a silty/sandy section of the East Fork of Harshaw Creek. Understory vegetation at the site is dominated by seep willow (*Baccharis salicifolia*), sideoats grama (*Bouteloua curtipendula*), and deergrass (*Muhlenbergia rigens*). Overstory vegetation is dominated by Fremont cottonwood (*Populus fremontii*), a preferential riparian species, with velvet mesquite (*Prosopis velutina*), desert willow (*Chilopsis linearis*), and Bonpland willow (*Salix bonplandiana*) also present. No aquatic vertebrates have been observed. No aquatic invertebrates or vertebrates have been observed.

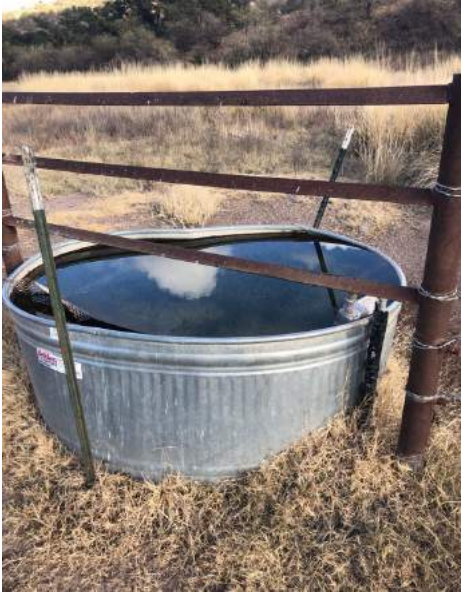
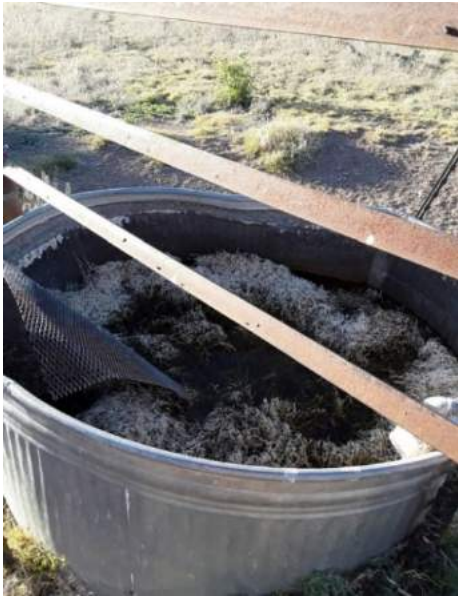
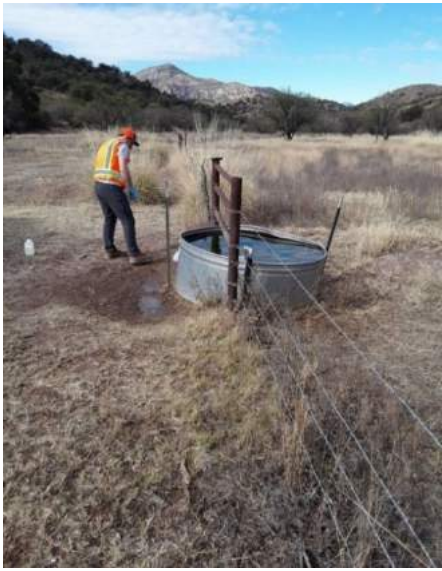
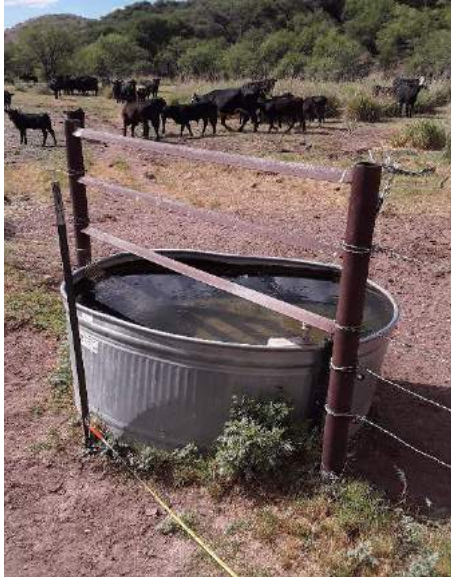
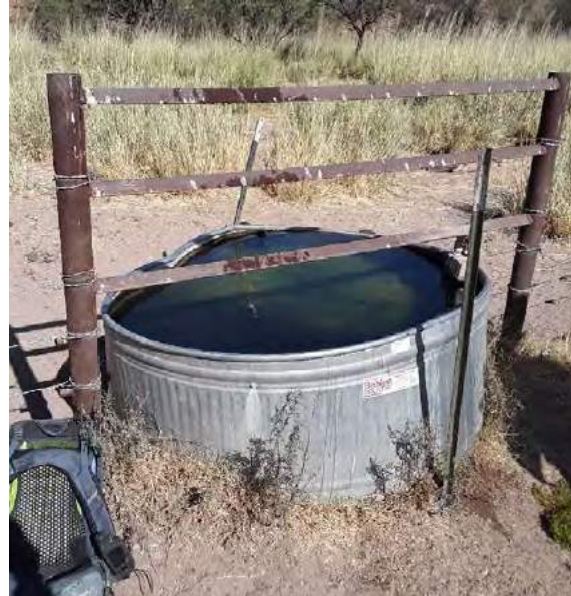
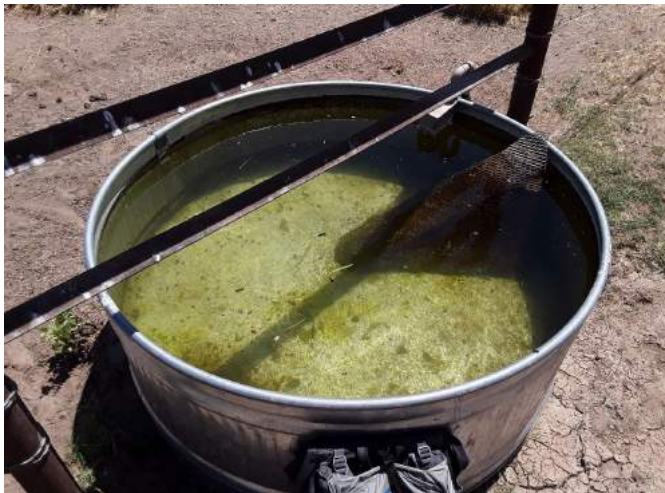
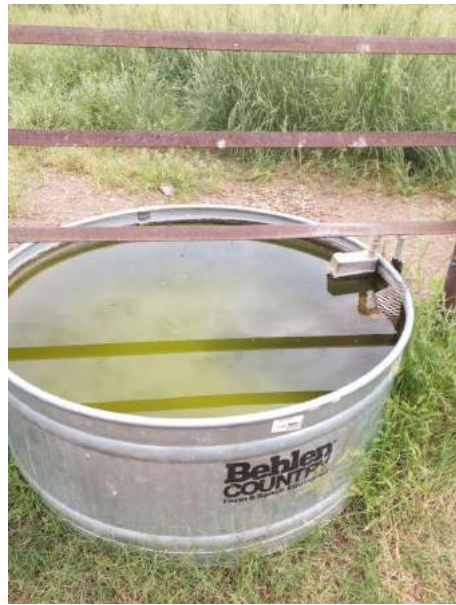
<b>Site ID</b>	HE7-WELL-ST-01	<b>Interpretation of Groundwater Age:</b> Evaporative and modern, no deep source.
<b>Watershed</b>	E. Fork of Harshaw Creek	
<b>Monitoring Period</b>	11/2017-12/2021	<b>Potential Impacts/Effects:</b> This site is not a seep or spring, site it is fed by a well. No changes are predicted at this site.
<b>Number of Visits</b>	12

**Aquatic and Vegetation Survey Findings:** This site is a metal stock drinker associated with an adjacent solar well and closed cistern, located within the East Fork of Harshaw Creek. Invasive Bermudagrass (*Cynodon dactylon*) dominates the site with alkali sacaton (*Sporobolus airoides*) also present. No overstory canopy cover occurs at the site. Aquatic invertebrates observed in this drinker include backswimmers, boatmen, beetles, and dragonflies. No aquatic vertebrates have been observed. Cattle and grazing are present on adjacent land.

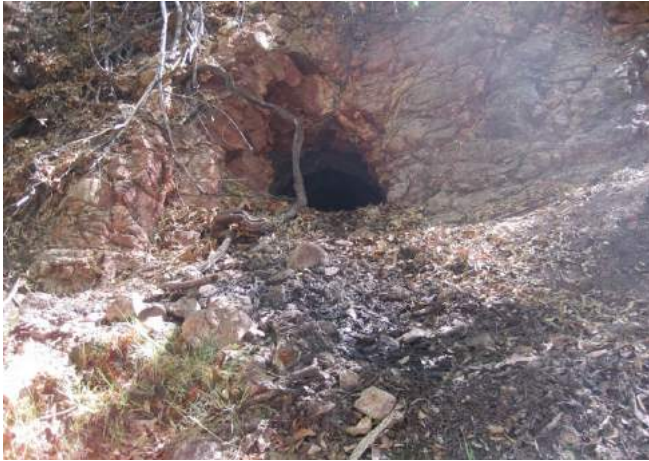
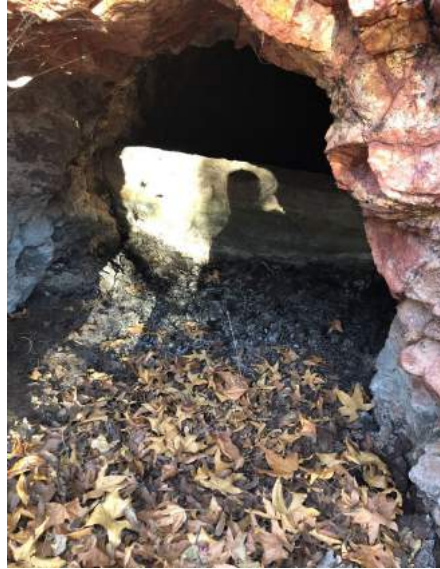
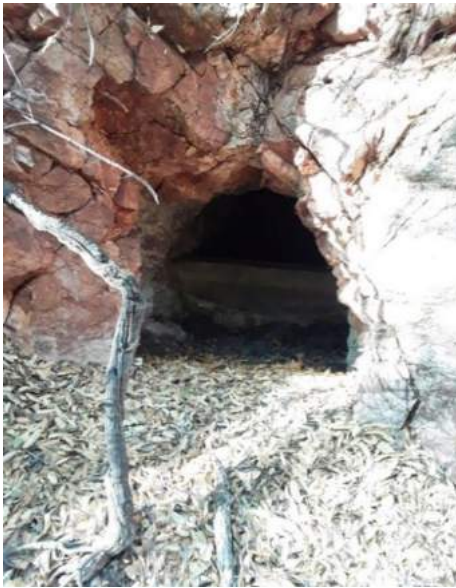
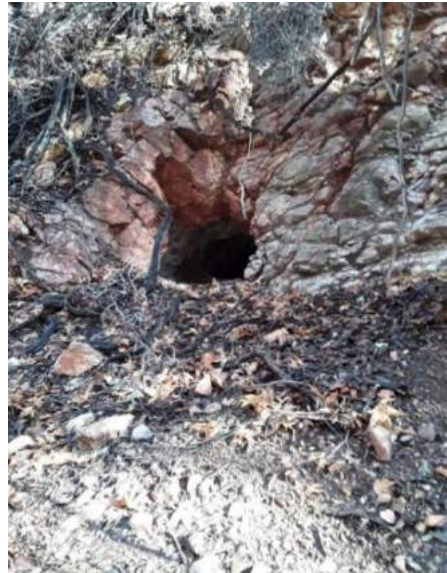
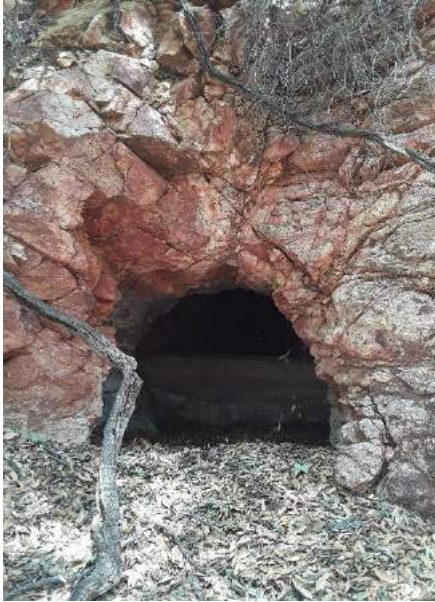
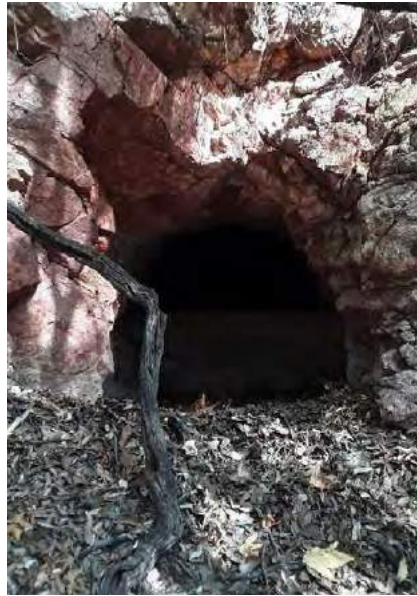
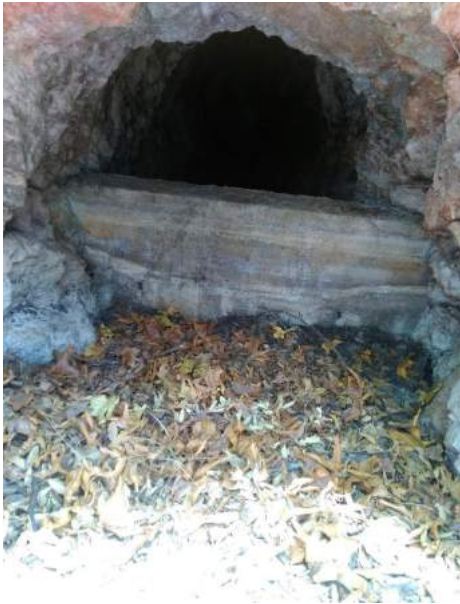
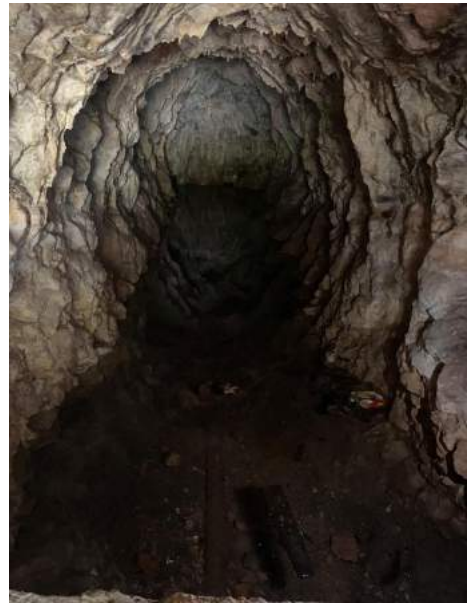
<b>Site ID</b>	HM7-AD-01	<b>Interpretation of Groundwater Age:</b> Deep groundwater source.
<b>Watershed</b>	Hermosa Canyon	
<b>Monitoring Period</b>	4/2017 - 12/2021	<b>Potential Impacts/Effects:</b> Flows observed at this site have ranged from 0 to 0.45 gpm. This site has been dry during several surveys during the dry season suggesting the site may not be in connection with a perennial groundwater source. No changes are predicted at this site.
<b>Number of Visits</b>	13

**Aquatic and Vegetation Survey Findings:** This site is located at an adit along the eastern wall of Hermosa Canyon with a built-in spring box. This site was dry during site visits in 2019 and 2020. The moss mat at the adit entrance is desiccated. Bullgrass (*Muhlenbergia emersleyi*), canyon grape (*Vitis arizonica*), and California buckthorn (*Frangula californica*) dominate the limited herbaceous cover within the drainage bottom. Overstory tree cover is dominated by Arizona sycamore (*Platanus wrightii*), a preferential riparian tree species, and netleaf hackberry (*Celtis reticulata*). No aquatic invertebrates, or vertebrates have been observed in recent years.

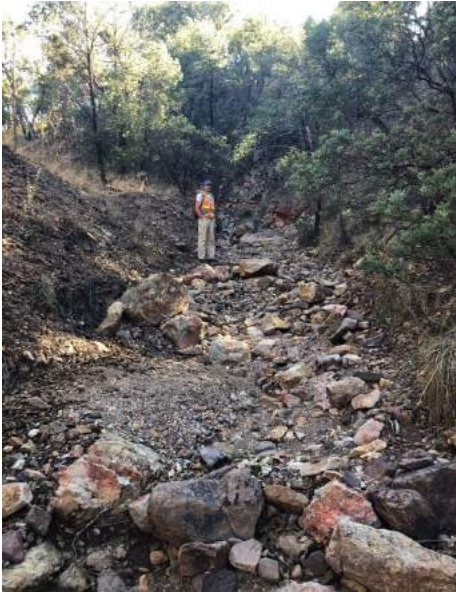
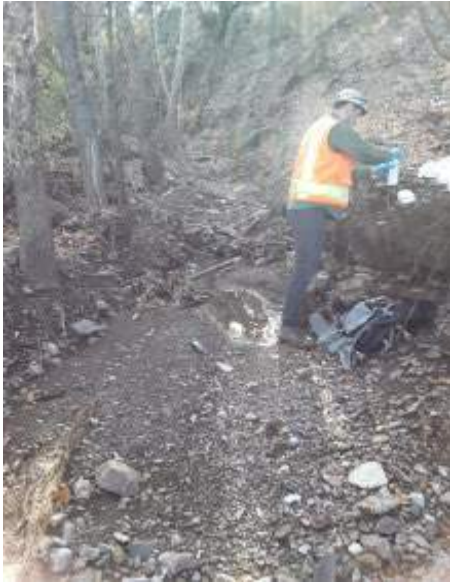
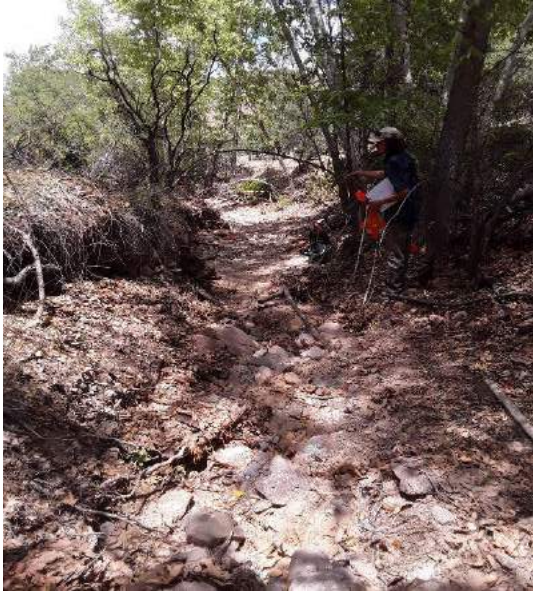
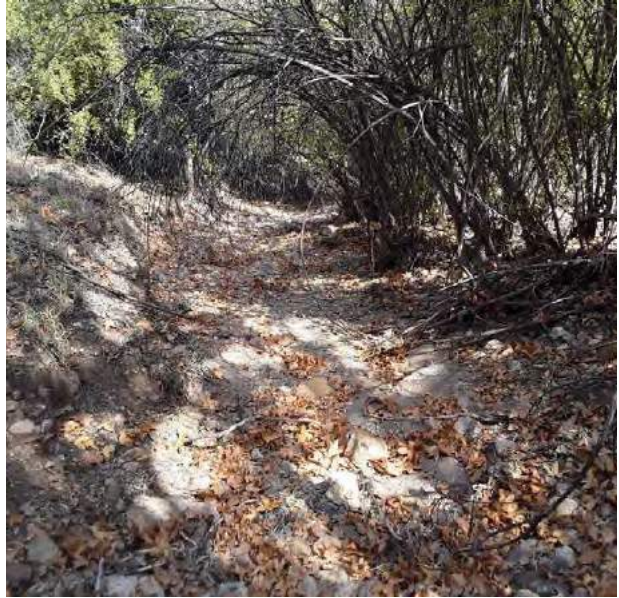
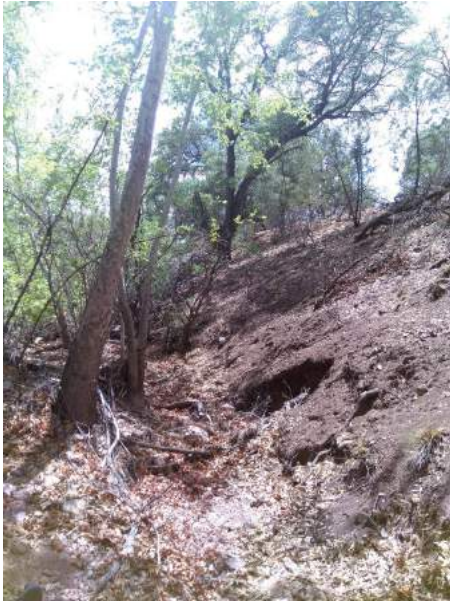
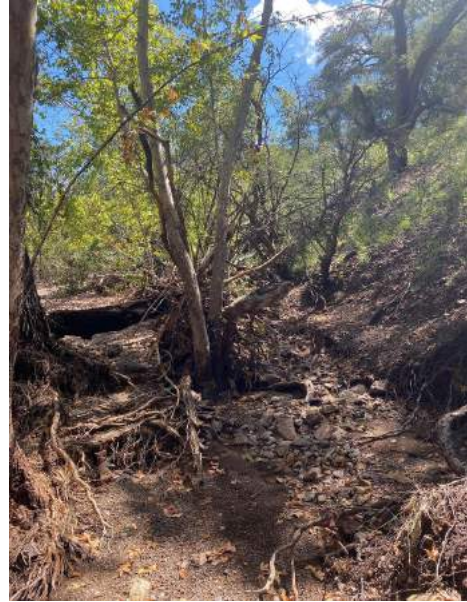
<b>Site ID</b>	HM8-01	<b>Interpretation of Groundwater Age:</b> Inconclusive.
<b>Watershed</b>	Hermosa Canyon	
<b>Monitoring Period</b>	5/2017 - 12/2021	<b>Potential Impacts/Effects:</b> Flows observed at this site have ranged from 0 to trace flow. This site has been dry during most dry season surveys suggesting the site may not be in connection with a perennial groundwater source. In the first 4 years, there may be up to 0.07 gpm decrease in flow.
<b>Number of Visits</b>	12

**Aquatic and Vegetation Survey Findings:** This site is located within a silty and cobbly portion of Hermosa Canyon. The site contains little herbaceous cover, limited to perennial grasses (*Poaceae* family). Overstory vegetation is dominated by riparian trees including Arizona sycamore (*Platanus wrightii*), Fremont cottonwood (*Populus fremontii*), and coyote willow (*Salix exigua*). Invasive tree-of-heaven (*Ailanthus altissima*) has been observed. No aquatic invertebrates or vertebrates have been observed at this site.

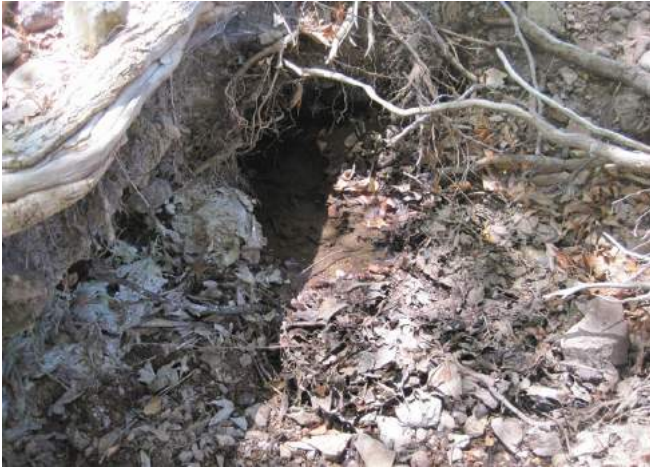
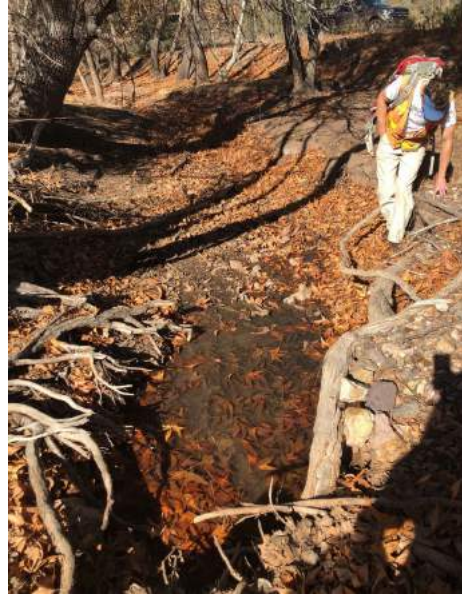
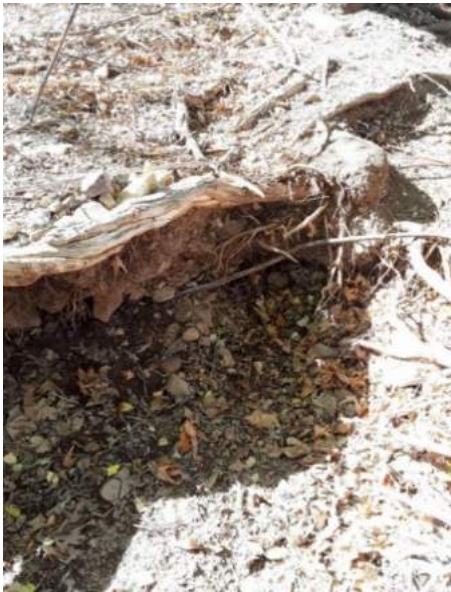
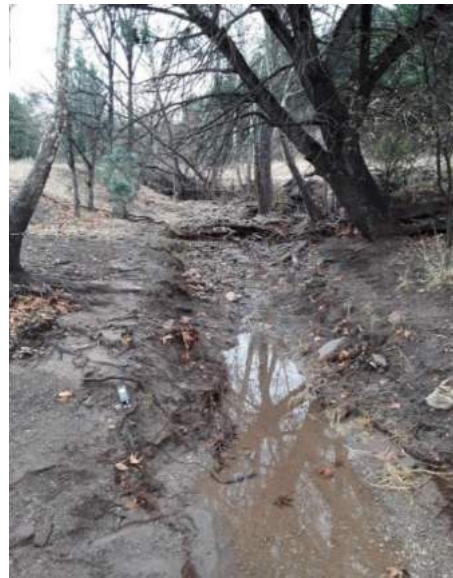
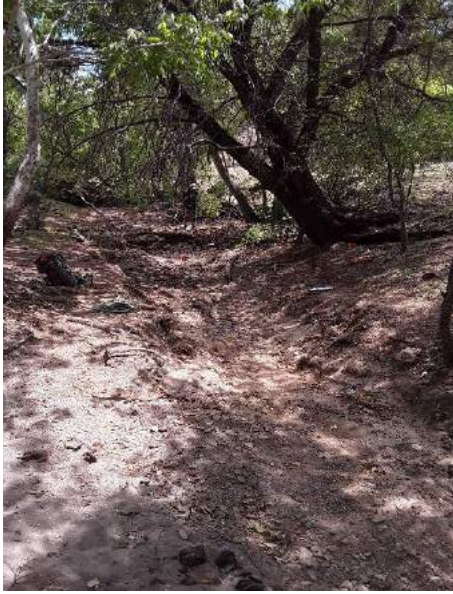
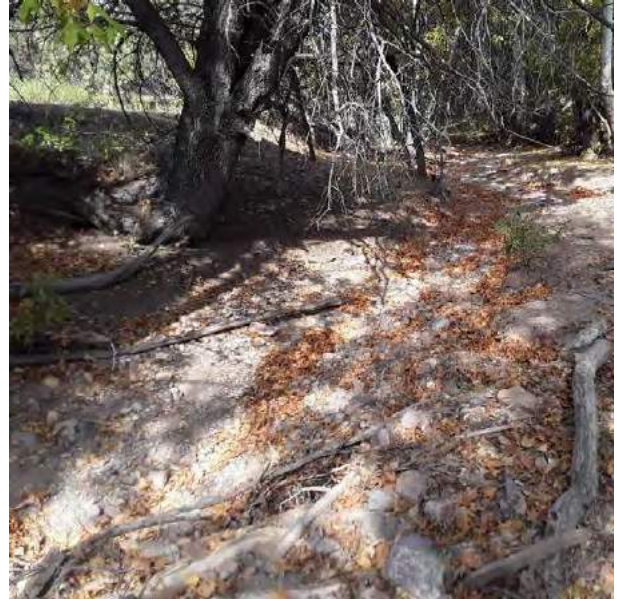
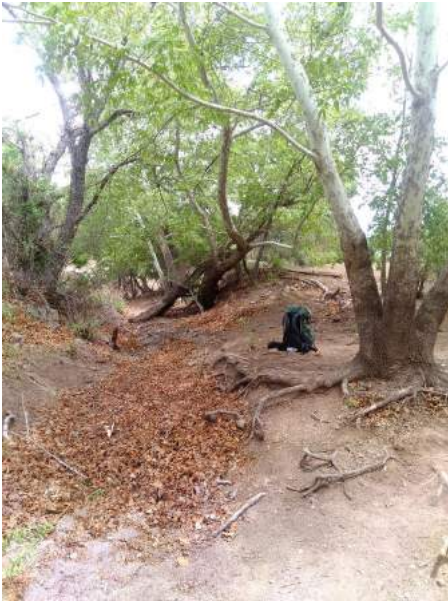
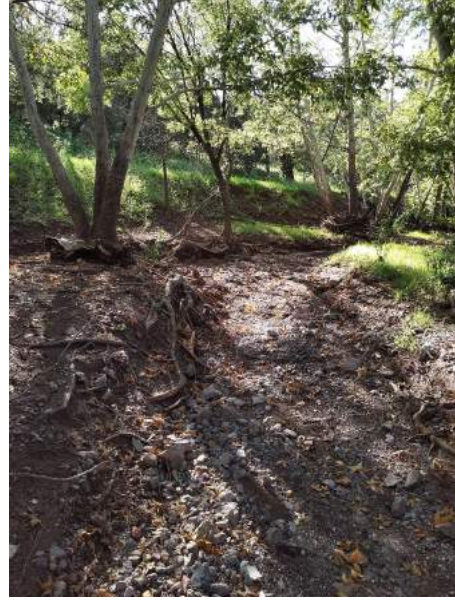
<b>Site ID</b>	HM8-02	<b>Interpretation of Groundwater Age:</b> Consistently submodern with a deep groundwater source.
<b>Watershed</b>	Hermosa Canyon	
<b>Monitoring Period</b>	01/2017 - 12/2021	<b>Potential Impacts/Effects:</b> Flows observed at this site have ranged from 0 to 15 gpm.
<b>Number of Visits</b>	13

**Aquatic and Vegetation Survey Findings:** Site located at downstream end of Hermosa Canyon. Overstory riparian tree cover includes Arizona sycamore (*Platanus wrightii*), Arizona walnut (*Juglans major*), Arizona ash (*Fraxinus velutina*), and coyote willow (*Salix exigua*). Netleaf hackberry (*Celtis reticulata*) and alligator juniper (*Juniperus deppeana*) are also present overstory tree species.

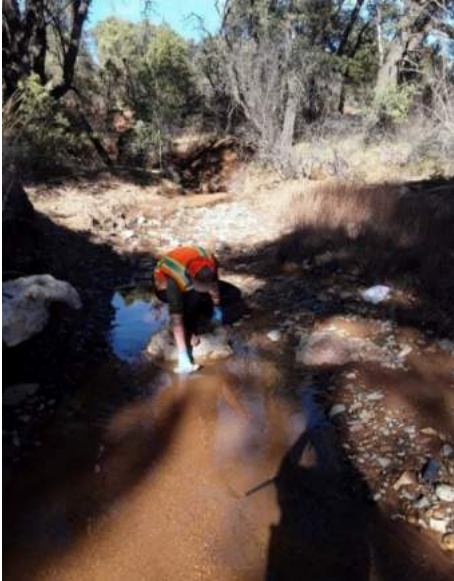
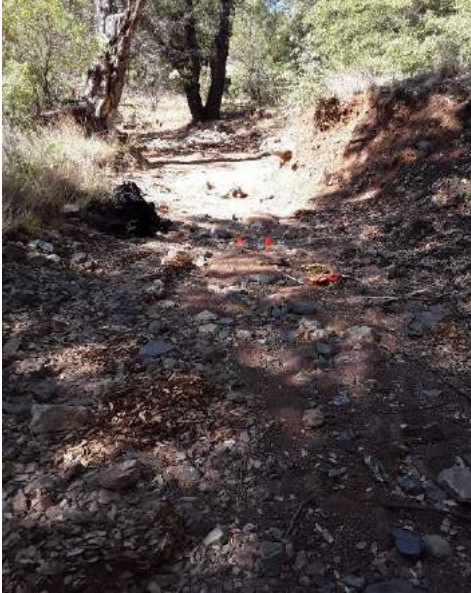
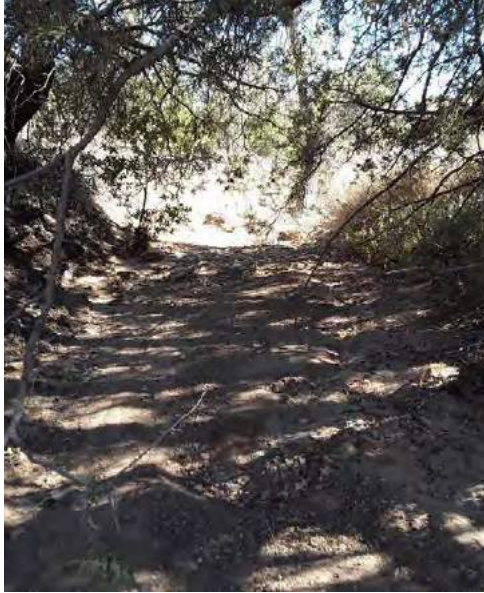
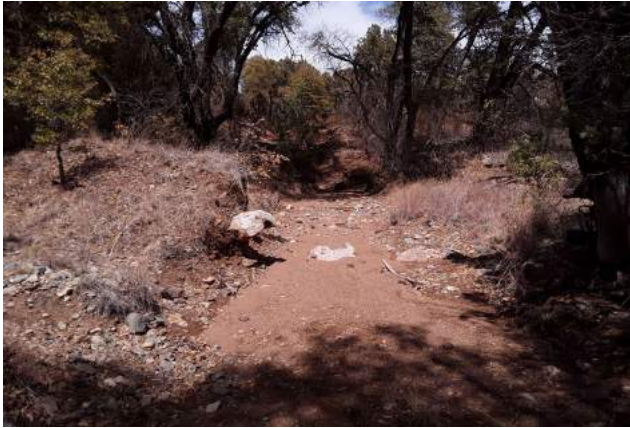
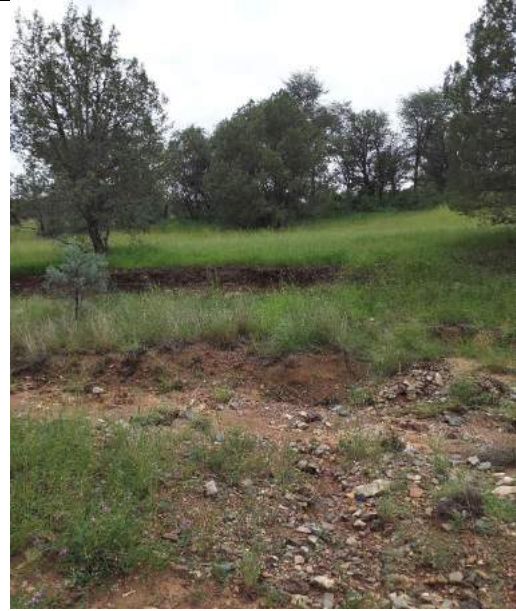
Site ID	MW1-01	Interpretation of Groundwater Age: Inconclusive.
Watershed	Mowry Wash	
Monitoring Period	12/2019 - 12/2021	<b>Potential Impacts/Effects:</b> This site has been dry during all site visits except for 1 visit where flow was recorded at 4.75 gpm, suggesting the site may not be in connection with a perennial groundwater source. No changes are predicted at this site.
Number of Visits	8

**Aquatic and Vegetation Survey Findings:** This site is located within a cobbly and silty section of north Mowry Wash. The site contains little herbaceous cover with dominate species being Texas bluestem (*Schizachyrium cirratum*), ticktrefoil (*Desmodium* sp.), and lovegrass (*Eragrostis* sp.). Overstory vegetation is dominated by Emory oak (*Quercus emoryi*). No aquatic invertebrates or vertebrates have been observed at this site.

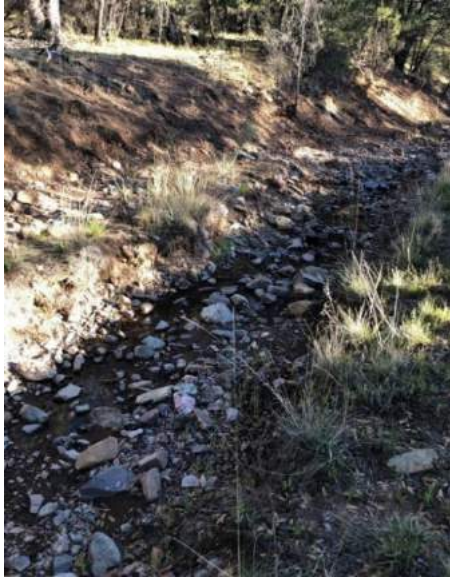
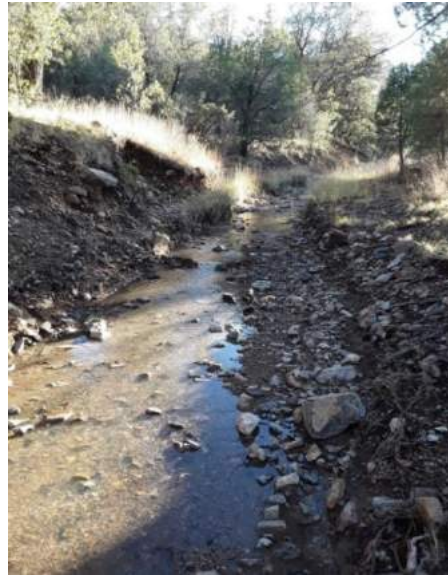
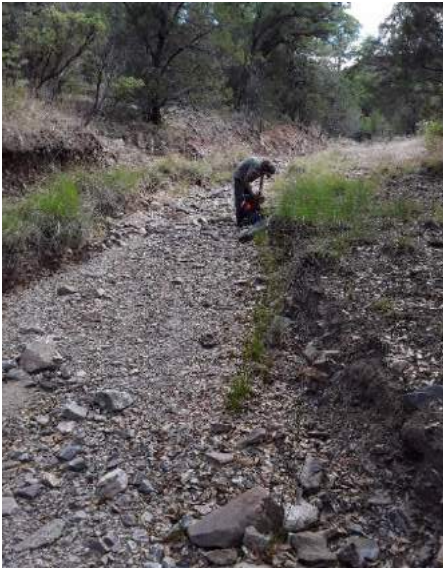
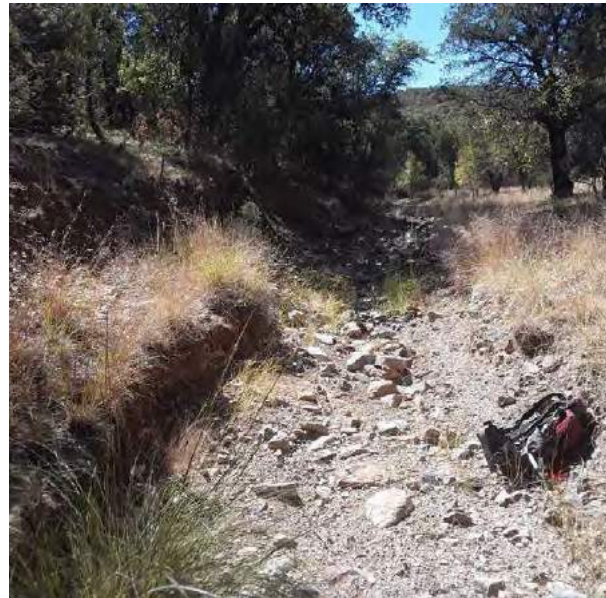
<b>Site ID</b>	MWS1-01	Interpretation of Groundwater Age: Inconclusive.
<b>Watershed</b>	Mowry Wash South	
<b>Monitoring Period</b>	5/2019 - 12/2021	<b>Potential Impacts/Effects:</b> Flows observed at this site have ranged from 0 to 84 gpm.
<b>Number of Visits</b>	9

**Aquatic and Vegetation Survey Findings:** This site is located within rocky/gravelly section of south Mowry Wash. Deergrass (*Muhlenbergia rigens*) is the dominate perimeter vegetation at this site with pinyon ricegrass (*piptochaetium fimbriatum*), and riparian obligates, spikerush (*Eleocharis* sp.), rushes (*Juncus* spp.), and seep monkeyflower (*Mimulus guttatus*), are also present. Other understory shrub vegetation noted include skunkbush (*Rhus trilobata*) and Wright's silktassel (*Garrya wrightii*). Overstory vegetation is dominated by alligator juniper (*Juniperus deppeana*), Emory oak (*Quercus emoryi*), and Mexican pinyon (*Pinus cembroides*). Non-native annual rabbitsfoot grass (*Polypogon monspeliensis*) and invasive weeping lovegrass (*Eragrostis curvula*) have been observed. Aquatic invertebrates observed along this drainage include beetles and backswimmers. No aquatic vertebrates have been observed at this site.

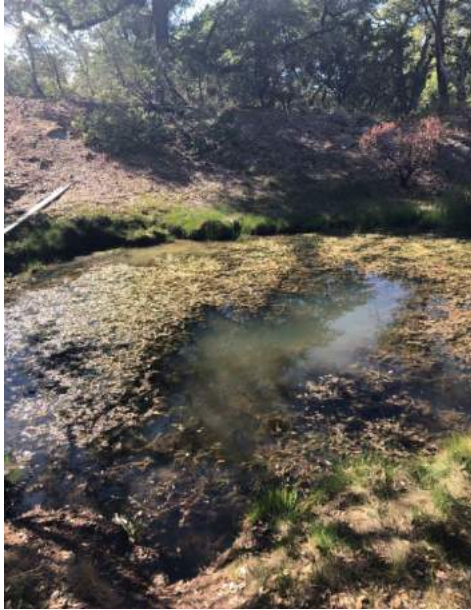
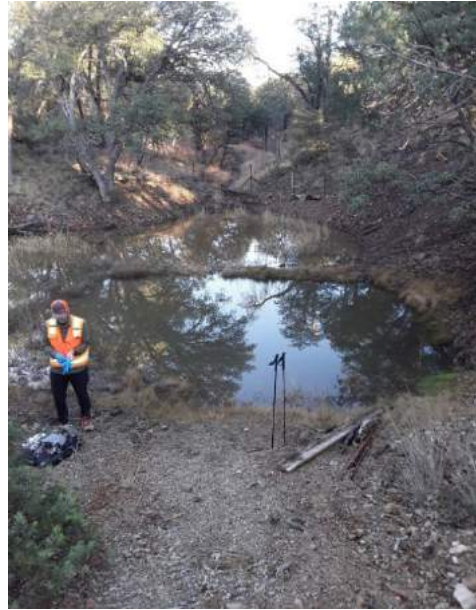
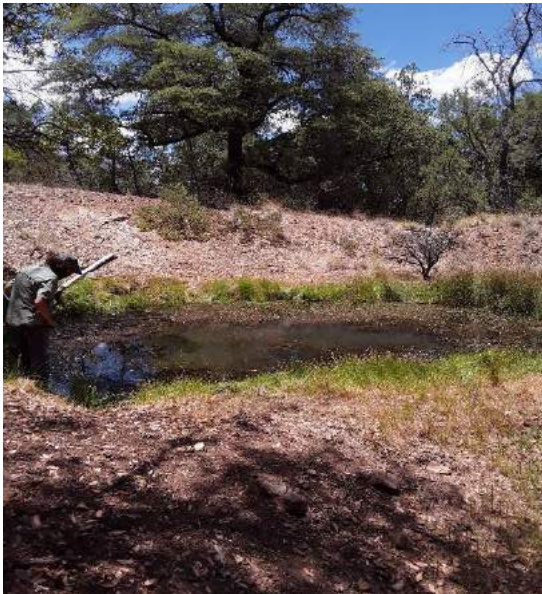
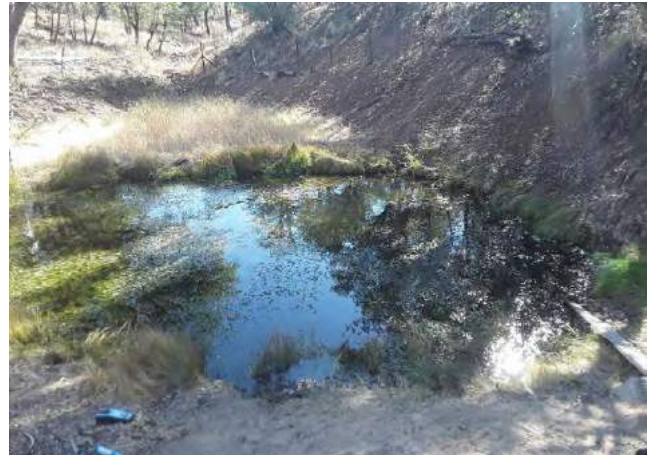
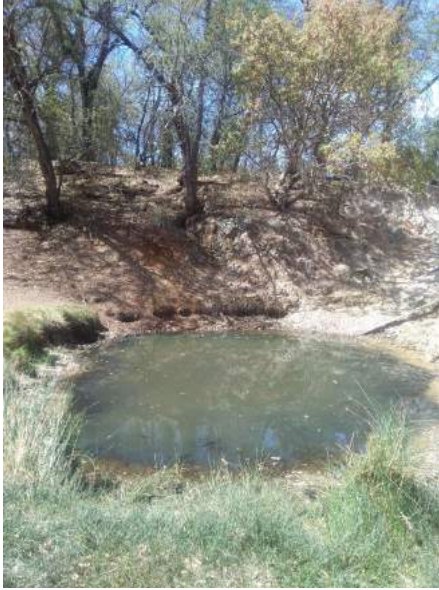
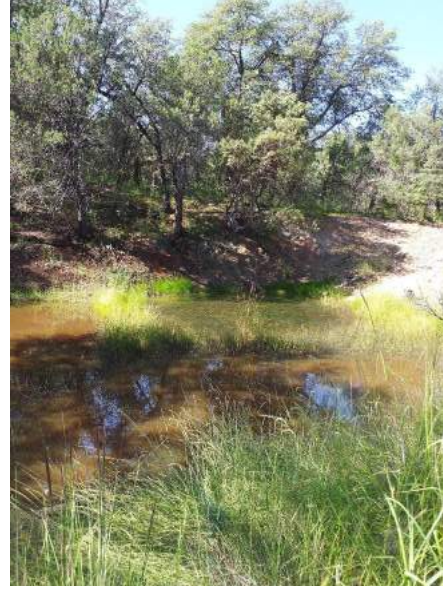
<b>Site ID</b>	MWS1-02	Interpretation of Groundwater Age: Inconclusive.
<b>Watershed</b>	Mowry Wash South	
<b>Monitoring Period</b>	05/2019 - 12/2021	<b>Potential Impacts/Effects:</b> No surface flow has been observed at this site during site visits, rather it exists as a still pond. In the first 4 years, there may be up to 0.0006 gpm decrease in flow.
<b>Number of Visits</b>	9

**Aquatic and Vegetation Survey Findings:** Tank dug out against hillside, potentially fed by groundwater. Water present year-round with riparian obligate plant species including rushes (*Juncus* spp.) and aquatic vegetation including non-native Brazilian waterweed (*Egeria densa*). Nonnative fish and bullfrogs (*Lithobates catesbeianus*) have been observed. Aquatic invertebrates including beetles, boatmen, backswimmers, damselflies, and leeches, as well as snails, have been observed. Invasive plants, water milfoil (*Myriophyllum* sp.) and Johnsongrass (*Sorghum halepense*), have been observed.

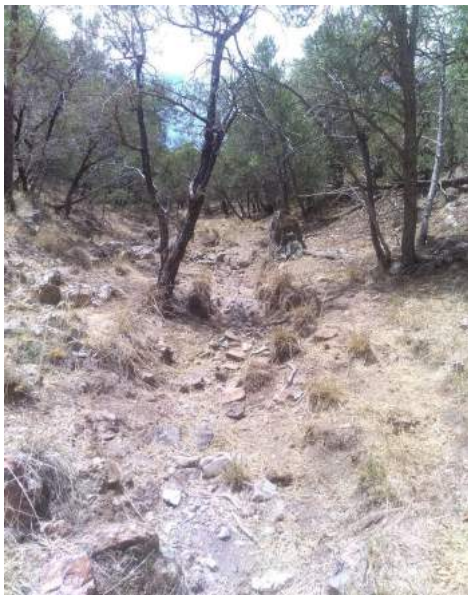
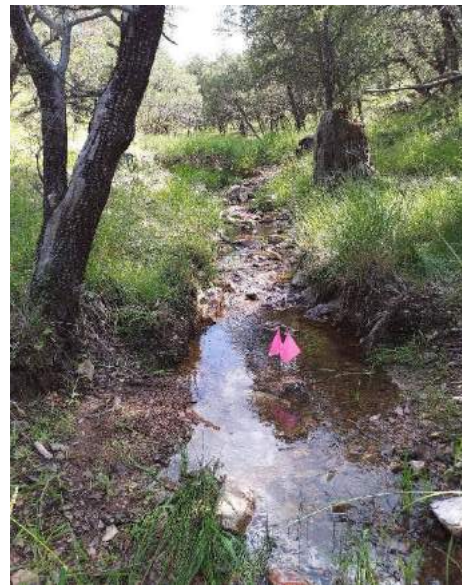
Site ID	MWS1-03	Interpretation of Groundwater Age: Inconclusive
Watershed	Mowry Wash South	
Monitoring Period	03/2021 - 12/2021	Potential Impacts/Effects: Flows observed at this site have ranged from 0 to 11.9 gpm. Predictions will be made once additional data is obtained.
Number of Visits	4

**Aquatic and Vegetation Survey Findings:** Water seeps from alluvium behind the concrete dam and flows atop volcanic bedrock/alluvium channel. This is a surface water section of Mowry Wash. Aquatic beetles have been observed. The dominant vegetation is Madrean oak woodland, dominated by alligator juniper (*Juniperus deppeana*) and Mexican pinyon (*Pinus cembroides*). No invasive plant species were noted, but one USFS sensitive species, Sonoran nose burn (*Tragia laciniata*), has been observed. Deer tracks and livestock sign has been noted.

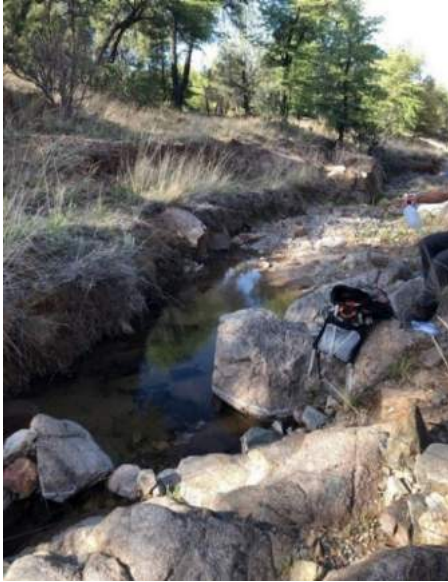
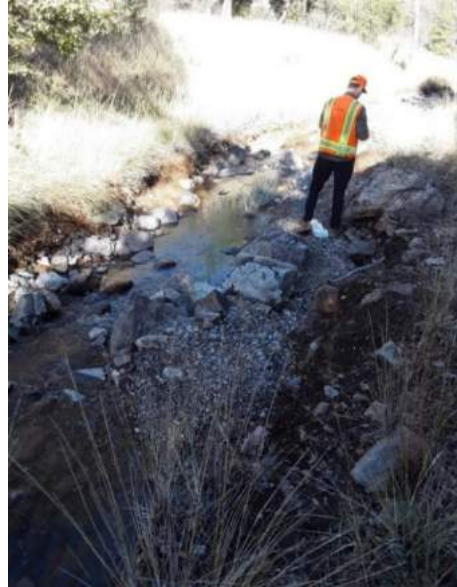
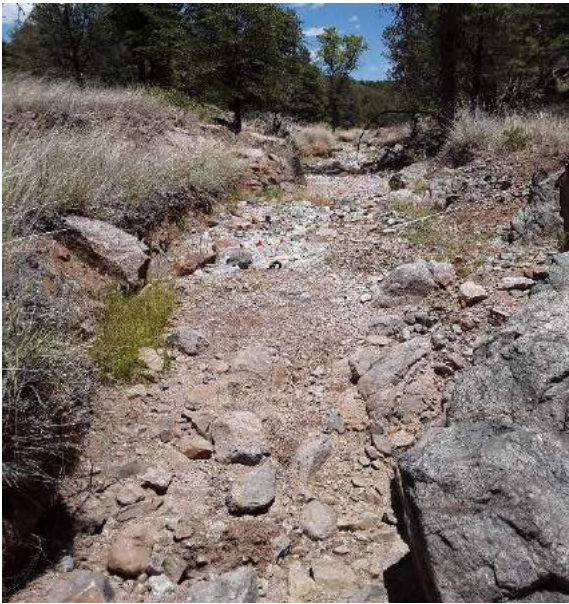
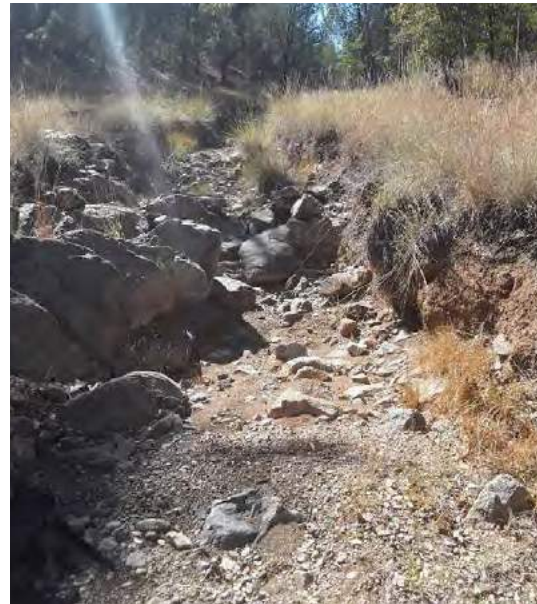
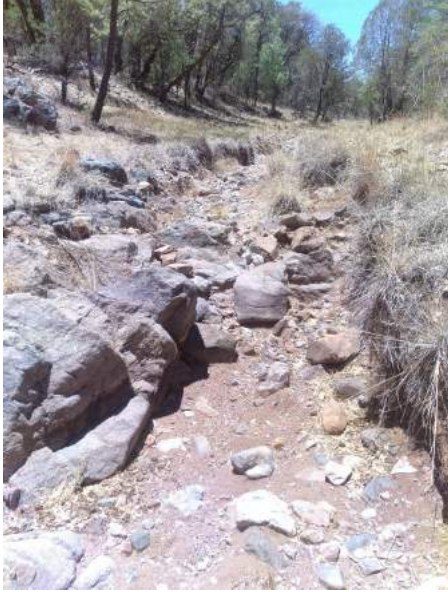
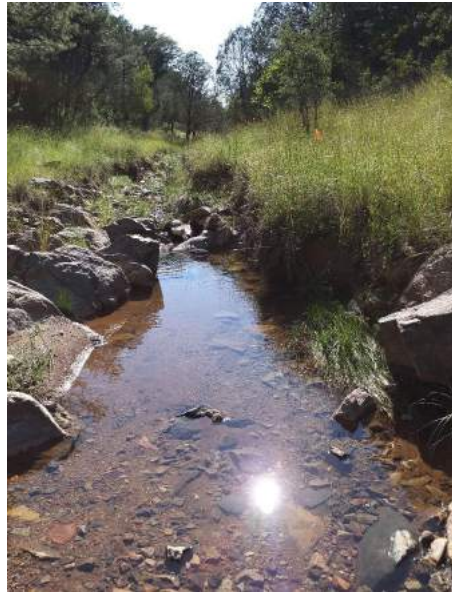
Site ID	MWS2-01	Interpretation of Groundwater Age: Inconclusive.
Watershed	Mowry Wash South	
Monitoring Period	5/2019 - 12/2021	Potential Impacts/Effects: Site has been dry for all site visits except for 2 visits, where flow ranged from 32.6 to 128 gpm.
Number of Visits	9

**Aquatic and Vegetation Survey Findings:** This site is located within rocky/gravelly section of south Mowry Wash with some bedrock outcrop constrictions. Threeawn (*Aristida* sp.) is the dominate perimeter vegetation at this site with deergrass (*Muhlenbergia rigens*), pointleaf manzanita (*Arctostaphylos pungens*), and panicgrass (*Panicum* sp.). Riparian obligates, Mexican rush (*Juncus mexicana*) and spikerush (*Eleocharis* sp.), and seepwillow (*Baccharis salicifolia*) were also noted at the site. This site lacks tree canopy cover, however, overstory vegetation adjacent to the site is dominated by Emory oak (*Quercus emoryi*). Non-native annual rabbitsfoot grass (*Polypogon monspeliensis*) and invasive plants, Lehmann lovegrass (*Eragrostis lehmanniana*) and weeping lovegrass (*Eragrostis curvula*) have been observed. Aquatic invertebrates observed along this drainage include beetles and backswimmers. No aquatic vertebrates have been observed at this site.

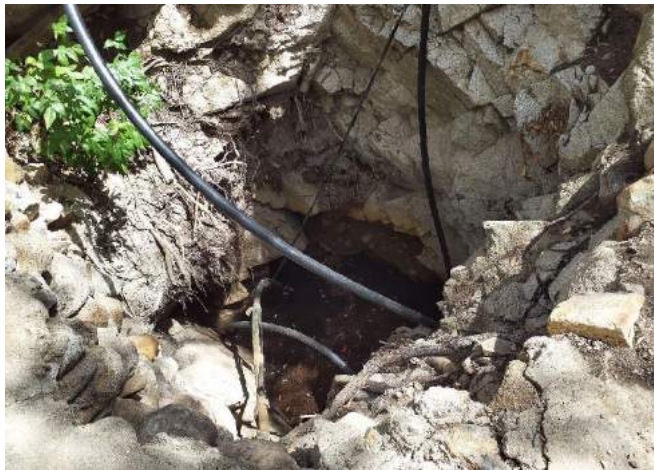
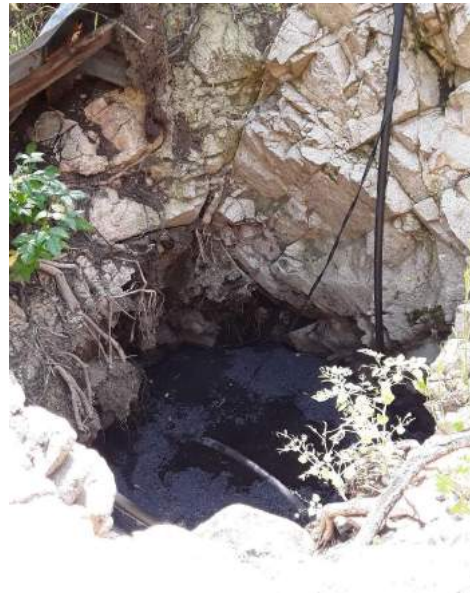
Site ID	PC-SP-01	Interpretation of Groundwater Age: Inconclusive
Watershed	Providencia Canyon	
Monitoring Period	06/2021 - 12/2021	Potential Impacts/Effects: No flow has been observed at this site.
Number of Visits	3

**Aquatic and Vegetation Survey Findings:** Also called Shannon Spring, water pools in the shaft on the southern side of Providencia canyon. A functioning submersible solar pump with polyline tubing in all directions resides at the site. Pumped water runs up the canyon side to a cistern about 500 ft up the hillside. The tubing then runs back down and across the canyon to the cattle drinker. The predominant vegetation is consistent with the Madrean oak woodland, with poison ivy (*Toxicodendron radicans*) and velvet ash (*Fraxinus velutina*) surrounding the cistern. Invasive Bermudagrass (*Cynodon dactylon*) is present. Aquatic beetles have been observed, but no aquatic herpetofauna has been observed.

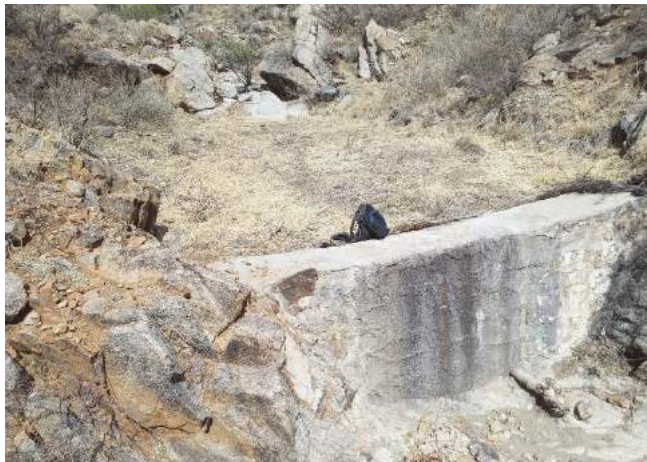
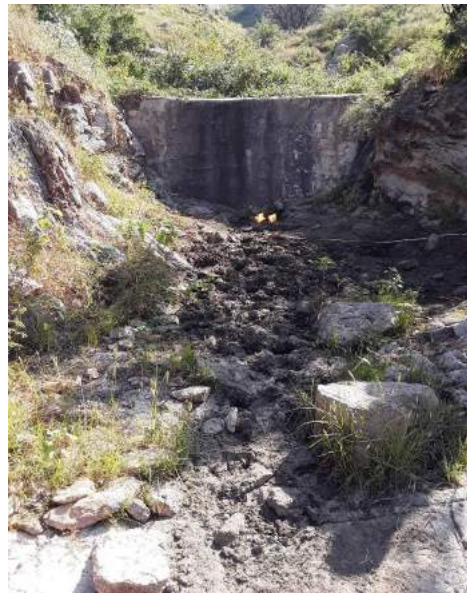
Site ID	PV1-01	Interpretation of Groundwater Age: Inconclusive
Watershed	Paja Verde Wash	
Monitoring Period	06/2021 - 12/2021	Potential Impacts/Effects: No flow has been observed at this site.
Number of Visits	3

**Aquatic and Vegetation Survey Findings:** Dry wash with a masonry dam with a dry valve at the base. No signs of recent water. Stomped mud at site hardened dry. Surrounding vegetation is sparse, dominated by kidneywood (*Eysenhardtia orthocarpa*) and mimosa (*Mimosa dysocarpa*). Invasive cocklebur (*Xanthium strumarium*) occurs. No aquatic herpetofauna or invertebrates have been observed.
