# Hermosa Spring and Seep Catalog

Hermosa Project Area

## SPRING AND SEEP CATALOG Hermosa Project Area

### INTRODUCTION

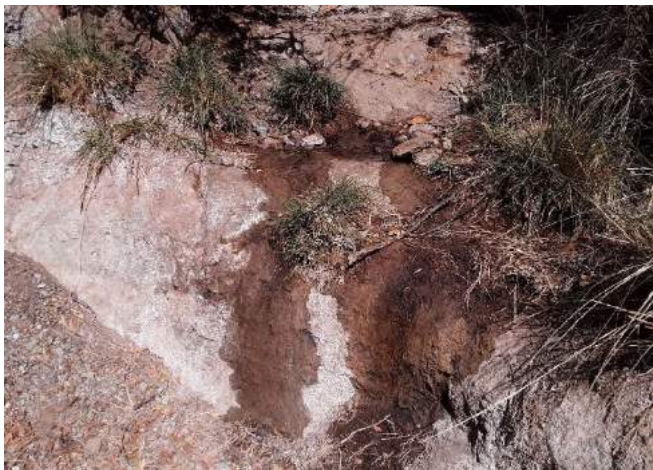
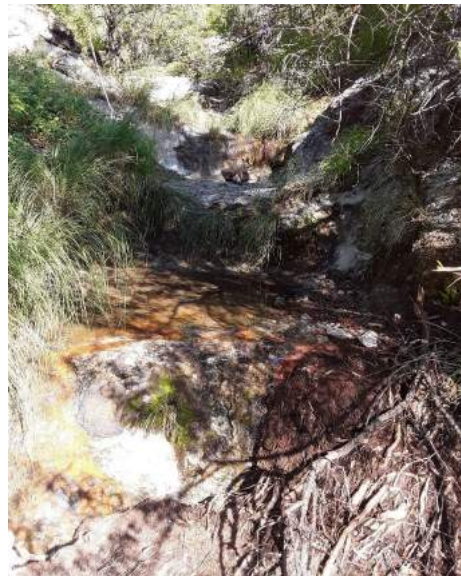
<b>Site ID</b>	RM-SP-01	<b>Interpretation of Groundwater Age:</b> Inconclusive
<b>Watershed</b>	Red Mountain Tributary	
<b>Monitoring Period</b>	06/2021 - 12/2021	<b>Potential Impacts/Effects:</b> Flows measured at this site have ranged from 0 to 0.01 gpm.
<b>Number of Visits</b>	3

**Aquatic and Vegetation Survey Findings:** Water seeping from bedrock ledges in trachyandesite cascades over shelves into a lower muddy pool. Vegetation is Madrean evergreen woodland with an overstory dominated by Toumey oak (*Quercus toumeyi*). No aquatic herpetofauna or invertebrates have been observed. Cattle scat has been observed below the spring. Javelina tracks have been observed.

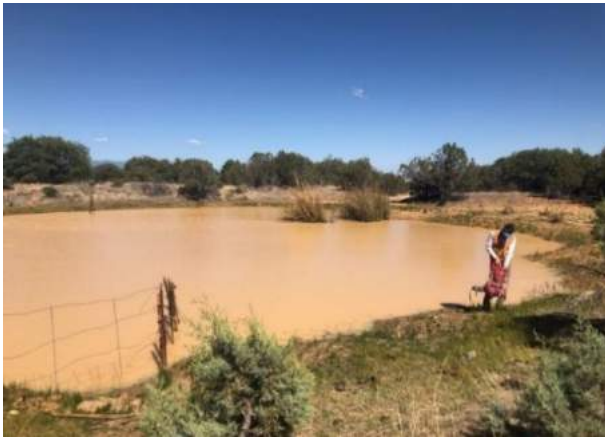
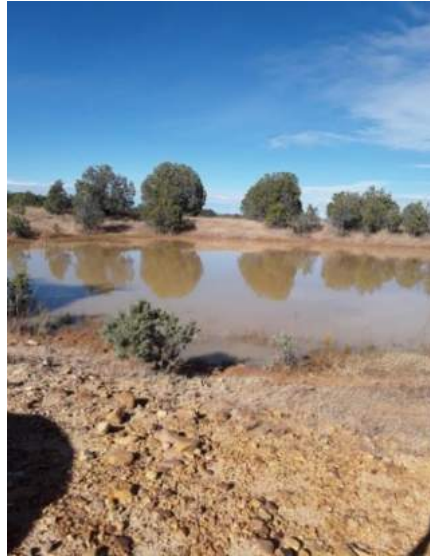
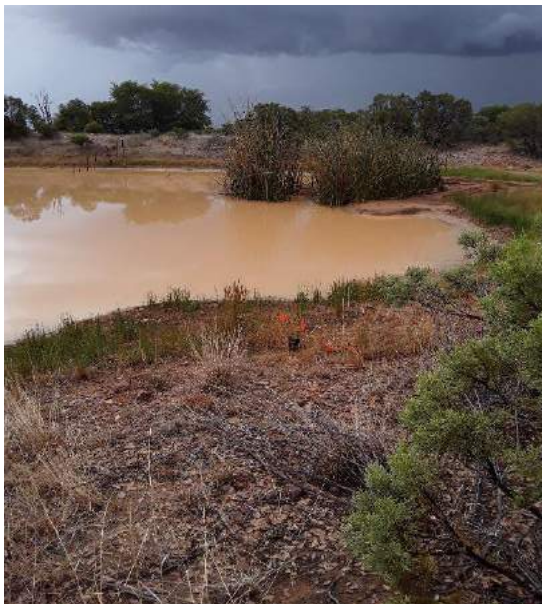
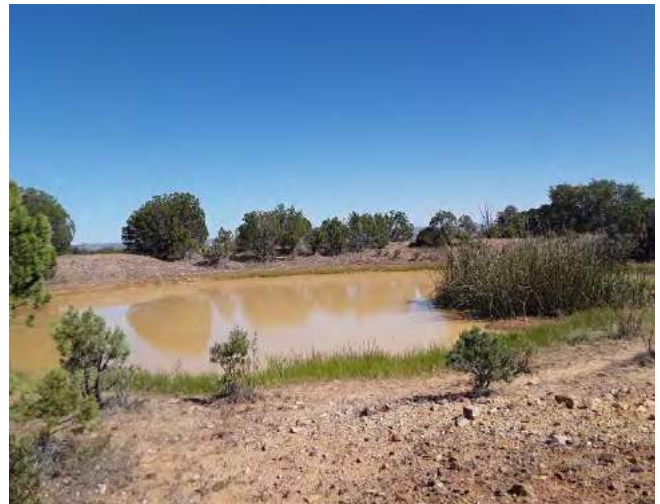
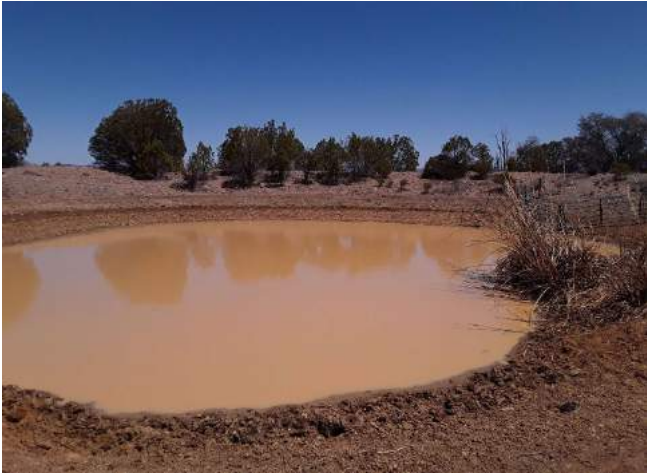
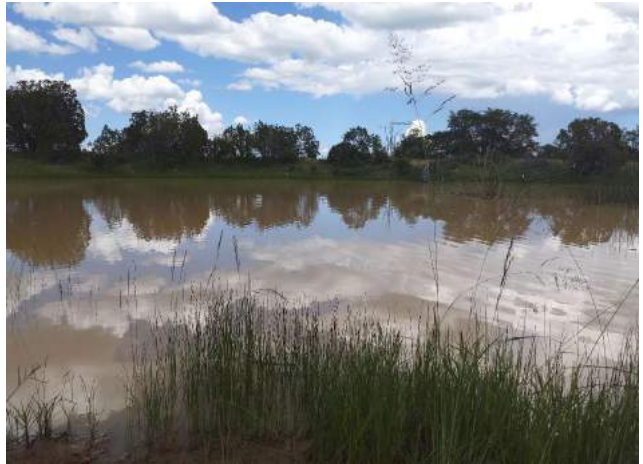
Site ID	RT-01	Interpretation of Groundwater Age: Inconclusive.
Watershed	Ridge Tank	
Monitoring Period	5/2019 - 12/2021	Potential Impacts/Effects: No flow has been measured at this site. This site sits atop a ridge and is a dirt tank (excavated depression) that holds precipitation and some surface runoff. Groundwater does not contribute to this site. No changes are predicted at this site.
Number of Visits	9

**Aquatic and Vegetation Survey Findings:** Ridge Tank, a large earthen tank, is located on the ridgetop divide between Adams Canyon and Chino Draw. California bulrush (*Schoenoplectus californicus*), a wetland associated species, is present as emergent vegetation. Hairy watercress (*Marsilea vestita*), a wetland associated species is present as floating vegetation and algae as submerged vegetation. Riparian obligates, spikerush (*Eleocharis* sp.) and Baltic rush (*Juncus balticus*), dominate the perimeter of the tank. Upland overstory vegetation surrounding the tank is dominated by juniper (*Juniperus* spp.) and pointleaf manzanita (*Arctostaphylos pungens*). Invasive plants observed at this site include Lehmann lovegrass (*Eragrostis lehmanniana*), giant reed (*Arundo donax*), and Bermudagrass (*Cynodon dactylon*). Aquatic invertebrates including beetles, damselflies, dragonflies, water scorpions, backswimmers, and snails have been observed. Aquatic vertebrates observed include the black-necked gartersnake (*Thamnophis cyrtopsis*). Non-native sunfish (*Centrarchidae* family) and the invasive American bullfrog (*Lithobates catesbeianus*) have also been noted at this site.

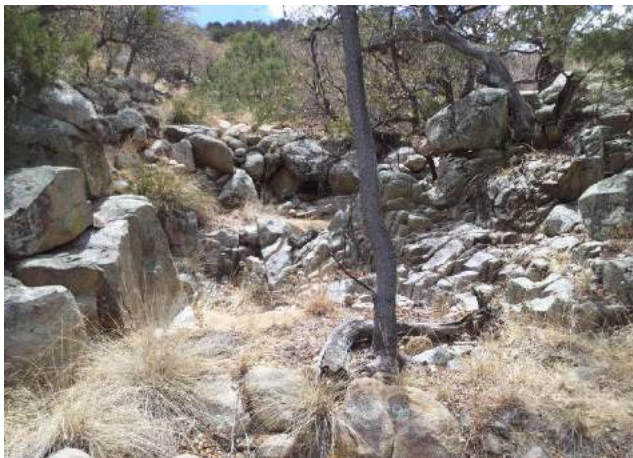
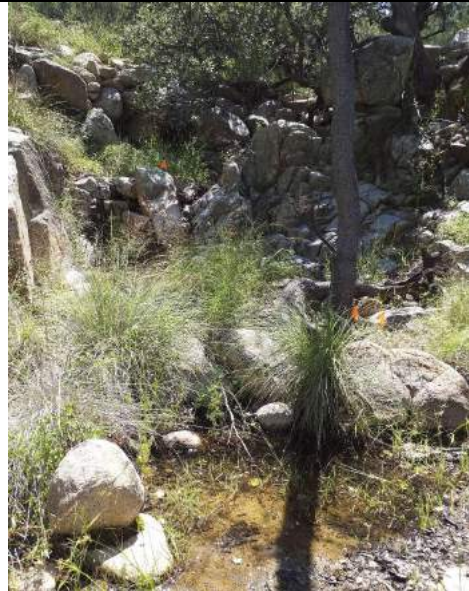
Site ID	SB1-01	Interpretation of Groundwater Age: Inconclusive
Watershed	Soldier Basin	
Monitoring Period	06/2021 - 12/2021	Potential Impacts/Effects: Flow has been observed at this site during the wet season. Predictions will be made once additional data is obtained.
Number of Visits	3

**Aquatic and Vegetation Survey Findings:** Colluvial dam, followed by series of terraces with alluvial deposition. A cobble and concrete container was built into the eastern hillside. Vegetation is Madrean evergreen woodland with a riparian overstory dominated by Fremont cottonwood (*Populus fremontii*). Invasive Lehmann lovegrass (*Eragrostis lehmanniana*) was present. Aquatic beetles were observed. No aquatic herpetofauna have been observed.

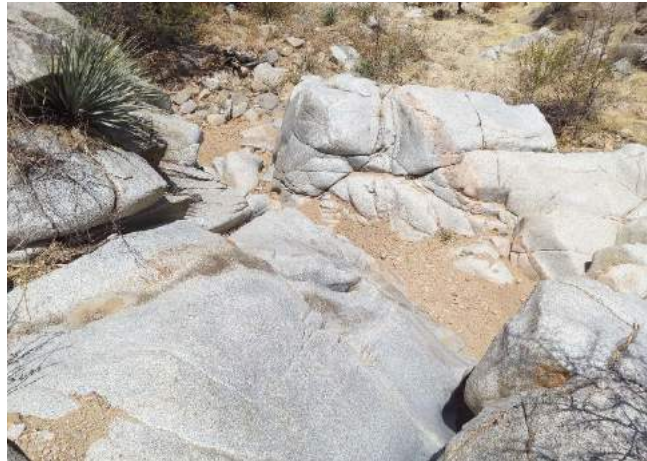
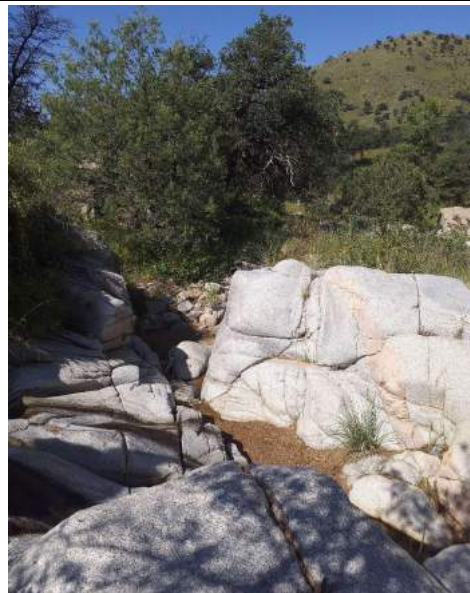
Site ID	SB1-02	Interpretation of Groundwater Age: Inconclusive
Watershed	Soldier Basin	
Monitoring Period	06/2021 - 12/2021	Potential Impacts/Effects: Flow has been observed at this site during the wet season. Predictions will be made once additional data is obtained.
Number of Visits	3

**Aquatic and Vegetation Survey Findings:** Granitic bedrock outcrop in channel near road crossing with seeping trace flow atop outcrop. Vegetation is Madrean evergreen woodland with woody vegetation dominated by beargrass (*Nolina microcarpa*), coyote willow (*Salix exigua*), and mimosa (*Mimosa aculeaticarpa* var. *biuncifera*). Invasive Bermudagrass (*Cynodon dactylon*) and Lehmann lovegrass (*Eragrostis lehmanniana*) are present. Aquatic beetles and one red-spotted toad tadpole (*Anaxyrus punctatus*) were observed. Deer tracks were noted.

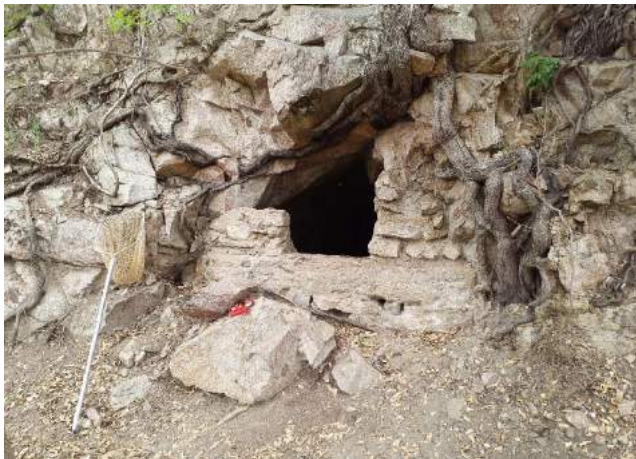
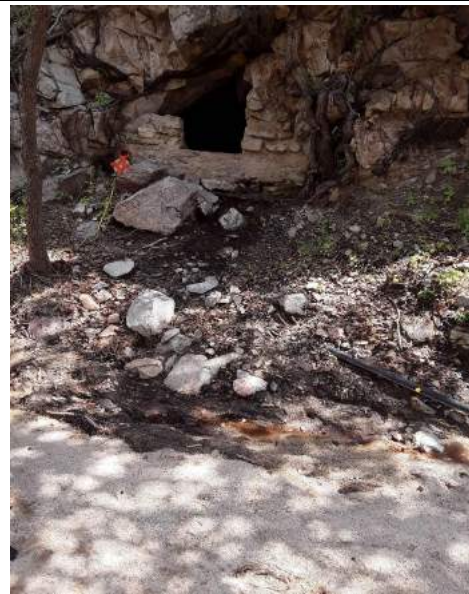
Site ID	SC-SP-01	Interpretation of Groundwater Age: Inconclusive
Watershed	Sycamore Canyon	
Monitoring Period	6/2021 - 12/2021	Potential Impacts/Effects: Little flow has been observed at the site during the dry season. Predictions will be made once additional data is obtained.
Number of Visits	3

**Aquatic and Vegetation Survey Findings:** Old qanat dug 20 feet back into granodiorite bedrock wall with trace flow. Vegetation is Madrean evergreen woodland with a tree overstory dominated by velvet ash (*Fraxinus velutina*) and Arizona white oak (*Quercus arizonica*). No aquatic invertebrates or herpetofauna were observed. Unknown mammal tracks were present in the mud.

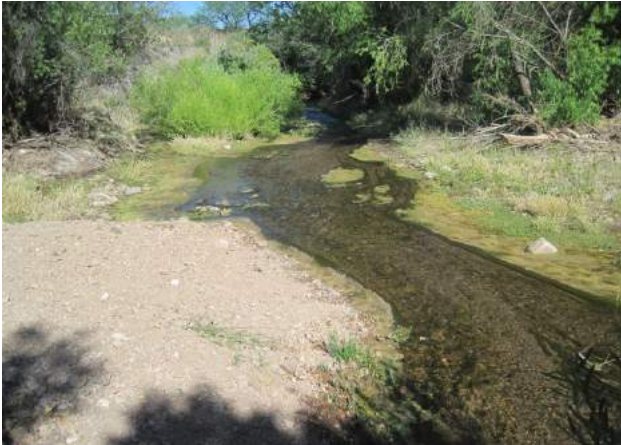
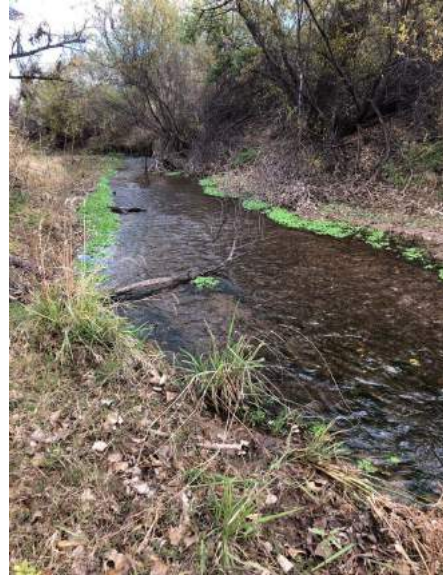
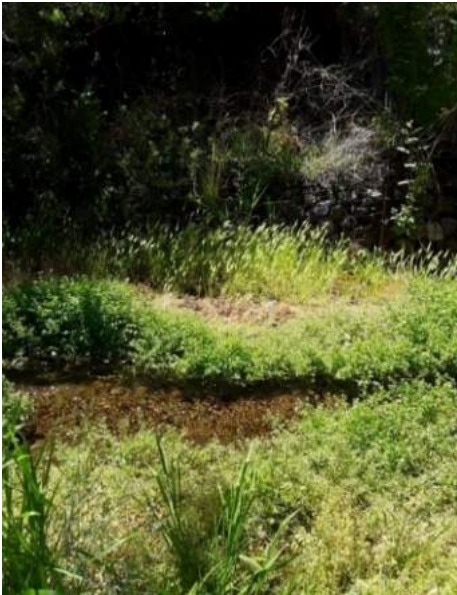
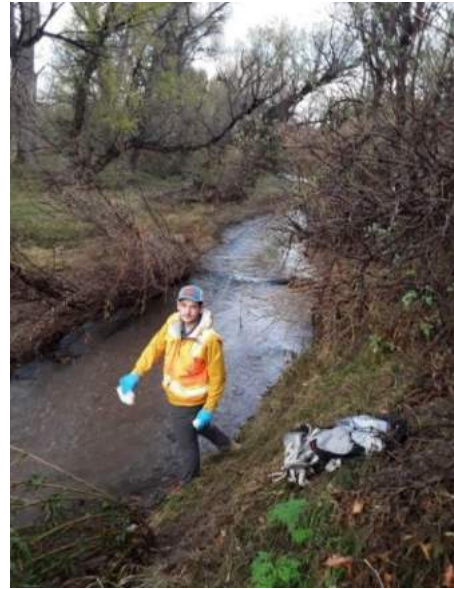
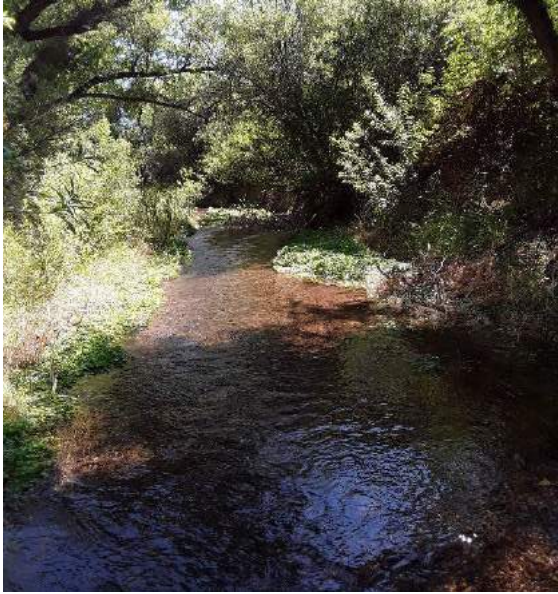
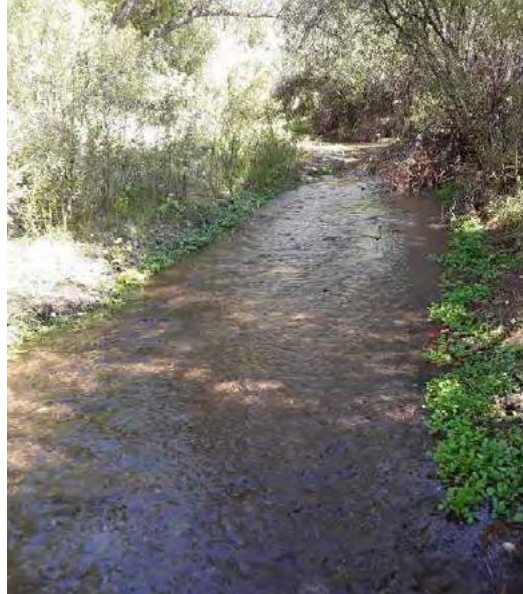
<b>Site ID</b>	SNTA-01	<b>Interpretation of Groundwater Age:</b> Consistent deep groundwater source.
<b>Watershed</b>	Sonoita Creek	
<b>Monitoring Period</b>	6/2018-12/2021	<b>Potential Impacts/Effects:</b> Flows observed at this site have ranged from 545 to 4,620 gpm (1.2 to 10 cfs). In the first 4 years, flows in Sonoita Creek increased slightly due to discharge water in Harshaw Creek recharging the groundwater system.
<b>Number of Visits</b>	11

**Aquatic and Vegetation Survey Findings:** This site located along a section of Sonoita Creek upstream of the Alum Gulch confluence. Water is present in shallow riffles and runs. Riparian tree species present include Bonpland willow (*Salix bonplandiana*) and Fremont cottonwood (*Populus fremontii*). Emergent and perimeter vegetation is dominated by invasive plants including Bermudagrass (*Cynodon dactylon*), yellow sweet clover (*Melilotus officinalis*), and Johnson grass (*Sorghum halepense*). Fish have been observed at this site and include speckled dace (*Rhinichthys osculus*) and longfin dace (*Agosia chrysogaster*). Invasive crayfish have been observed. Aquatic invertebrates observed include belostomatids and damselfly.

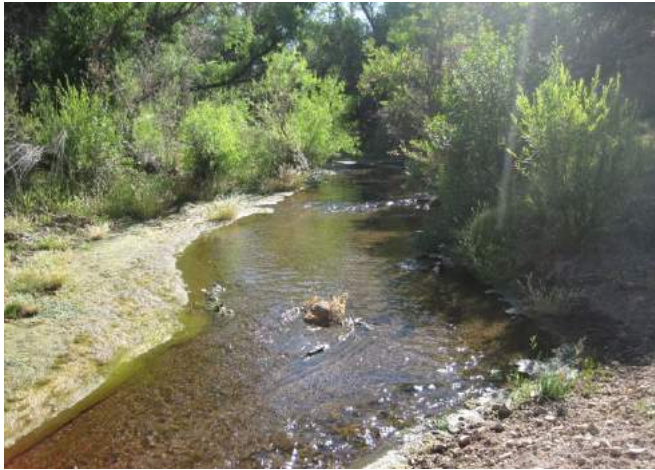
**Dry Season Photo (6/4/2018)**

**Aquatic and Vegetation Survey Findings:** This site located along a section of Sonoita Creek downstream of the Alum Gulch confluence. Water is present in shallow riffles and runs. Riparian tree species present include Bonpland willow (*Salix bonplandiana*), narrowleaf willow (*Salix exguia*), Fremont cottonwood (*Populus fremontii*), and velvet ash (*Fraxinus velutina*). Emergent and perimeter vegetation is dominated by invasive yellow sweet clover (*Melilotus officinalis*) and native seepwillow (*Baccharis salicifolia*). Non-native annual rabbitsfoot grass (*Polypogon monspeliensis*) and other invasive plants, water cress (*Nasturtium officinale*) and Johnson grass (*Sorghum halepense*) have been observed. Fish have been observed at this site and include speckled dace (*Rhinichthys osculus*) and longfin dace (*Agosia chrysogaster*). Invasive crayfish have been observed. Aquatic invertebrates observed include belostomatids, boatmen, beetles, water scorpions, and snails.

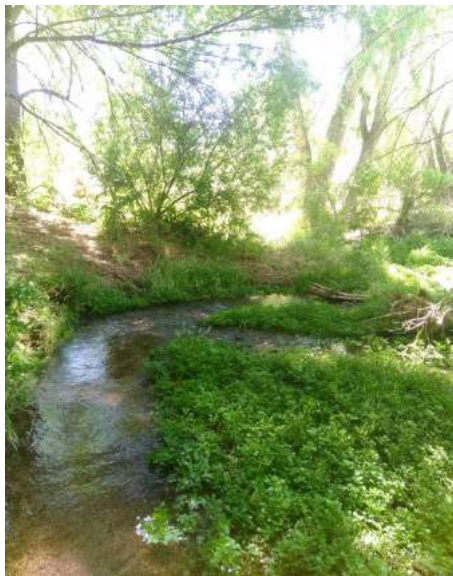
**Dry Season Photo (05/27/2021)**

**Aquatic and Vegetation Survey Findings:** Water flowing through the channel. Sandy soil banks on both sides. Sandy gravelly bottom. Vegetation is riparian forest and scrub dominated by Goodding's willow (*Salix exigua*) and coyote willow (*Salix exigua*), with a dense ground cover of watercress (*Nasturtium officinale*) in places. Native speckled dace (*Rhinichthys osculus*), longfin dace (*Agosia chrysogaster*), and Sonoran desert sucker (*Catostomus insignis*) were found in the creek, along with non-native crayfish. Invasive Bermudagrass (*Cynodon dactylon*), Johnsongrass (*Sorghum halepense*), and cocklebur (*Xanthium strumarium*) were observed. Aquatic invertebrates observed include beetles, belostomatids, and dragonflies. White-tailed deer (*Odocoileus virginianus*), javelina (*Tayassu tajacu*), and grey squirrels (*Sciurus carolinensis*) were present. Bird species observed include ravens (*Corvus corax*), painted redstarts (*Myioborus pictus*), vermilion flycatchers (*Pyrocephalus obscurus*), and a flicker (*Colaptes auratus*).

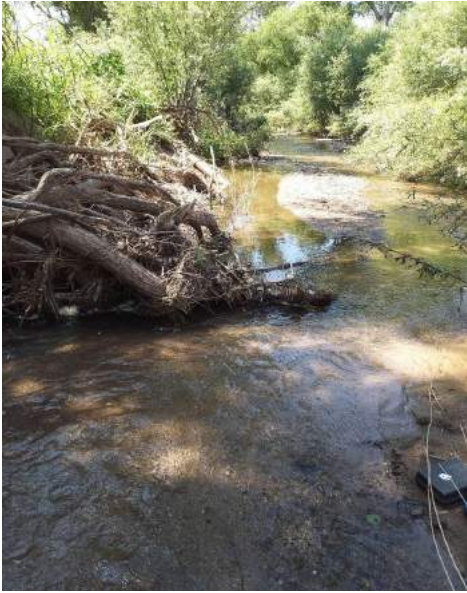
<b>Dry Season Photo (05/27/2021)</b>	<b>Wet Season Photo (09/14/2021)</b>
See SNTA-TNC-01

**Aquatic and Vegetation Survey Findings:** Water flows in a meandering stream channel. Alluvial sediment with sandy, gravelly substrate and cobbles. Vegetation is riparian scrub dominated by coyote willow (*Salix exigua*). Invasive Johnsongrass (*Sorghum halepense*) was observed.

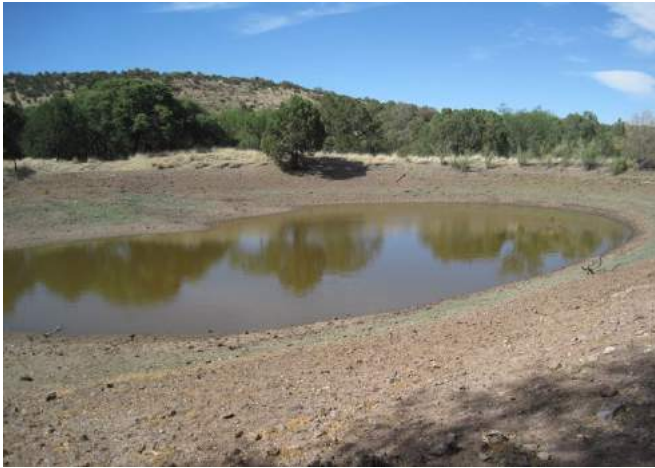
**Dry Season Photo (6/1/2018)**

**Aquatic and Vegetation Survey Findings:** Site is an earthen stock tank located within a tributary to Corral Canyon. The tank typically supports some floating vegetation, Chihuahuan waterclover (*Marsilea mollis*), as well as perimeter vegetation dominated by non-native jungle rice (*Echinochloa colona*). Invasive plants observed include Bermudagrass (*Cynodon dactylon*) and Lehmann lovegrass (*Eragrostis lehmanniana*). Aquatic invertebrates observed include beetles, belostomatid, backswimmers, boatmen, dragonfly, leeches, water scorpions, and snails. Invasive mosquitofish (*Gambusia affinis*) and American bullfrogs (*Lithobates catesbeianus*) have been observed.

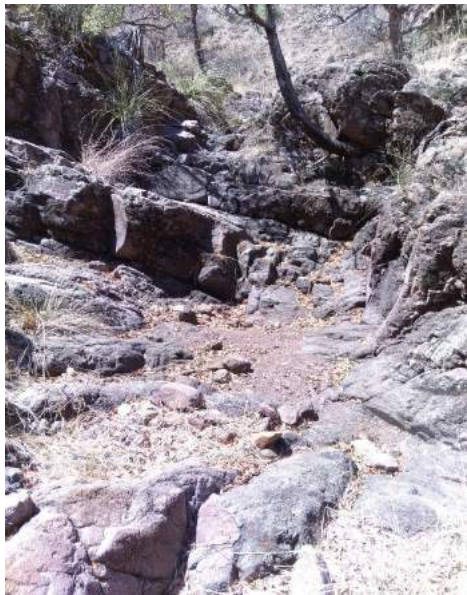
**Dry Season Photo (06/03/2021)**

**Aquatic and Vegetation Survey Findings:** Plunge pool at the base of bedrock outcrop. Surrounding vegetation is Madrean evergreen woodland. Aquatic backswimmers, boatmen, dragonflies, fairy shrimp, and red-spotted toads (*Anaxyrus punctatus*) have been observed.

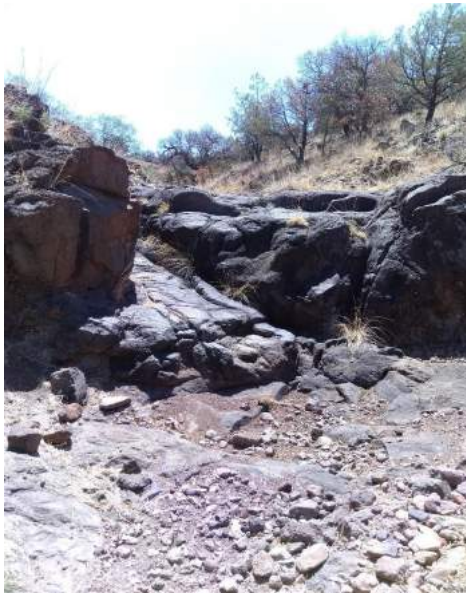
**Dry Season Photo (06/03/2021)**

**Aquatic and Vegetation Survey Findings:** Ponded water is located in a bedrock notch within the tributary channel. Surrounding vegetation is Madrean evergreen woodland. Aquatic beetles, backswimmers, dragonflies, boatmen, and fairy shrimp have been observed.

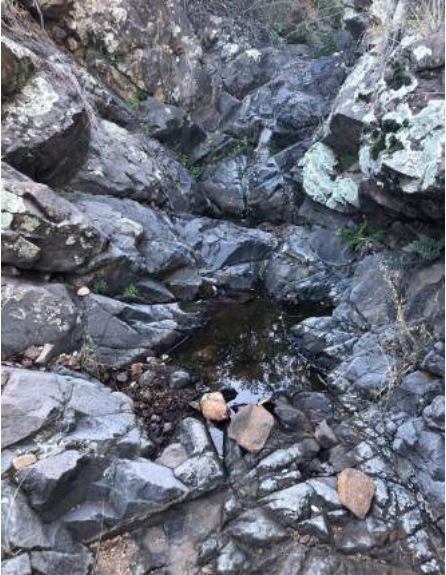
<b>Dry Season Photo</b>	<b>Wet Season Photo (12/3/2018)</b>
No photo taken

**Aquatic and Vegetation Survey Findings:** This site located within a bedrock section of a tributary to Harshaw Creek. Understory vegetation at the site is limited to upland species predominated by perennial grasses (*Poaceae* family), rockloving spikemoss (*Selaginella rupincola*), and sugar sumac (*Rhus ovata*). Overstory vegetation is dominated by Arizona white oak (*Quercus arizonica*) and alligator juniper (*Juniperus deppeana*). No aquatic invertebrates and no aquatic vertebrates have been observed.

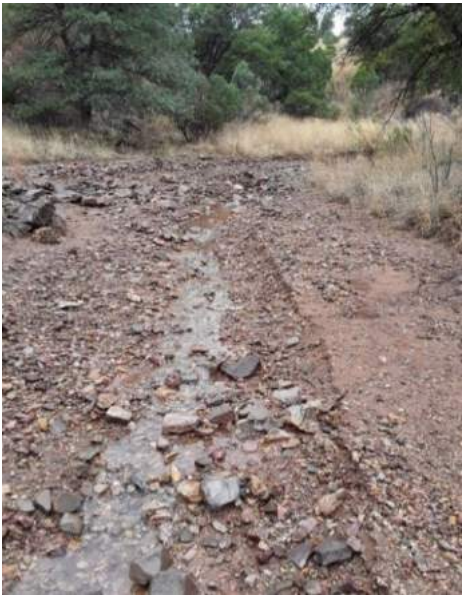
Dry Season Photo	Wet Season Photo (12/8/2019)
No photo taken

**Aquatic and Vegetation Survey Findings:** This site located within a gravely and cobbly section of a tributary to Harshaw Creek. This portion of the creek has little vegetation cover within the drainage. Understory vegetation lining the channel includes grasses and seepwillow (*Baccharis salicifolia*). Overstory cover is dominated by Arizona walnut (*Juglans major*), oak (*Quercus* spp.), and velvet mesquite (*Prosopis velutina*). Invasive plant species observed include common mullein (*Verbascum thapsus*). No aquatic invertebrates or vertebrates have been observed.

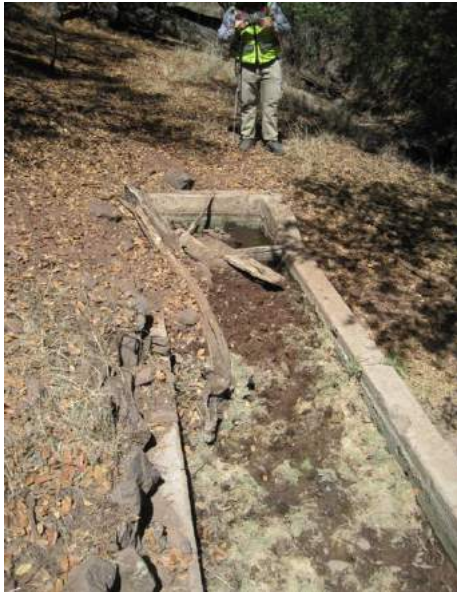
**Dry Season Photo (6/1/2018)**

**Aquatic and Vegetation Survey Findings:** This concrete drinker is located in the upstream extent of an unnamed tributary to Harshaw Creek. Understory vegetation is dominated by sumac (*Rhus* spp.), Wright's silktassel (*Garrya wrightii*), pinyon ricegrass (*Piptochaetium fimbriatum*), and bull grass (*Muhlenbergia emersley*). Overstory vegetation is dominated by Arizona white oak (*Quercus arizonica*) and alligator juniper (*Juniperus deppeana*). Invasive plant species observed include Lehmann lovegrass (*Eragrostis lehmanniana*) and Bermudagrass (*Cynodon dactylon*). Aquatic beetles have been observed.

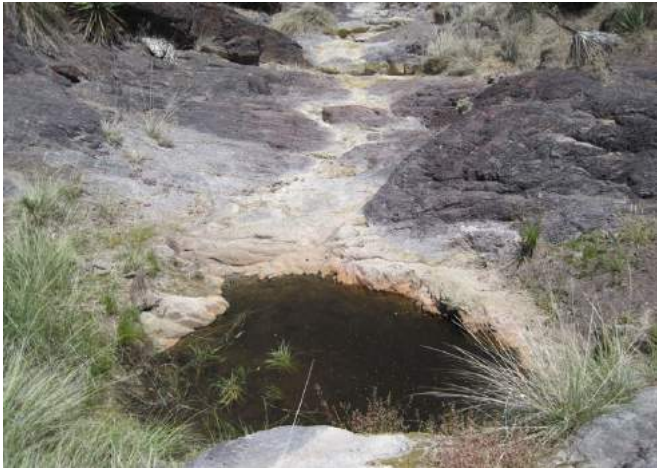
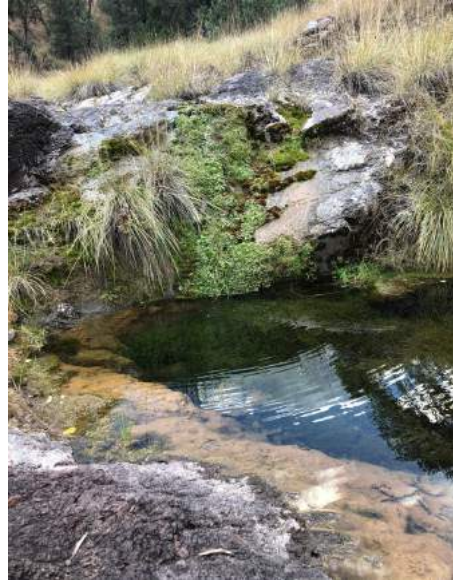
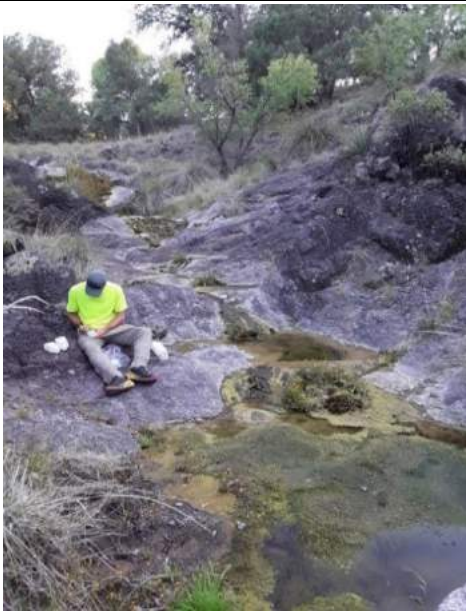
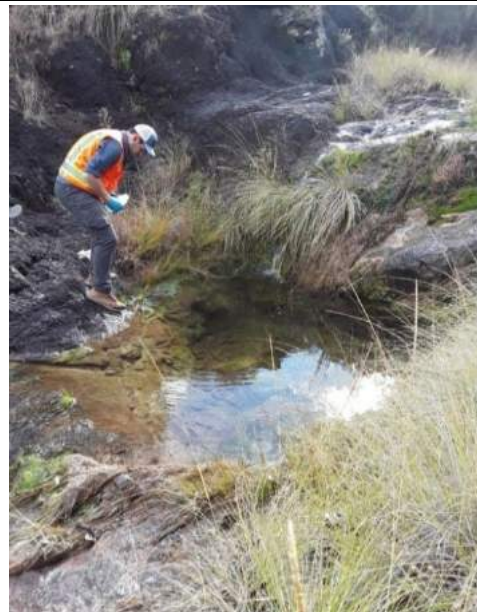
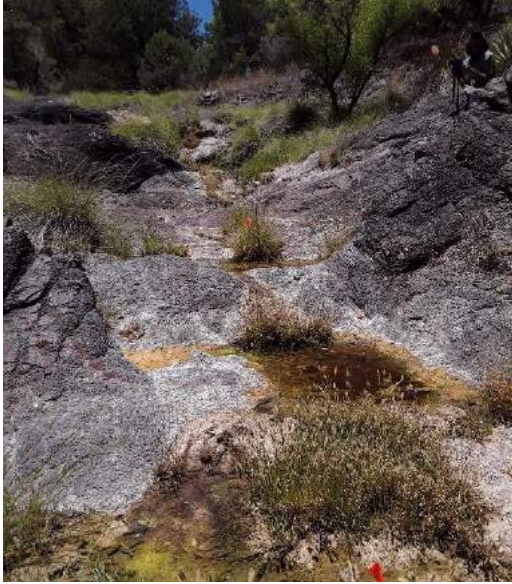
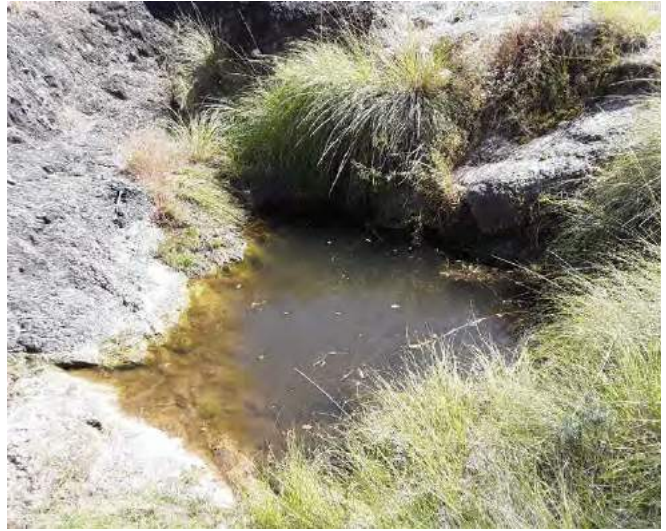
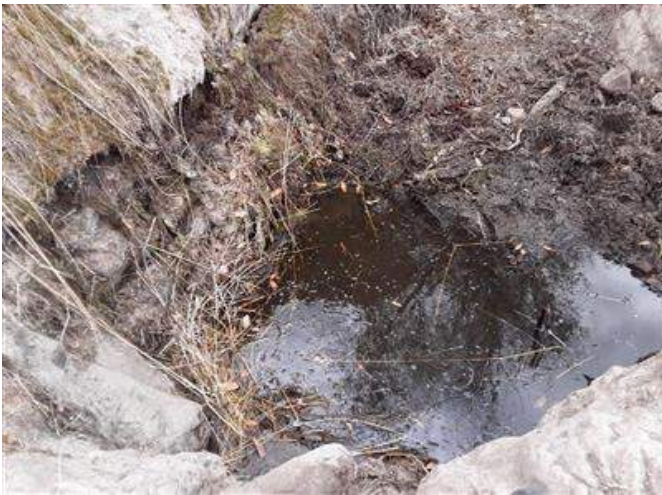
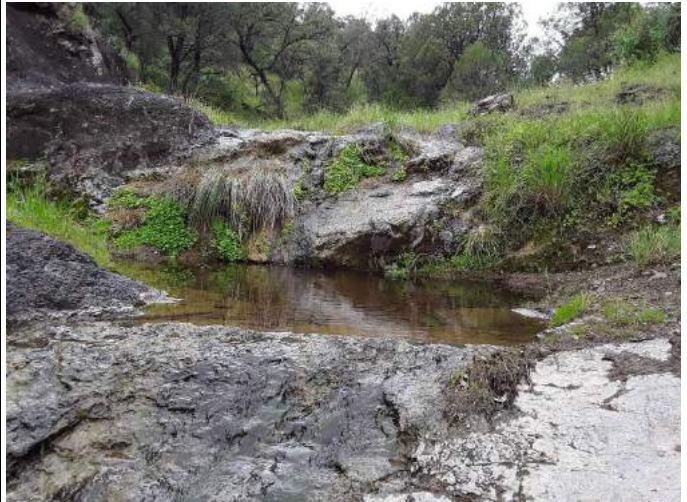
Site ID	TH14-01	Interpretation of Groundwater Age: Inconclusive
Watershed	Trib. To Harshaw Creek	
Monitoring Period	5/2017 - 12/2021	Potential Impacts/Effects: Flows observed at this site have ranged from 0 to 9.20 gpm. No changes are predicted at this site.
Number of Visits	13

**Aquatic and Vegetation Survey Findings:** This seep is located in section of unnamed tributary to Harshaw Creek with exposed bedrock. Generally, water is present in shallow pools. The site supports a number of herbaceous riparian obligate or wetland associated species including seep monkeyflower (*Mimulus guttatus*) and Mexican rush (*Juncus mexicanus*) as well as a variety of other herbaceous and shrub cover including bullgrass (*Muhlenbergia emersley*), catclaw mimosa (*Mimosa aculeaticarpa* var. *biuncifera*), sotol (*Dasyliion wheeleri*), green sprangletop (*Leptochloa dubia*), and Gentry yucca (*Yucca madrensis*). Non-native rabbitsfoot grass (*Polypogon* spp.) and invasive Lehmann lovegrass (*Eragrostis lehmanniana*) have been observed. Aquatic beetles, backswimmers, and dragonflies have been observed along this portion of the drainage. No aquatic vertebrates have been observed along this portion of the drainage.

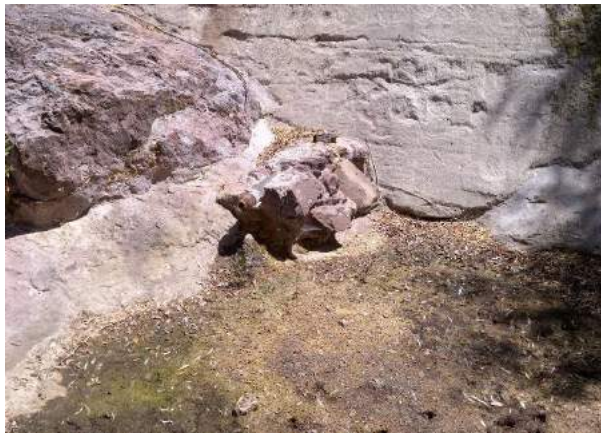
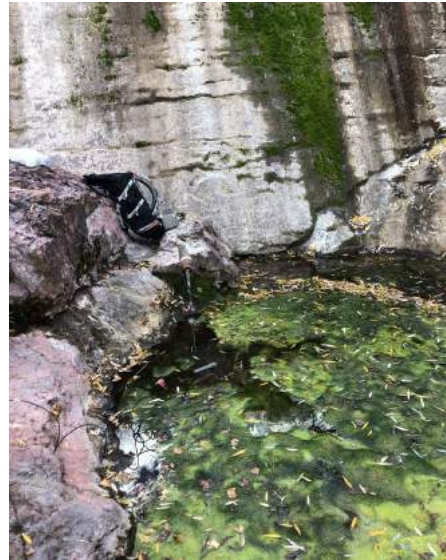
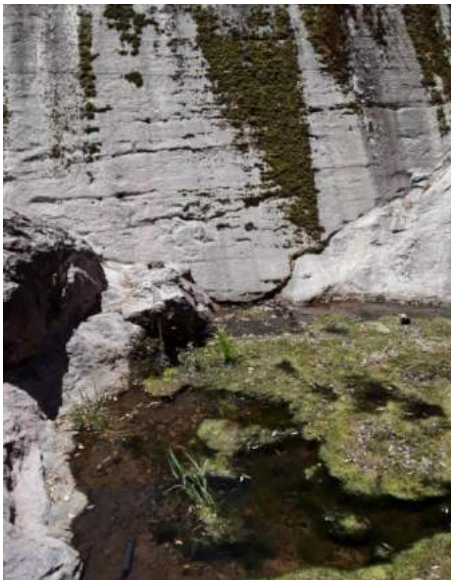
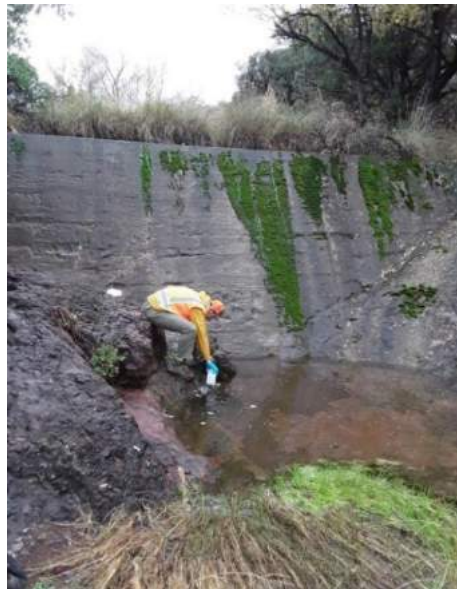
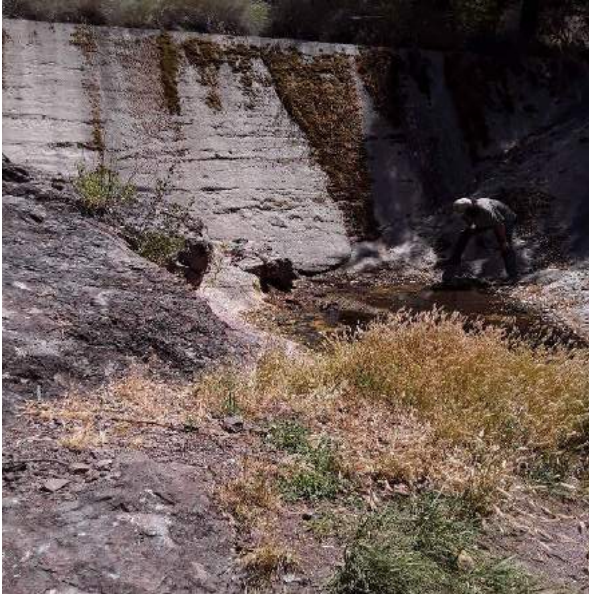
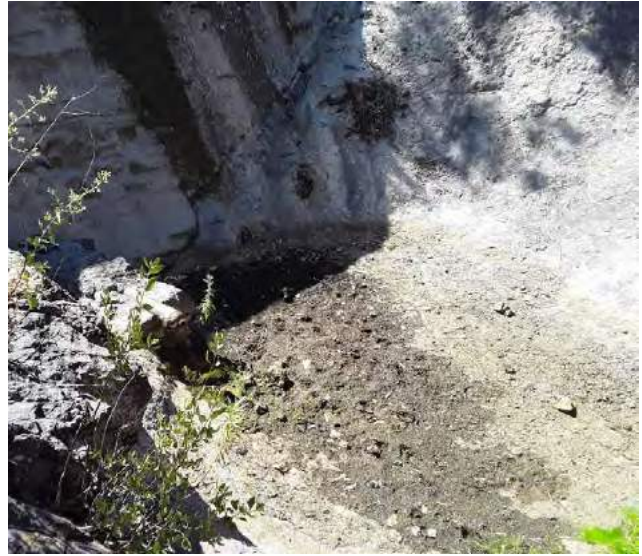
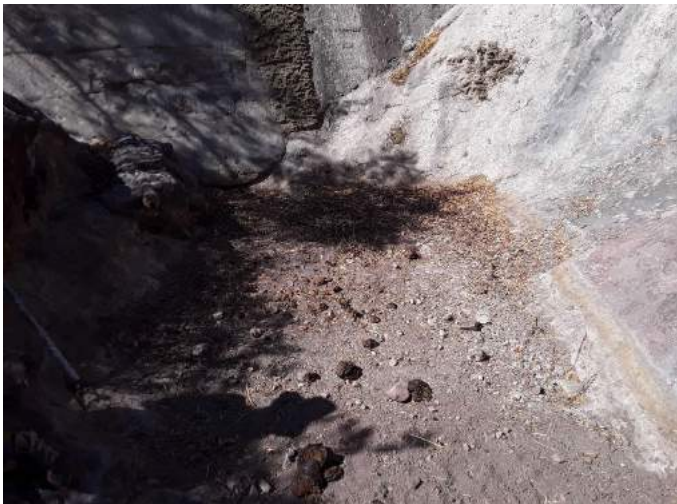
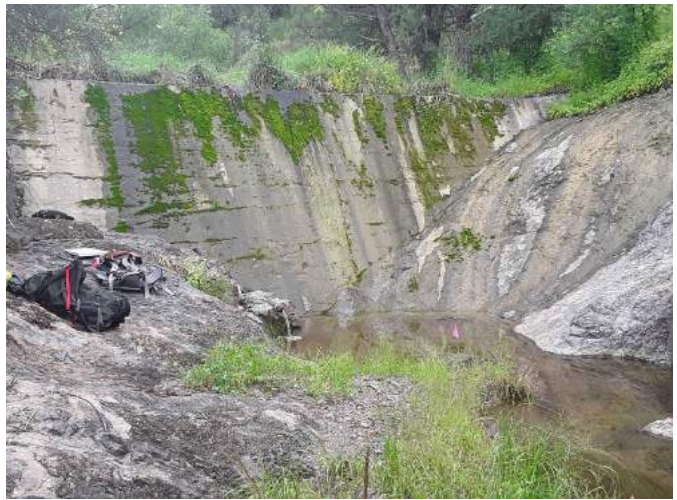
<b>Site ID</b>	TH15-01	<b>Interpretation of Groundwater Age:</b> Modern water.
<b>Watershed</b>	Trib. To Harshaw Creek	
<b>Monitoring Period</b>	11/2018 - 12/2021	<b>Potential Impacts/Effects:</b> Flows observed at this site have ranged from 0 to 8.2 gpm. No changes are predicted at this site.
<b>Number of Visits</b>	10

**Aquatic and Vegetation Survey Findings:** A relic concrete dam that has silted in within an unnamed tributary to Harshaw Creek, downstream of Great Silver Mine supports water at the base of the dam in form of pools and flowing runs during the wet season. Algae is typically present as floating substrate. Understory vegetation is dominated by deergrass (*Muhlenbergia rigens*) and seepwillow (*Baccharis salicifolia*) with seep monkeyflower (*Mimulus guttatus*), a wetland associated plant, also present. Non-native annual rabbitsfoot grass (*Polypogon monspeliensis*) has been noted. Aquatic invertebrates that have observed include boatmen, backswimmers, dragonflies, belostomatids, and beetles. Canyon treefrog (*Hyla arenicolor*) tadpoles, toad (*Bufo* sp.) tadpoles, and black-necked gartersnakes (*Thamnophis cyrtopsis*) have been observed at this site.

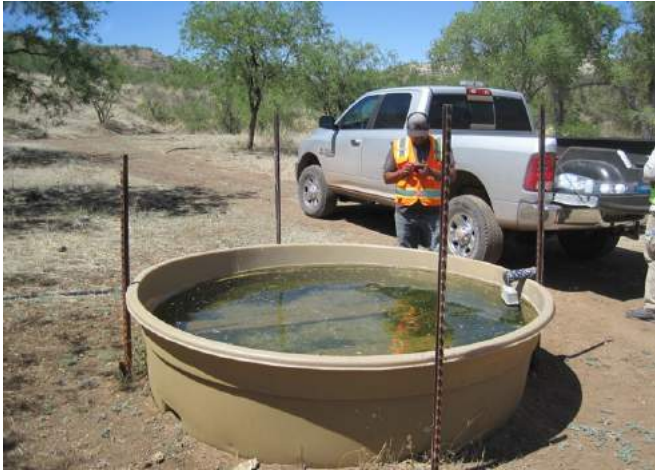
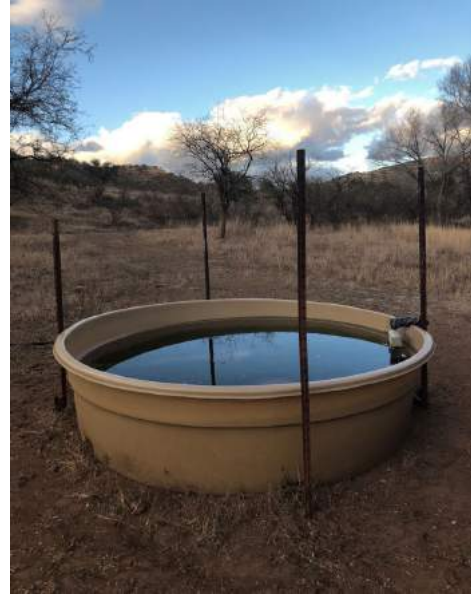
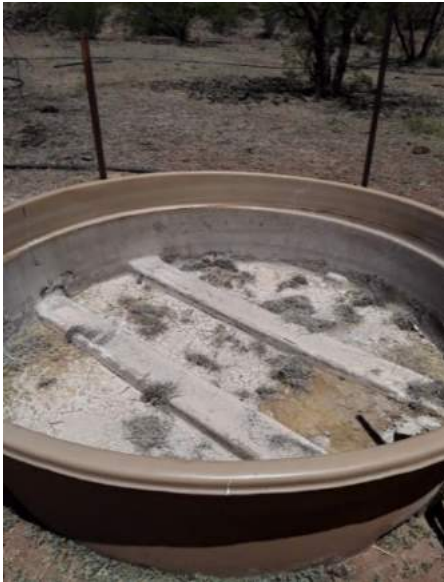
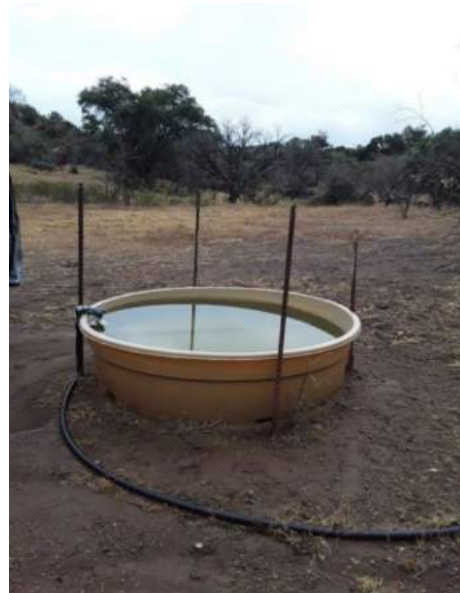
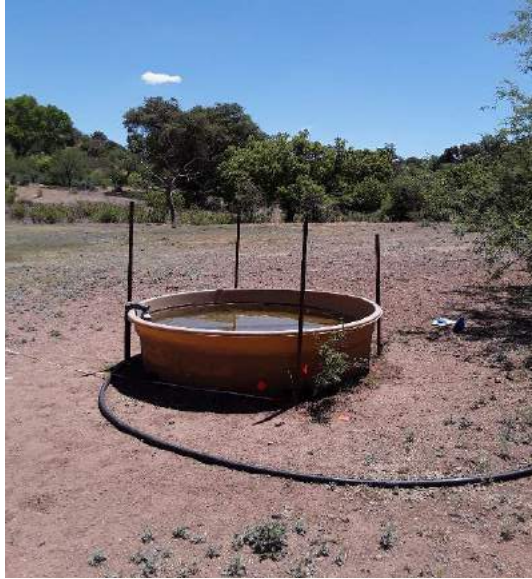
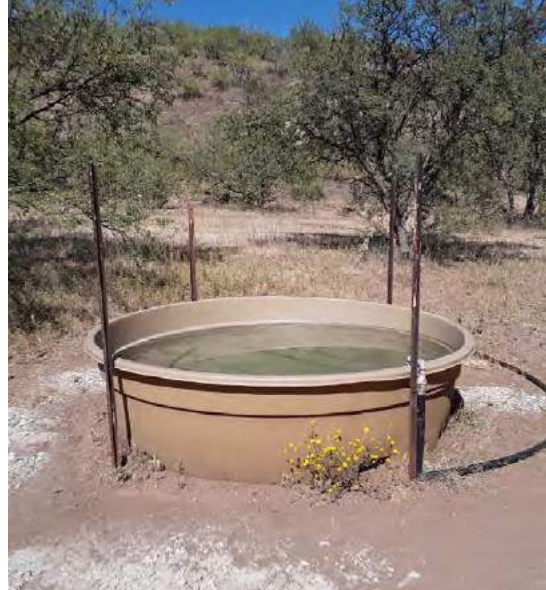
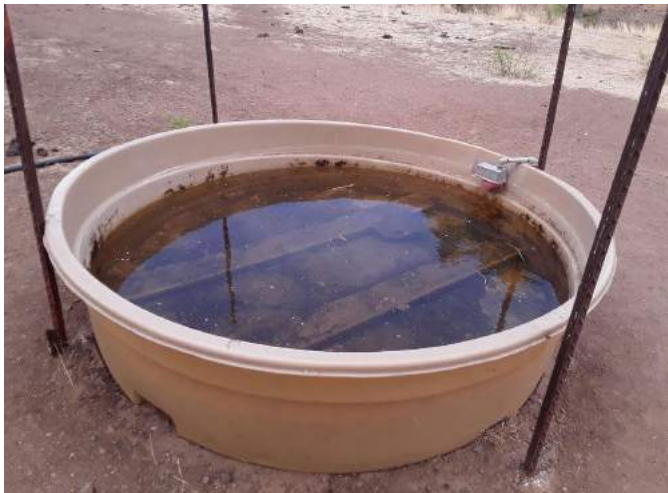
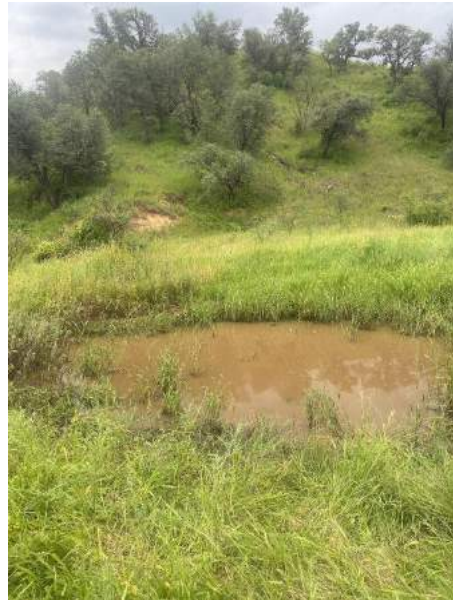
<b>Site ID</b>	TH21-WELL-ST-01	<b>Interpretation of Groundwater Age:</b> Modern water.
<b>Watershed</b>	Trib. To Harshaw Creek	
<b>Monitoring Period</b>	11/2017 - 12/2021	<b>Potential Impacts/Effects:</b> This site is not a seep or spring; it is fed by a well. No changes are predicted at this site.
<b>Number of Visits</b>	12

**Aquatic and Vegetation Survey Findings:** This site is a plastic stock drinker located in an unnamed tributary to Harshaw Creek. Algae has been observed as submerged vegetation at this site. This site does not support emergent or perimeter riparian vegetation. Understory and overstory vegetation at the site includes velvet mesquite (*Prosopis velutina*) and weakleaf bur ragweed (*Ambrosia confertiflora*). Invasive Bermudagrass (*Cynodon dactylon*) has been observed at this site. Aquatic invertebrates observed in this drinker include backswimmers, boatmen, beetles, dragonflies, and belostomatids. There have been no aquatic vertebrates observed.

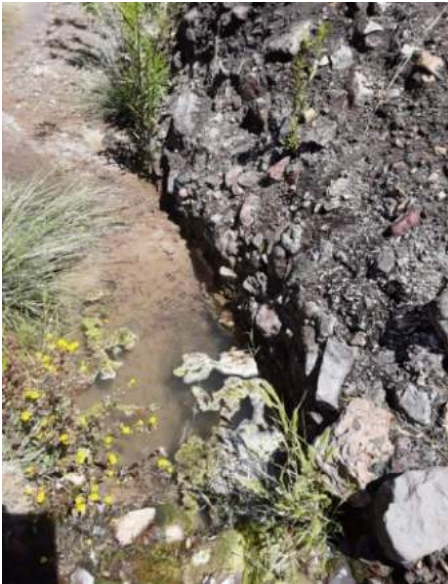
**Dry Season Photo (5/24/2019)**

**Aquatic and Vegetation Survey Findings:** Located in unnamed tributary to Harshaw Creek in portion with bedrock channel. Generally, water is present in shallow pools. Aquatic beetles, boatmen, belostomatids, and dragonflies have been observed. No aquatic vertebrates have been observed along drainage. Riparian overstory is limited to a few individual cottonwood (*Populus fremontii*) trees in the vicinity. Understory vegetation is dominated by seepwillow (*Baccharis salicifolia*), skunkbush sumac (*Rhus trilobata*), and deergrass (*Muhlenbergia rigens*). Riparian obligate forbs, seep monkeyflower (*Mimulus guttatus*) and annual rabbitsfoot grass (*Polypogon monspeliensis*), have been noted. Upland vegetation is characterized as oak woodlands with pointleaf manzanita (*Arctostaphylos pungens*).

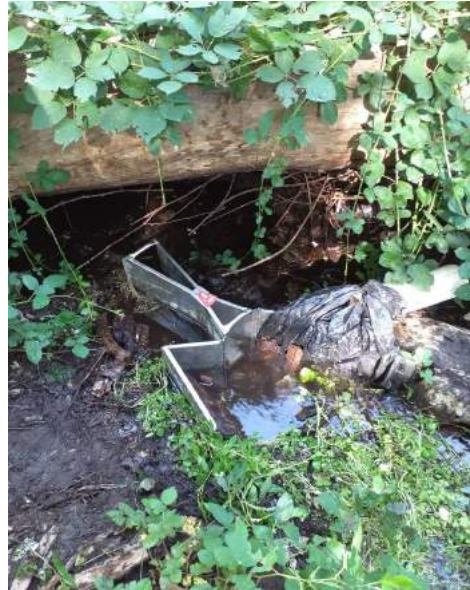
#### Wet Season Photo (09/14/2021)

**Aquatic and Vegetation Survey Findings:** Emergence of spring at the base of small hill flowing out from under log forming large cienega. Predominant floating and emergent vegetation include watercress (*Rorippa nasturtium-aquaticum*), chairmaker's bulrush (*Schoenoplectus americanus*), and whorled pennywort (*Hydrocotyle verticillata*). Perimeter vegetation consists of Himalayan blackberry (*Rubus discolor*), velvet ash (*Fraxinus velutina*), and Goodding's willow (*Salix gooddingii*). An adult red-spotted toad (*Anaxyrus punctatus*) has been observed.

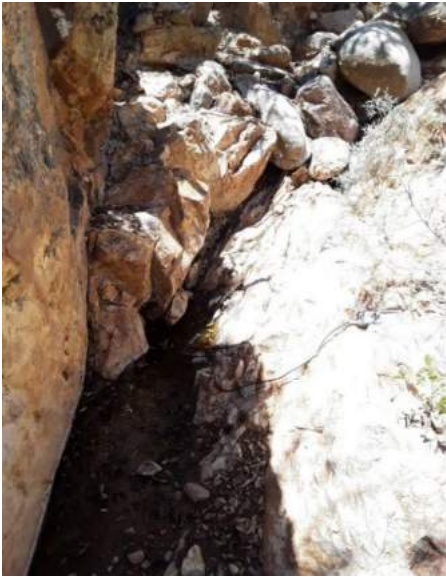
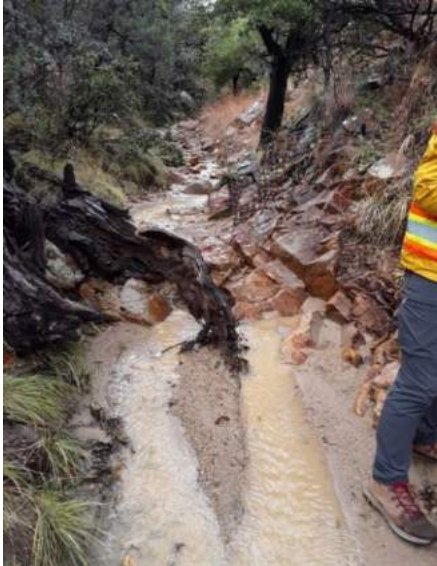
Dry Season Photo (5/23/2019)	Wet Season Photo (12/9/2019)

**Aquatic and Vegetation Survey Findings:** This is a seep is located at exposed bedrock constriction in the upper Finley and Adams Canyon. Grasses and shrubs occur in sparse distributions, mostly dominated by little bluestem (*Schizachyrium* sp.), pinyon ricegrass (*Piptochaetium fimbriatum*), and skunkbush sumac (*Rhus trilobata*). Riparian obligate rushes (*Juncus* spp.) are also present at the site. Overstory vegetation cover is dominated by Mexican pinyon (*Pinus cembroides*) and oak (*Quercus* spp.). Invasive plants observed include Lehmann lovegrass (*Eragrostis lehmanniana*). No aquatic invertebrates or vertebrates have been observed at this site.

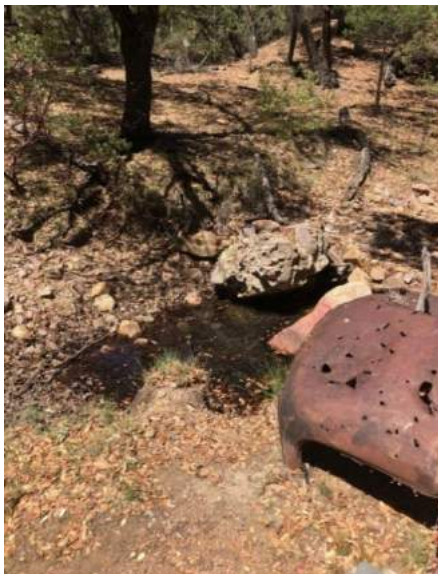
**Dry Season Photo (5/21/2019)**

**Aquatic and Vegetation Survey Findings:** This seep is located in a rocky/gravelly section of Finley and Adams Canyon. Water is typically present in a small, shallow pool. Limited herbaceous cover is dominated by deergrass (*Muhlenbergia rigens*) and riparian obligate Rocky Mountain rush (*Juncus saximontanus*). Understory shrub cover is dominated by pointleaf manzanita (*Arctostaphylos pungens*), skunkbush sumac (*Rhus trilobata*), and Wright's siltkassel (*Garrya wrightii*). Overstory vegetation is dominated by Arizona sycamore (*Platanus wrightii*), a preferential riparian tree species, and oak (*Quercus* spp.). Aquatic invertebrates observed along the Finley and Adams drainage include backswimmers and beetles. No aquatic vertebrates have been observed at this site.

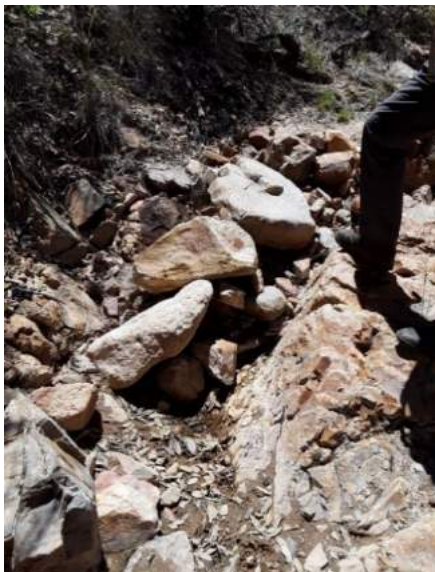
**Dry Season Photo (5/21/2019)**

**Aquatic and Vegetation Survey Findings:** This site is located in rocky/bouldery section of Finley and Adams Canyon. Herbaceous cover is sparsely distributed, dominated by bullgrass (*Muhlenbergia emersleyi*) and pinyon ricegrass (*Piptochaetium fimbriatum*). Riparian obligate Rocky Mountain rush (*Juncus saximontanus*) is also present. Overstory vegetation is dominated by oak (*Quercus* spp.) and pine (*Pinus* spp.) trees. No aquatic invertebrates or vertebrates have been observed at this site.
