# Hermosa Spring and Seep Catalog

Hermosa Project Area

## SPRING AND SEEP CATALOG Hermosa Project Area

### INTRODUCTION

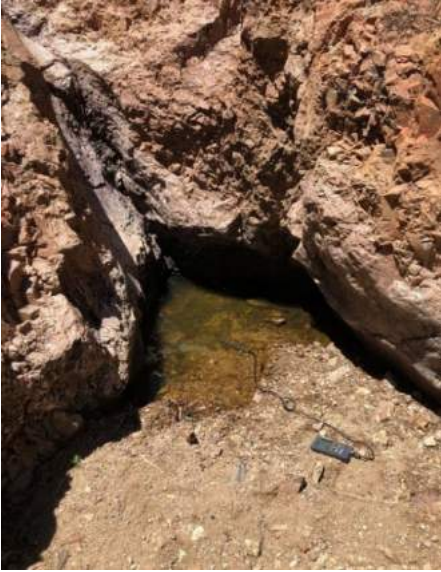
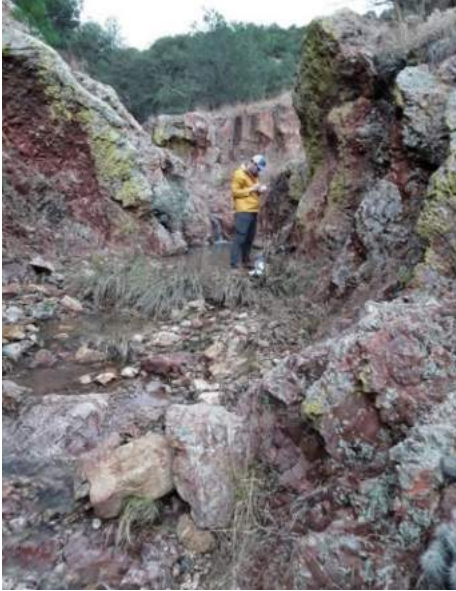
Dry Season Photo (5/21/2019)	Wet Season Photo (12/9/2019)

**Aquatic and Vegetation Survey Findings:** Seep is located at a bedrock constriction in Finley and Adams Canyon where a plunge pool is present at the base of the bedrock. The plunge pool does not support emergent or perimeter vegetation. Within the drainage, understory vegetation is sparse, dominated by deergrass (*Muhlenbergia rigens*) and hummingbird trumpet (*Epilobium canum*). Other perennial grasses (*Poaceae* family) and riparian obligate Baltic rush (*Juncus balticus*) are present. Alligator juniper (*Juniperus deppeana*) and Mexican pinyon (*Pinus cembroides*) dominate the overstory vegetation within this section of the drainage. Invasive plant species observed include Johnson grass (*Sorghum halepense*). Aquatic invertebrates observed include backswimmers and water striders. No aquatic herpetofauna have been observed at this site. Deer tracks have been noted during some visits.

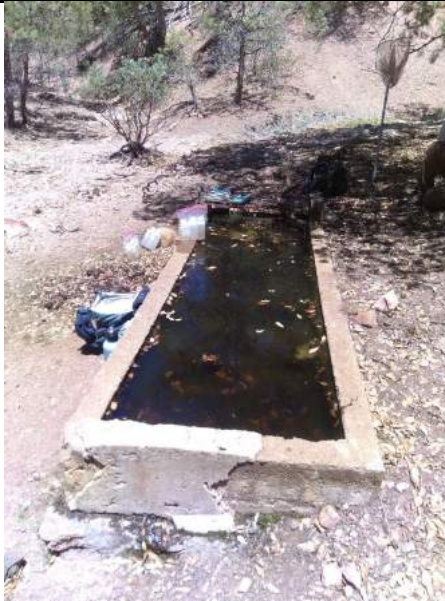
**Dry Season Photo (05/20/2021)**

**Aquatic and Vegetation Survey Findings:** Hillslope spring emergence is captured in the springbox and plumbed to the downstream concrete drinker. The ground is saturated downstream of the spring box in the wash for a slight reach. Concrete, rectangular stock drinker (approx. 4m x 2m) is fed from a pipe sunk into the adjacent hillside. The line may collect water from a subsurface source or the adjacent concrete stock drinker. Upland vegetation is Madrean evergreen woodland. Aquatic beetles, backswimmers, and boatmen have been observed. An elegant trogon (*Trogon elegans*) and grey fox (*Urocyon cinereoargenteus*) have been observed at the site.

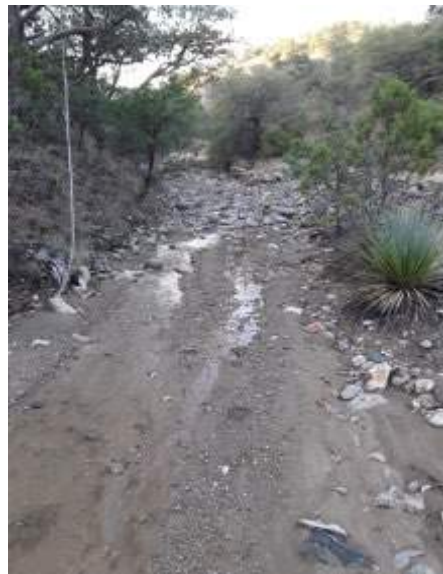
**Aquatic and Vegetation Survey Findings:** Site is located in silty and cobbly section of Washington Gulch. Herbaceous vegetation is sparse, dominated by hairy grama (*Bouteloua hirsuta*), Wright's buckwheat (*Eriogonum wrightii*), and annual muhly (*Muhlenbergia minutissima*). Limited overstory cover is provided by oak (*Quercus* spp.), and alligator juniper (*Juniperus deppeana*) trees. No aquatic invertebrates or vertebrates have been observed at this site.
