Hermosa Spring and Seep Catalog

Hermosa Project Area

SPRING AND SEEP CATALOG Hermosa Project Area

DATE: February 9, 2024

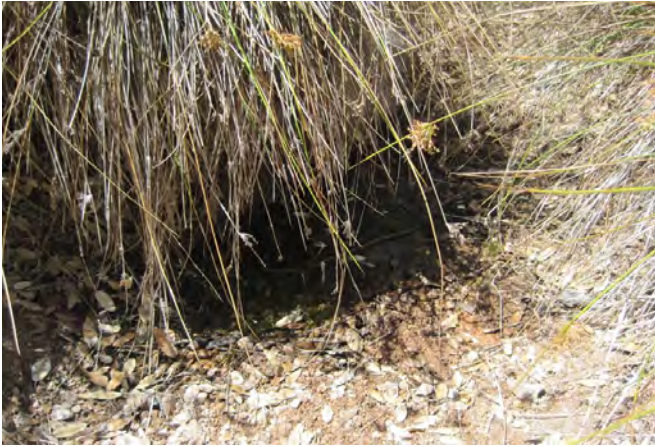
Dry Season Photo (5/24/2018)

Aquatic and Vegetation Survey Findings: This site is located within a section of Alum Gulch with some exposed bedrock. Water is generally present pre-monsoon and during monsoon in shallow flowing runs. Riparian obligate rushes (*Juncus* spp.) occur along perimeter where soil is present. Overstory tree coverage is limited to oaks [*Quercus* spp.] with no riparian tree species present. Invasive plants observed include Lehmann lovegrass (*Eragrostis lehmanniana*) and weeping lovegrass (*Eragrostis curvula*). Aquatic invertebrates, including beetles, boatmen, and backswimmers, have been observed. No aquatic vertebrates have been observed.

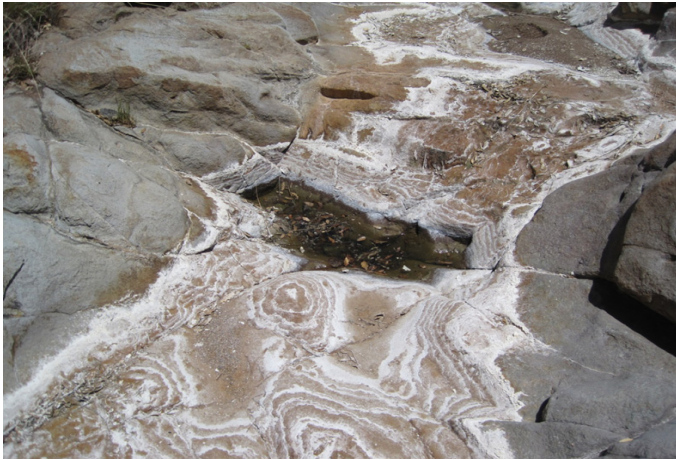
Dry Season Photo (5/23/2018)

Aquatic and Vegetation Survey Findings: Bedrock portion of Alum Gulch. No riparian overstory tree species present at the site. Some riparian obligate rushes (*Juncus* spp.) present along perimeter where soil is present. Typically dry during pre-monsoon visits (May and June). When water is present, it is available in pools and runs of shallow surface flow. Aquatic beetles and boatmen have been observed. No aquatic vertebrates have been observed. Drainage and hillside vegetation dominated by oak woodland. Invasive plant species observed are Lehmann lovegrass (*Eragrostis lehmanniana*) and Bermudagrass (*Cynodon dactylon*).

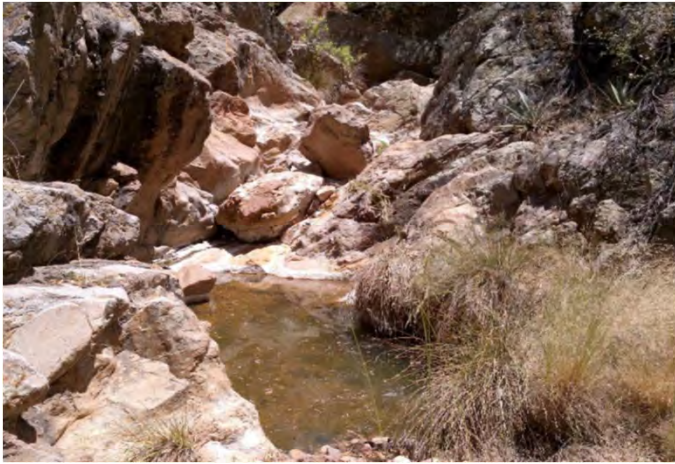
Dry Season Photo (5/24/2018)

Aquatic and Vegetation Survey Findings: Site is located in cobbly and rocky section of Alum Gulch with exposed bedrock. Water is present in pools. Aquatic beetles have been observed. No aquatic vertebrates have been observed along drainage. Overstory tree coverage is limited to upland tree species (oak [*Quercus* sp.] and juniper [*Juniperus* sp.]) within the drainage. Drainage and hillside vegetation dominated by oak woodland and grasses. Some riparian obligate rushes (*Juncus* spp.) present along perimeter of drainage channel. Invasive Bermudagrass (*Cynodon dactylon*) was observed.

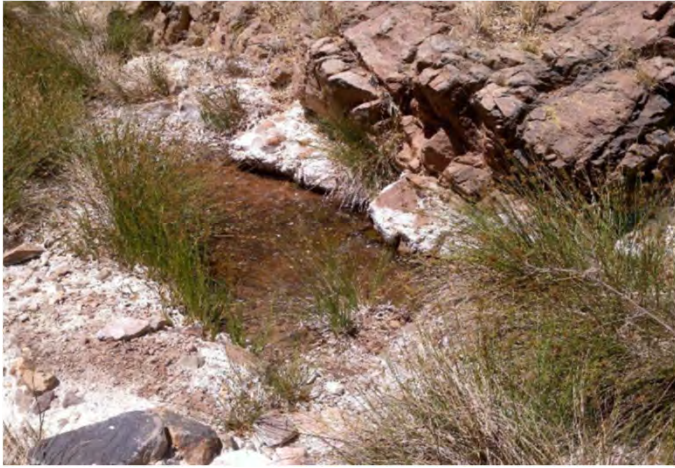
Dry Season Photo (5/24/2018)

Aquatic and Vegetation Survey Findings: Site is located in cobbly and rocky section of Alum Gulch with exposed bedrock. Generally, water is present in shallow pools and runs. Aquatic beetles and boatmen have been observed. No aquatic vertebrates have been observed. Overstory tree coverage is sparse within the drainage dominated by oak (*Quercus* spp.). Perimeter vegetation is dominated by riparian obligate rushes (*Juncus* spp.). Hillsides of drainage dominated by oak (*Quercus* spp.). Invasive Lehmann lovegrass (*Eragrostis lehmanniana*) was observed.

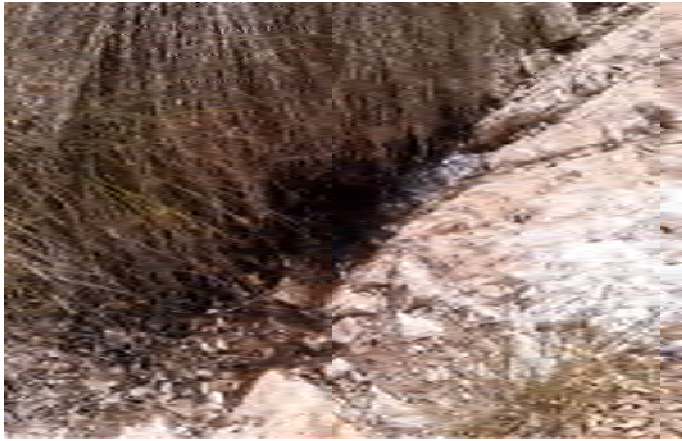
Dry Season Photo (5/25/2018)

Aquatic and Vegetation Survey Findings: Site is located in exposed bedrock section of Alum Gulch. Generally, water is present in shallow pools. Aquatic beetles and boatmen have been observed. No aquatic vertebrates have been observed. Deer tracks have been noted at this site. No overstory tree coverage is present and perimeter vegetation is dominated by *Juncus balticus*. Hillsides of drainage dominated by oak (*Quercus* spp.). Invasive plant species observed are Lehmann lovegrass (*Eragrostis lehmanniana*) and Bermudagrass (*Cynodon dactylon*).

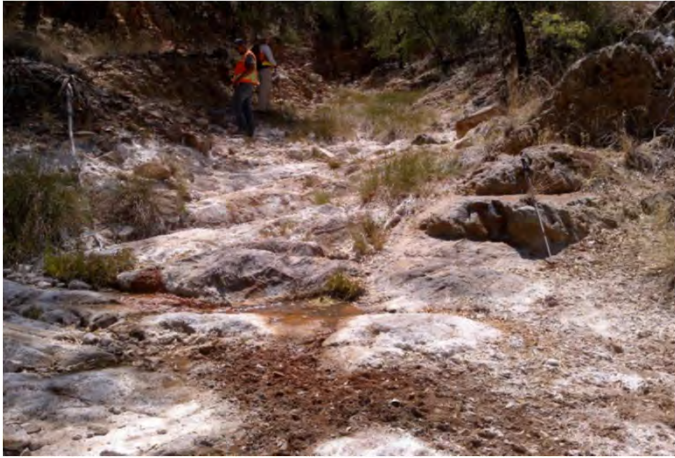
Dry Season Photo (5/25/2018)

Aquatic and Vegetation Survey Findings: Site is located in exposed bedrock section of Alum Gulch. Generally, water is present in shallow pools. Aquatic beetles and boatmen have been observed. No aquatic vertebrates have been observed. Deer tracks and bear scat have been noted at this site. Overstory tree coverage is dominated by an individual Fremont cottonwood (*Populus fremontii*) and also includes oak (*Quercus* spp.) and mesquite (*Prosopis velutina*). Perimeter vegetation is dominated by riparian obligate rushes (*Juncus* spp.), deergrass (*Muhlenbergia rigens*), and cane bluestem (*Bothriochloa barbinodis*). Hillsides of drainage dominated by oak (*Quercus* spp.). Invasive plant species observed are Lehmann lovegrass (*Eragrostis lehmanniana*) and Bermudagrass (*Cynodon dactylon*).

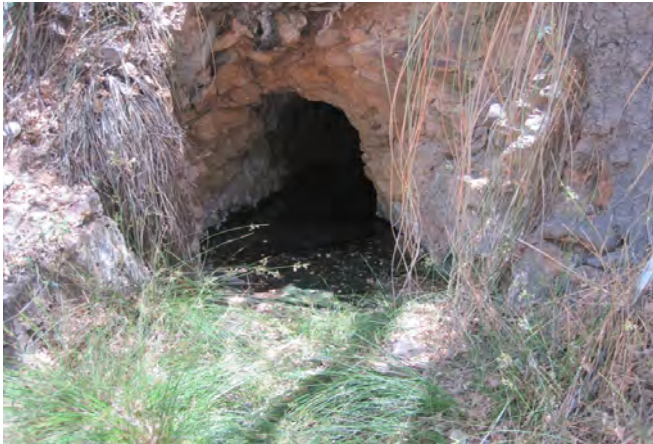
Dry Season Photo (5/28/2018)

Aquatic and Vegetation Survey Findings: This site is located at an adit with a concrete spring box that retains water at the adit entrance within Alum Gulch. Rushes (*Juncus* spp.), a riparian obligate genus, and deergrass (*Muhlenbergia rigens*) are present at the adit opening. Overstory cover dominated by oak (*Quercus* spp.) with individual Fremont cottonwood (*Populus fremontii*), and Mexican pinyon (*Pinus cembroides*) present. Invasive plants observed include Bermudagrass (*Cynodon dactylon*) and horehound (*Marrubium vulgare*). Aquatic beetles have been observed. No aquatic vertebrates have been observed.

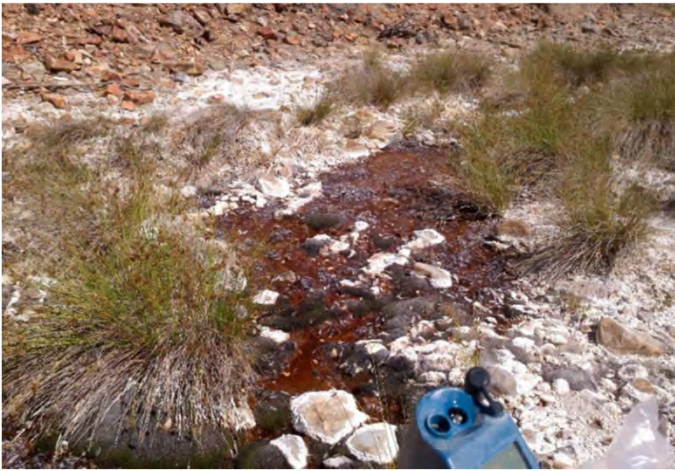
Dry Season Photo (5/29/2018)

Aquatic and Vegetation Survey Findings: Site is located in exposed bedrock section of Alum Gulch. Generally, water is present in shallow pools. Aquatic beetles have been observed. No overstory tree coverage is present within the drainage at this site. Perimeter vegetation is dominated by riparian obligate *Juncus balticus*. Hillsides of drainage dominated by oaks (*Quercus* spp.). Invasive plant species observed are Lehmann lovegrass (*Eragrostis lehmanniana*).

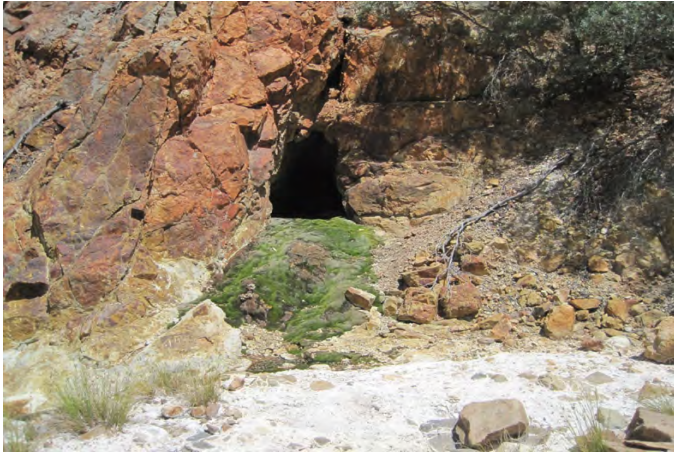
Dry Season Photo (5/29/2018)

Aquatic and Vegetation Survey Findings: This site is located at an adit within a rocky section of Alum Gulch. Water is present in the adit and discharges into the drainage. A large moss mat and some riparian obligate rushes (*Juncus* spp.) are present at the adit entrance. Although there is no overstory canopy at the site, overstory tree species along the drainage are dominated by oak (*Quercus* spp.) and Chihuahuan pine (*Pinus leiophylla*). Aquatic invertebrates observed include damselflies, beetles, boatmen, and backswimmers. No aquatic vertebrates have been observed.

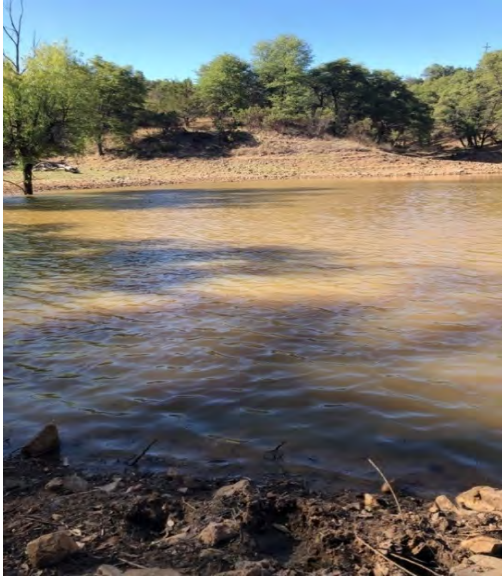
Dry Season Photo (5/22/2019)

Aquatic and Vegetation Survey Findings: This site is a large earthen stock tank located within Adams Canyon drainage. Two willow trees (*Salix* sp.) occur as emergent and canopy vegetation for the tank. Perimeter vegetation is dominated by non-native barnyard grass (*Echinochloa crus-galli*) and riparian obligate spikerush (*Eleocharis* sp.). The upland overstory vegetation is dominated by Emory oak (*Quercus emoryi*). Invasive Bermudagrass (*Cynodon dactylon*) and American bullfrogs (*Lithobates catesbeianus*) have been observed at this site.

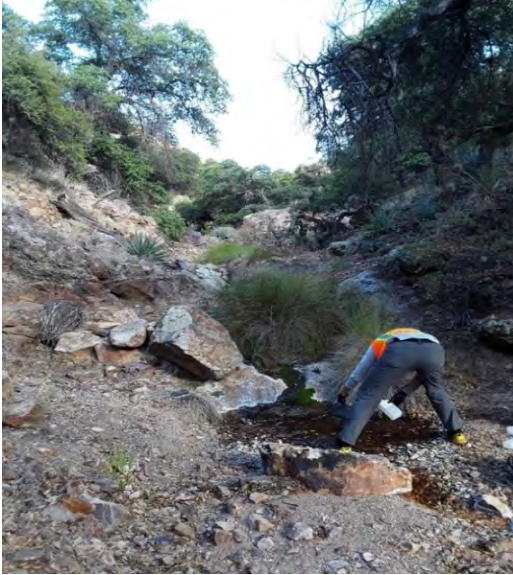
Dry Season Photo (5/27/2019)

Aquatic and Vegetation Survey Findings: This feature is a seep located within a section of exposed bedrock in Blue Eagle Canyon. Water is present in small pools. Herbaceous ground cover is dominated by riparian obligate Baltic rush (*Juncus balticus*). Also present is rockloving spikemoss (*Selaginella rupicola*) and sotol (*Dasyllirion wheeleri*). Overstory vegetation is dominated by oaks (*Quercus* spp.). Aquatic invertebrates observed include aquatic beetles and backswimmers. No aquatic vertebrates have been observed. Invasive Lehmann lovegrass (*Eragrostis lehmanniana*) and natalgrass (*Melinis repens*) were observed.

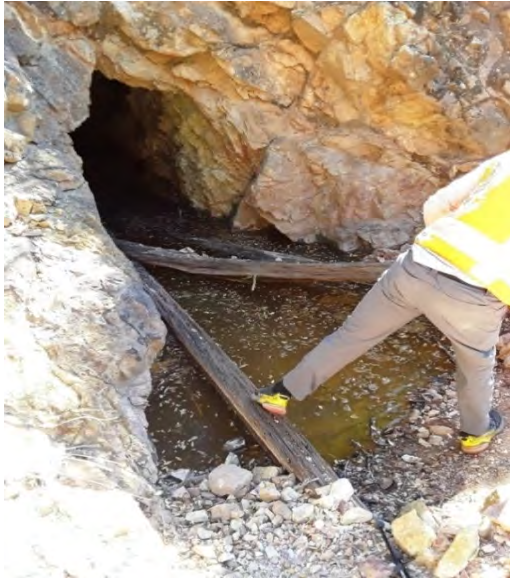
Dry Season Photo (5/27/2019)

Aquatic and Vegetation Survey Findings: This site is located at an adit within Blue Eagle Canyon with a rocky berm that dams water at the adit entrance. The site does not support emergent or perimeter vegetation. Oaks (*Quercus* spp.) dominate the overstory within the adjacent drainage. Rockloving spikemoss (*Selaginella rupicola*), hopbush (*Dodonaea viscosa*), and bullgrass (*Muhlenbergia emersleyi*) were also noted near the site. Aquatic invertebrates observed include beetles, boatmen, and backswimmers. No aquatic vertebrates have been observed.
