Hermosa Spring and Seep Catalog

Hermosa Project Area

SPRING AND SEEP CATALOG Hermosa Project Area

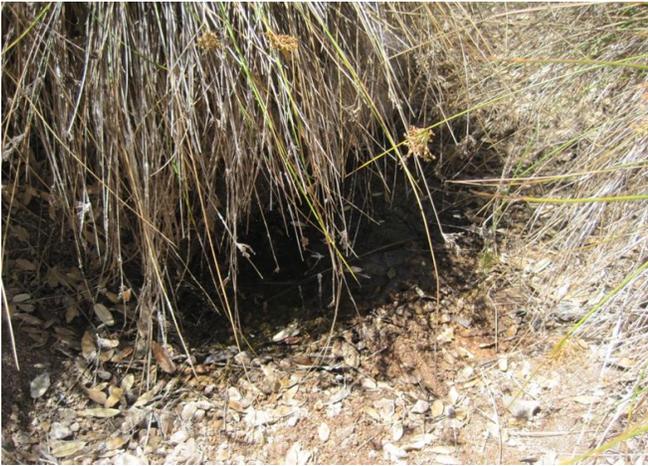
Dry Season Photo (5/24/2018)

Aquatic and Vegetation Survey Findings: This site is located within a section of Alum Gulch with some exposed bedrock. Water is generally present pre-monsoon and during monsoon in shallow flowing runs. Riparian obligate rushes (*Juncus* spp.) occur along perimeter where soil is present. Overstory tree coverage is limited to oaks [*Quercus* spp.] with no riparian tree species present. Invasive plants observed include Lehmann lovegrass (*Eragrostis lehmanniana*) and weeping lovegrass (*Eragrostis curvula*). Aquatic invertebrates, including beetles, boatmen, and backswimmers, have been observed. No aquatic vertebrates have been observed.

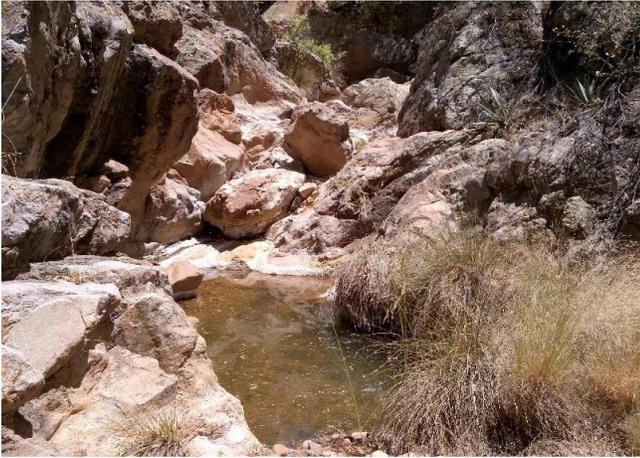
Dry Season Photo (5/24/2018)

Aquatic and Vegetation Survey Findings: Site is located in cobbly and rocky section of Alum Gulch with exposed bedrock. Water is present in pools. Aquatic beetles have been observed. No aquatic vertebrates have been observed along drainage. Overstory tree coverage is limited to upland tree species (oak [*Quercus* sp.] and juniper [*Juniperus* sp.]) within the drainage. Drainage and hillside vegetation dominated by oak woodland and grasses. Some riparian obligate rushes (*Juncus* spp.) present along perimeter of drainage channel. Invasive Bermudagrass (*Cynodon dactylon*) was observed.

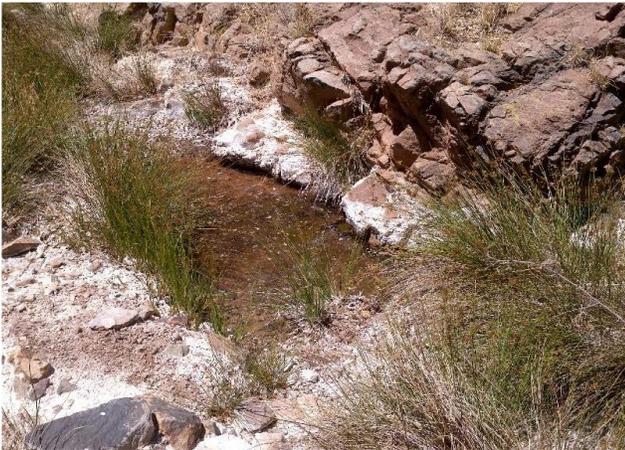
Dry Season Photo (5/24/2018)

Aquatic and Vegetation Survey Findings: Site is located in cobbly and rocky section of Alum Gulch with exposed bedrock. Generally, water is present in shallow pools and runs. Aquatic beetles and boatmen have been observed. No aquatic vertebrates have been observed. Overstory tree coverage is sparse within the drainage dominated by oak (*Quercus* spp.). Perimeter vegetation is dominated by riparian obligate rushes (*Juncus* spp.). Hillsides of drainage dominated by oak (*Quercus* spp.). Invasive Lehmann lovegrass (*Eragrostis lehmanniana*) was observed.

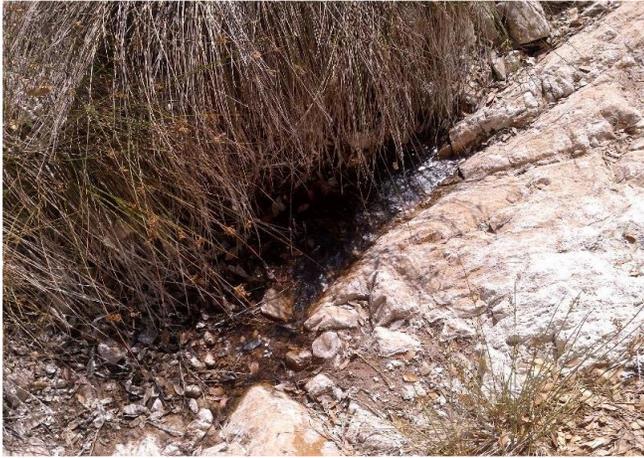
Dry Season Photo (5/25/2018)

Aquatic and Vegetation Survey Findings: Site is located in exposed bedrock section of Alum Gulch. Generally, water is present in shallow pools. Aquatic beetles and boatmen have been observed. No aquatic vertebrates have been observed. Deer tracks have been noted at this site. No overstory tree coverage is present and perimeter vegetation is dominated by *Juncus balticus*. Hillsides of drainage dominated by oak (*Quercus* spp.). Invasive plant species observed are Lehmann lovegrass (*Eragrostis lehmanniana*) and Bermudagrass (*Cynodon dactylon*).

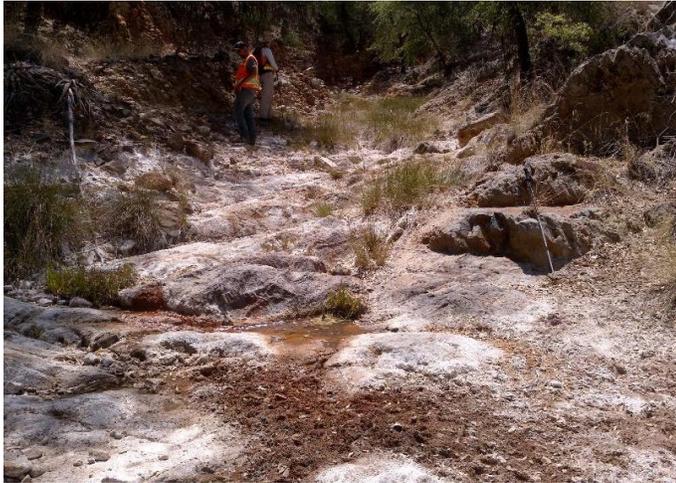
Dry Season Photo (5/25/2018)

Aquatic and Vegetation Survey Findings: Site is located in exposed bedrock section of Alum Gulch. Generally, water is present in shallow pools. Aquatic beetles and boatmen have been observed. No aquatic vertebrates have been observed. Deer tracks and bear scat have been noted at this site. Overstory tree coverage is dominated by an individual Fremont cottonwood (*Populus fremontii*) and also includes oak (*Quercus* spp.) and mesquite (*Prosopis velutina*). Perimeter vegetation is dominated by riparian obligate rushes (*Juncus* spp.), deergrass (*Muhlenbergia rigens*), and cane bluestem (*Bothriochloa barbinodis*). Hillsides of drainage dominated by oak (*Quercus* spp.). Invasive plant species observed are Lehmann lovegrass (*Eragrostis lehmanniana*) and Bermudagrass (*Cynodon dactylon*).

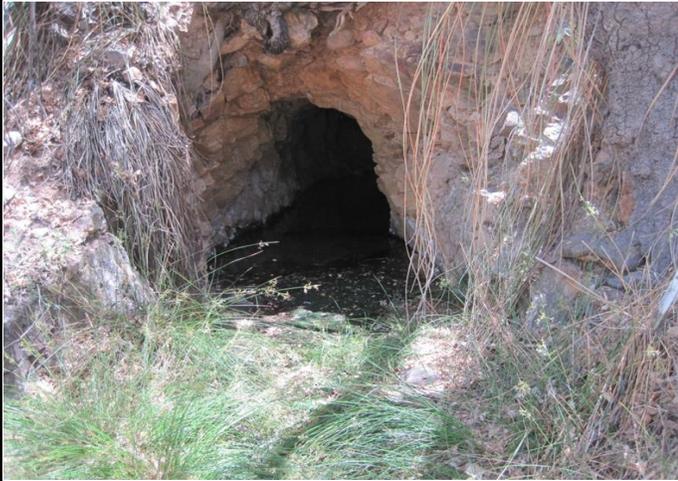
Dry Season Photo (5/28/2018)

Aquatic and Vegetation Survey Findings: This site is located at an adit with a concrete spring box that retains water at the adit entrance within Alum Gulch. Rushes (*Juncus* spp.), a riparian obligate genus, and deergrass (*Muhlenbergia rigens*) are present at the adit opening. Overstory cover dominated by oak (*Quercus* spp.) with individual Fremont cottonwood (*Populus fremontii*), and Mexican pinyon (*Pinus cembroides*) present. Invasive plants observed include Bermudagrass (*Cynodon dactylon*) and horehound (*Marrubium vulgare*). Aquatic beetles have been observed. No aquatic vertebrates have been observed.

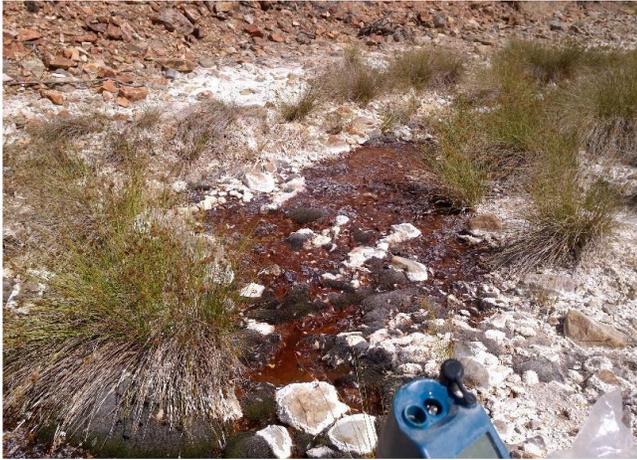
Dry Season Photo (5/29/2018)

Aquatic and Vegetation Survey Findings: Site is located in exposed bedrock section of Alum Gulch. Generally, water is present in shallow pools. Aquatic beetles have been observed. No overstory tree coverage is present within the drainage at this site. Perimeter vegetation is dominated by riparian obligate *Juncus balticus*. Hillsides of drainage dominated by oaks (*Quercus* spp.). Invasive plant species observed are Lehmann lovegrass (*Eragrostis lehmanniana*).

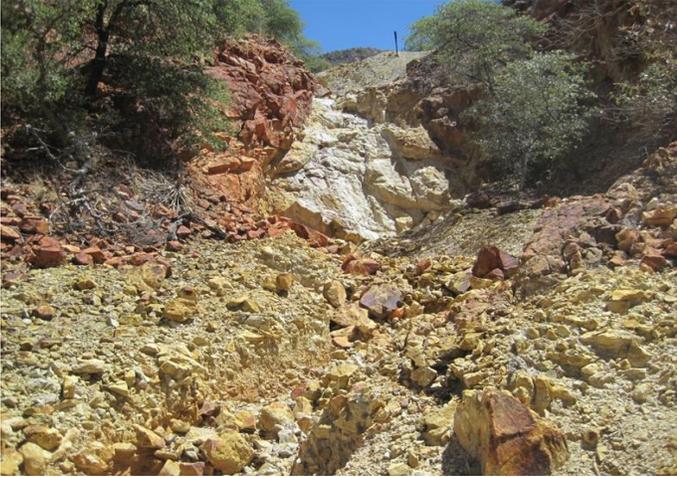
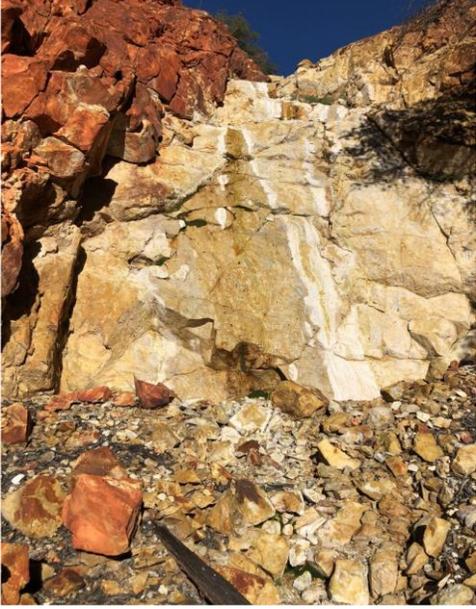
<p align="center">Dry Season Photo (5/29/2018)</p>	<p align="center">Wet Season Photo (11/28/2018)</p>

Aquatic and Vegetation Survey Findings: Site is a seep located in exposed bedrock section of a tributary to Alum Gulch. When water is present, it is typically available in shallow pools. Moss is present within the drainage bottom. Emory oak (*Quercus emoryi*) and Toumey oak (*Quercus toumeyii*) provide limited overstory tree coverage. Generally, aquatic beetles, boatmen, and backswimmers are present within the Alum Gulch drainage. No aquatic vertebrates have been observed at this site.

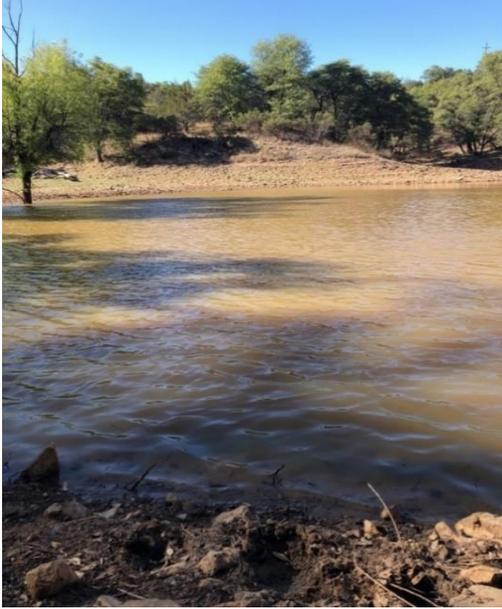
Dry Season Photo (5/22/2019)

Aquatic and Vegetation Survey Findings: This site is a large earthen stock tank located within Adams Canyon drainage. Two willow trees (*Salix* sp.) occur as emergent and canopy vegetation for the tank. Perimeter vegetation is dominated by non-native barnyard grass (*Echinochloa crus-galli*) and riparian obligate spikerush (*Eleocharis* sp.). The upland overstory vegetation is dominated by Emory oak (*Quercus emoryi*). Invasive Bermudagrass (*Cynodon dactylon*) and American bullfrogs (*Lithobates catesbeianus*) have been observed at this site.

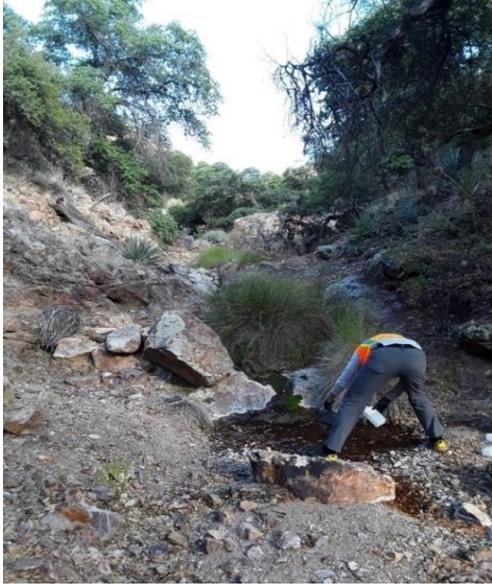
Dry Season Photo (5/27/2019)

Aquatic and Vegetation Survey Findings: This feature is a seep located within a section of exposed bedrock in Blue Eagle Canyon. Water is present in small pools. Herbaceous ground cover is dominated by riparian obligate Baltic rush (*Juncus balticus*). Also present is rockloving spikemoss (*Selaginella rupincola*) and sotol (*Dasyllirion wheeleri*). Overstory vegetation is dominated by oaks (*Quercus* spp.). Aquatic invertebrates observed include aquatic beetles and backswimmers. No aquatic vertebrates have been observed. Invasive Lehmann lovegrass (*Eragrostis lehmanniana*) and natalgrass (*Melinis repens*) were observed.

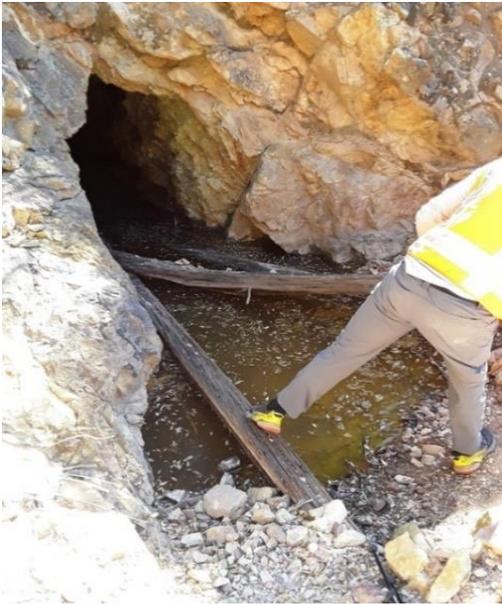
Dry Season Photo (5/27/2019)

Aquatic and Vegetation Survey Findings: This site is located at an adit within Blue Eagle Canyon with a rocky berm that dams water at the adit entrance. The site does not support emergent or perimeter vegetation. Oaks (*Quercus* spp.) dominate the overstory within the adjacent drainage. Rockloving spikemoss (*Selaginella rupincola*), hopbush (*Dodonaea viscosa*), and bullgrass (*Muhlenbergia emersleyi*) were also noted near the site. Aquatic invertebrates observed include beetles, boatmen, and backswimmers. No aquatic vertebrates have been observed.

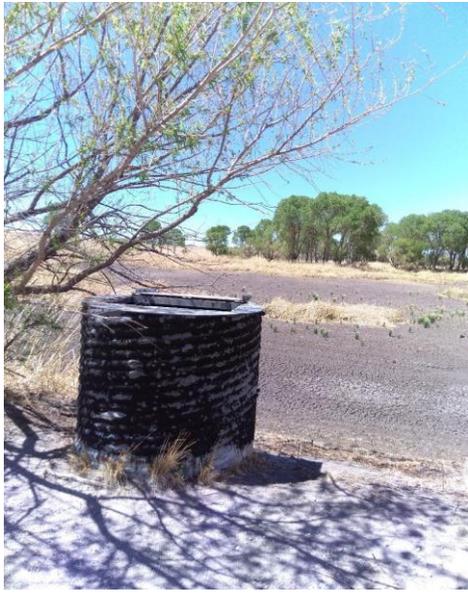
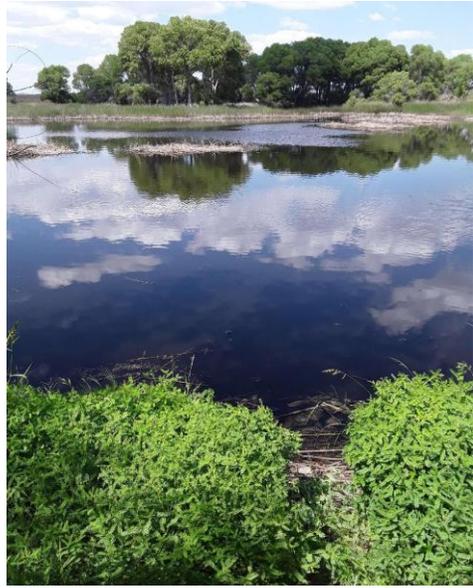
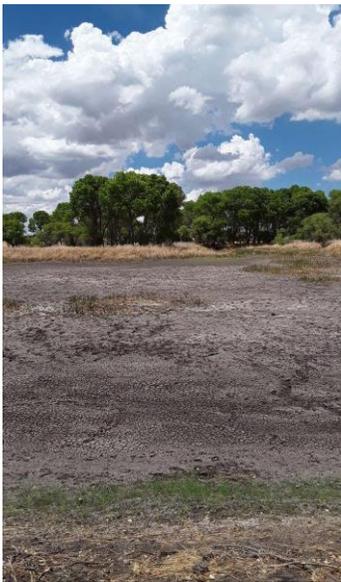
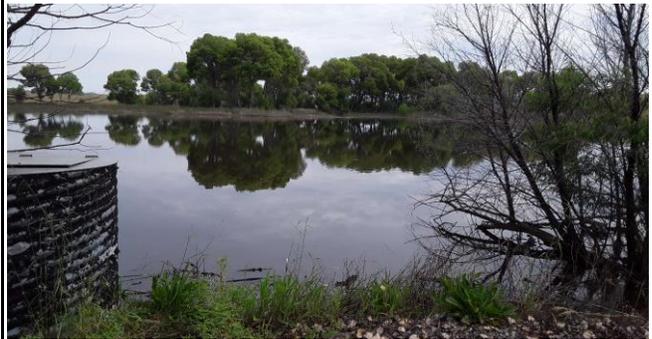
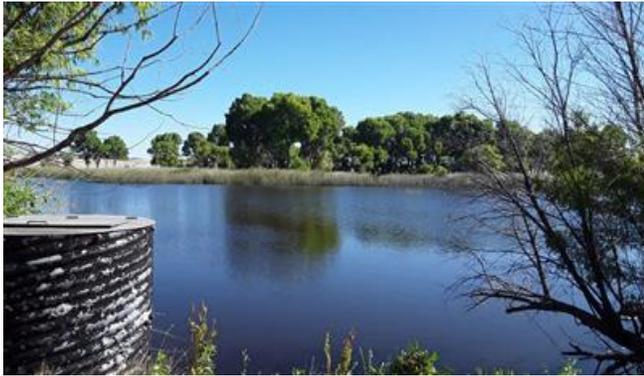
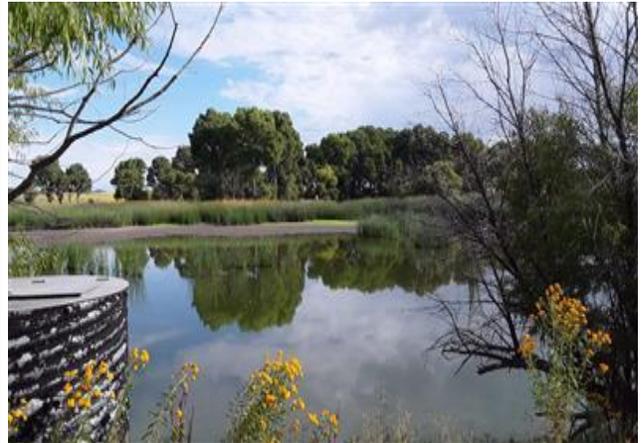
Aquatic and Vegetation Survey Findings: Poned water fills massive Cienega in dammed drainage. When water is present, water ponds in the area about 500 feet long and 700 feet wide. Adjacent vegetation is semidesert grassland with scattered Fremont cottonwoods (*Populus fremontii*). Aquatic invertebrates observed include backswimmers. During the 05/27/21 visit, a dead Sonoran mud turtle (*Kinosternon sonoriense*) and a monarch butterfly (*Danaus plexippus*) were observed. Invasive Lehmann lovegrass (*Eragrostis lehmanniana*) was observed.

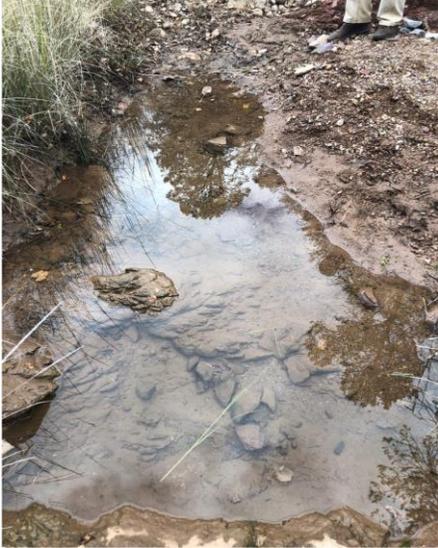
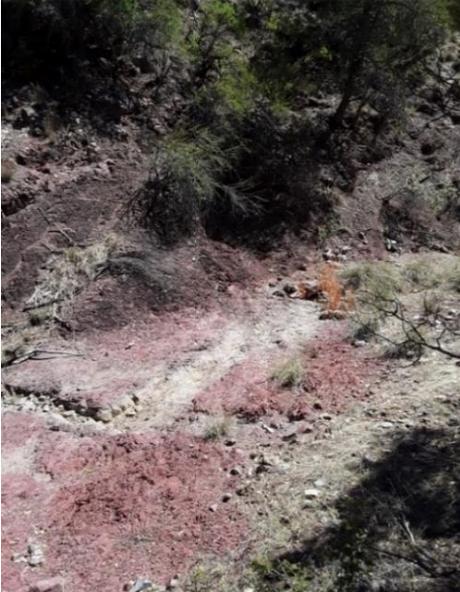
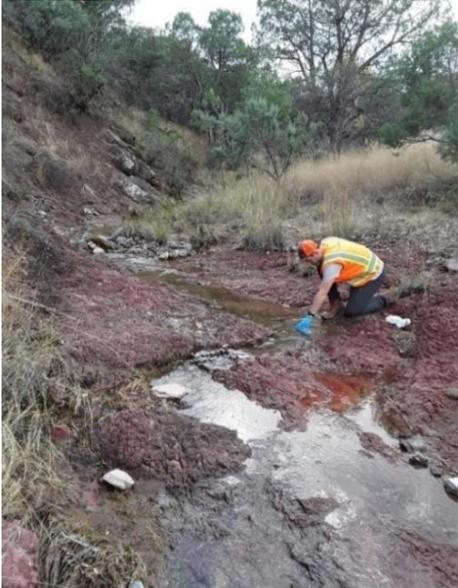
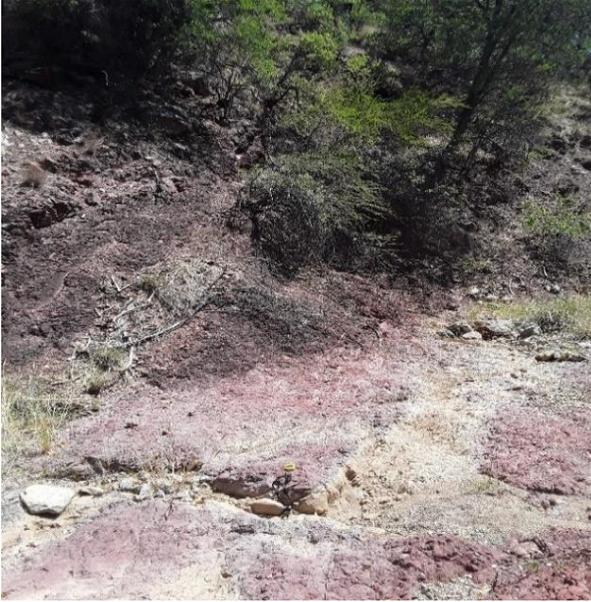
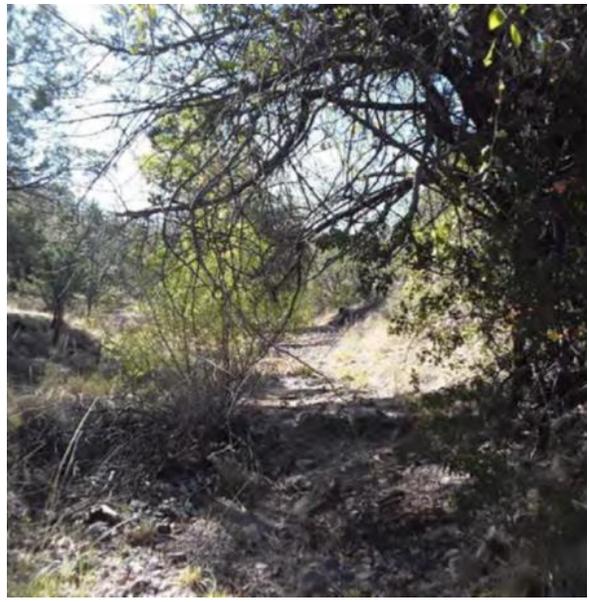
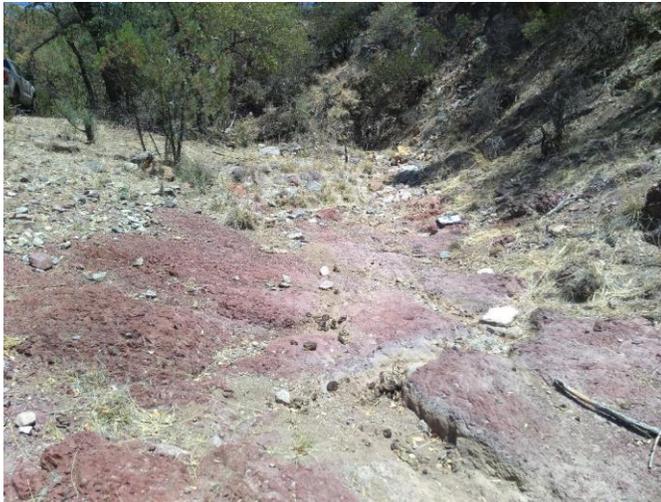
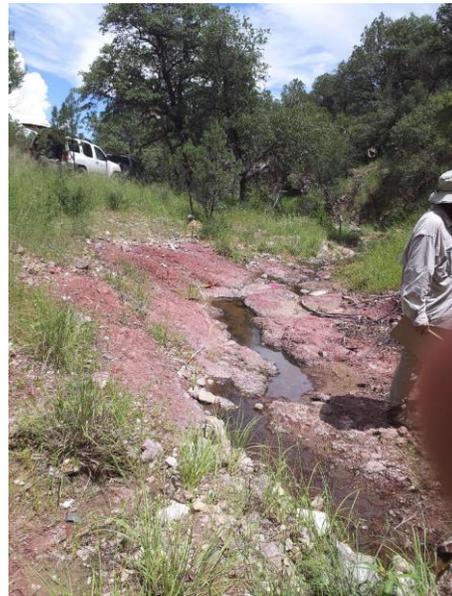
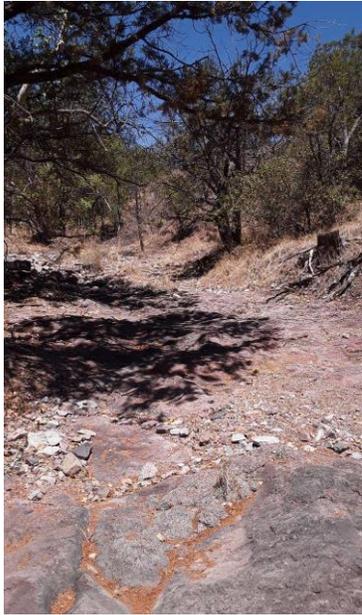
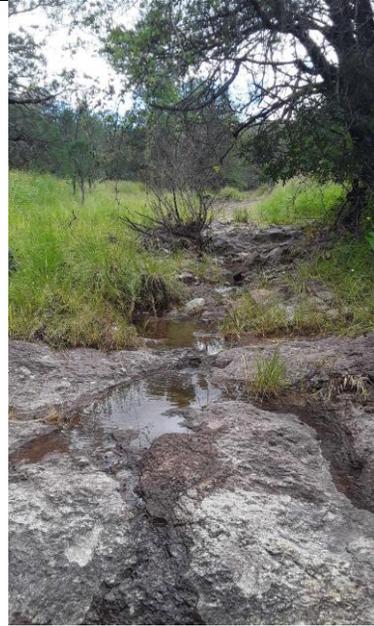
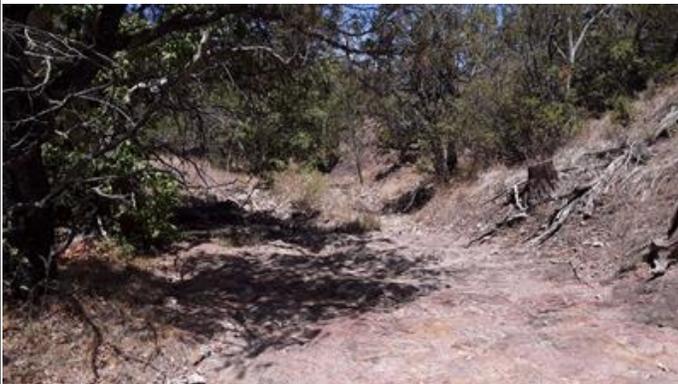
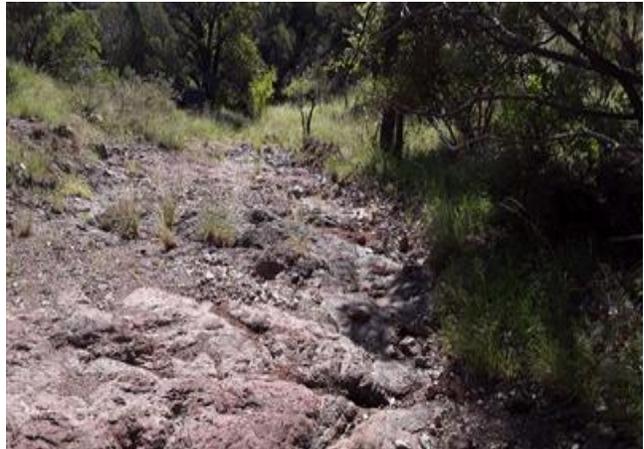
Aquatic and Vegetation Survey Findings: This site occurs in a section of exposed bedrock within the Corral Canyon drainage. The site was dry during pre-monsoon visits in 2019, 2020, and 2021. The site is dominated by deergrass (*Muhlenbergia rigens*), alderleaf mountain mahogany (*Cercocarpus montanus*), Wright's silktassel (*Garrya wrightii*), and bulb panicgrass (*Panicum bulbosum*). Although no overstory tree cover exists at the site, Arizona white oak (*Quercus arizonica*) occurs along the drainage. Trace amounts of cupgrass (*Eriochloa* sp.) and seep monkeyflower (*Mimulus guttatus*), a wetland associated plant, were noted. Non-native beardless rabbitsfoot grass (*Polypogon viridis*) has been noted. No aquatic invertebrates or vertebrates have been observed. Aquatic invertebrates observed are aquatic beetles, backswimmers, and waterstriders. Canyon treefrogs (*Hyla arenicolor*) have been observed.

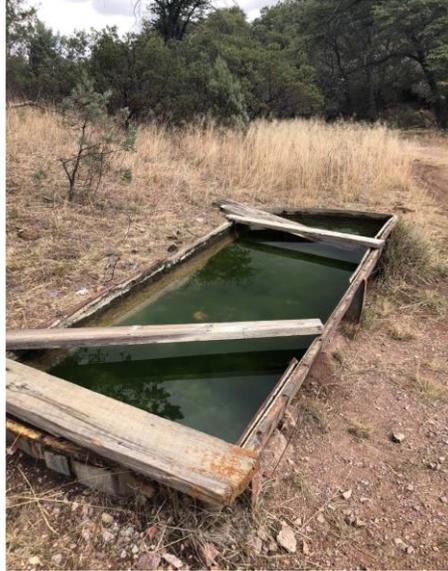
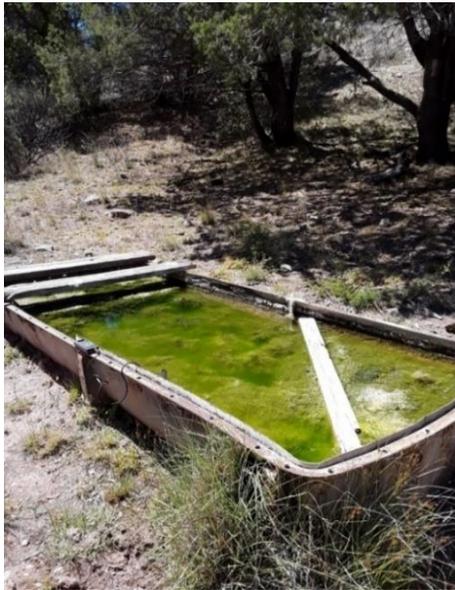
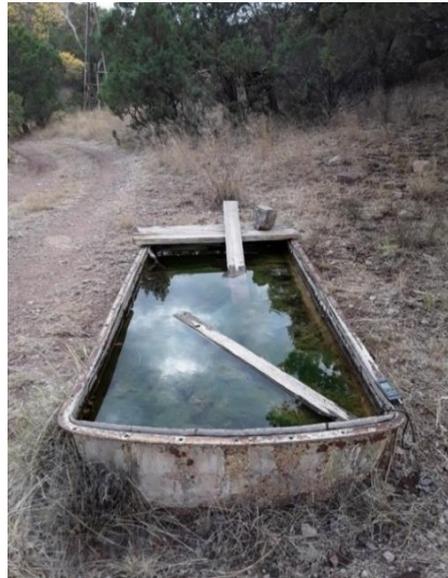
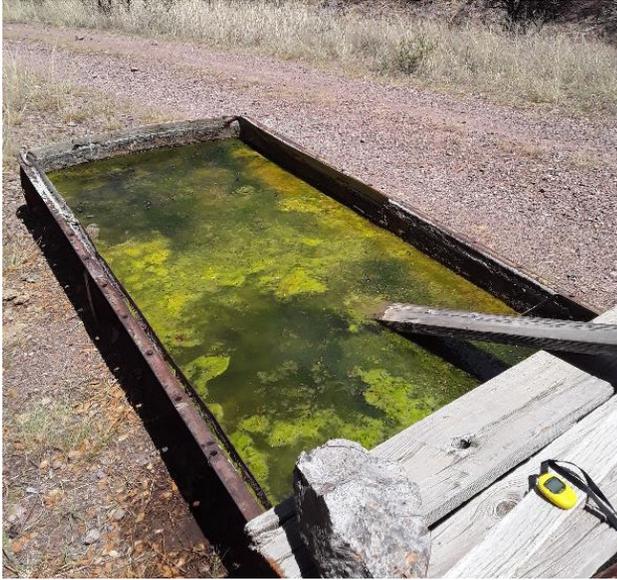
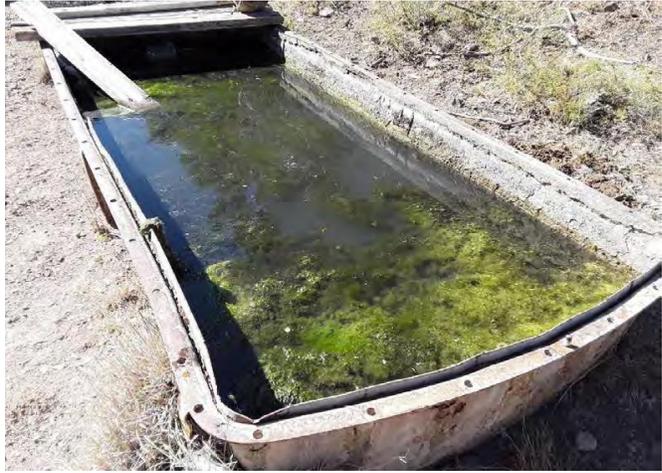
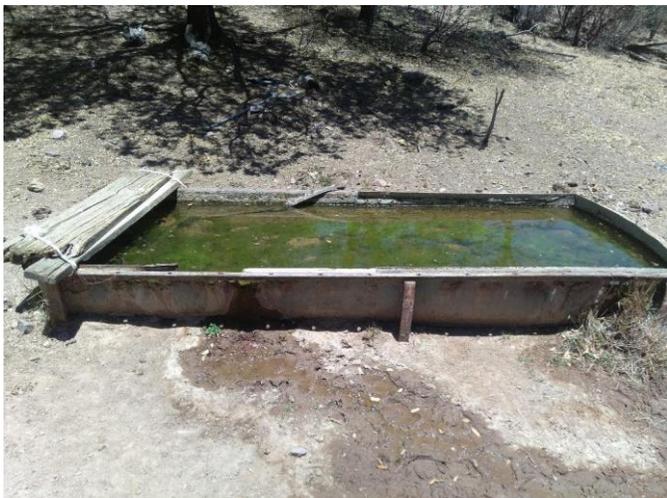
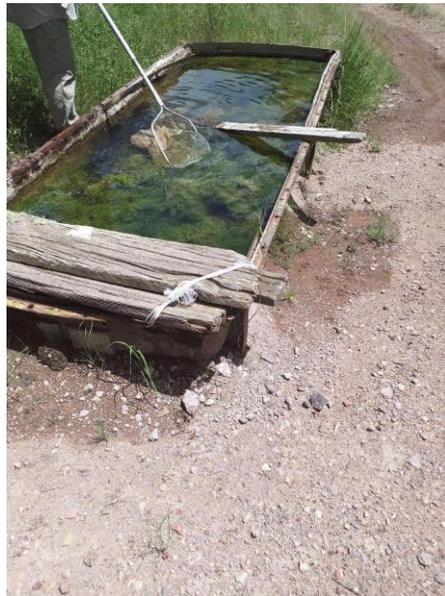
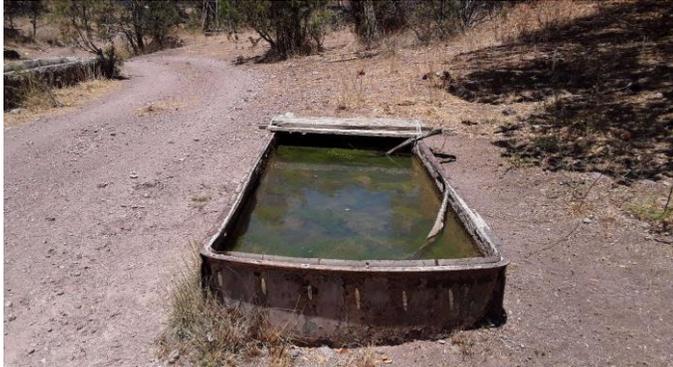
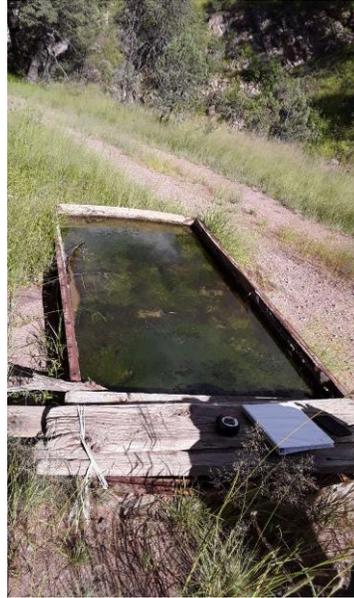
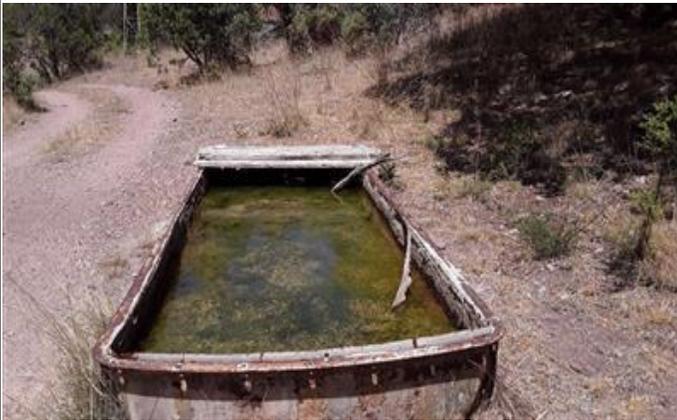
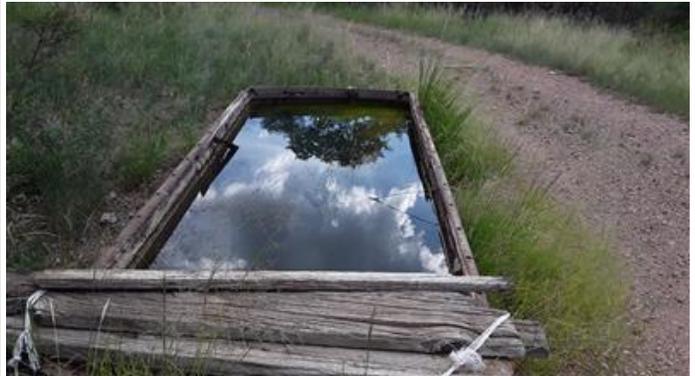
Aquatic and Vegetation Survey Findings: This site is an above ground, metal, rectangular stock drinker (approx. 3m x 1m) fed by an adjacent windmill and well system in Corral Canyon. Submerged algae and *Chara* sp. have been observed within the drinker. The site supports no emergent vegetation and only limited perimeter vegetation in the form of cane bluestem (*Bothriochloa barbinodis*) and some Rocky Mountain rush (*Juncus saximontanus*). Upland vegetation surrounding the site is dominated by alligator juniper (*Juniperus deppeana*) and catclaw mimosa (*Mimosa aculeaticarpa* var. *biuncifera*). Aquatic beetles, water boatmen, backswimmers, snails, water striders, and dragonfly larvae have been observed. Invasive American bullfrog (*Lithobates catesbeianus*) and black-necked gartersnake (*Thamnophis cyrtopsis*) have been observed at this drinker. Invasive saltcedar (*Tamarix* sp.), Lehmann lovegrass (*Eragrostis lehmanniana*) and natalgrass (*Melinis repens*) were observed.

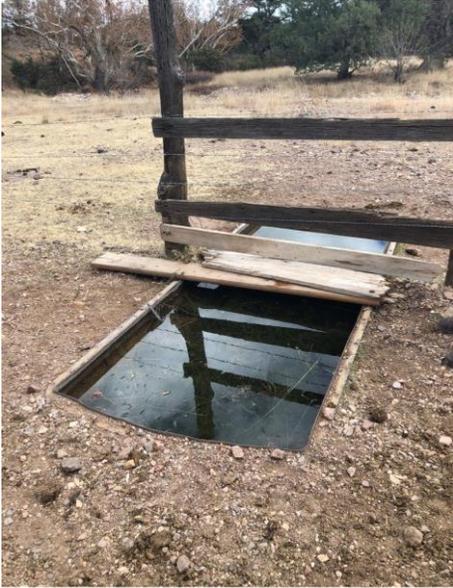
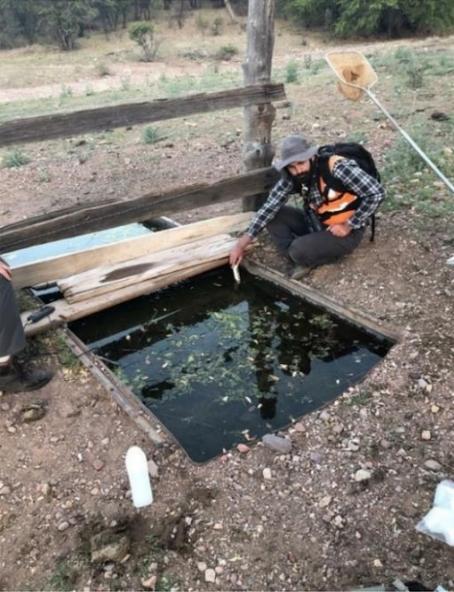
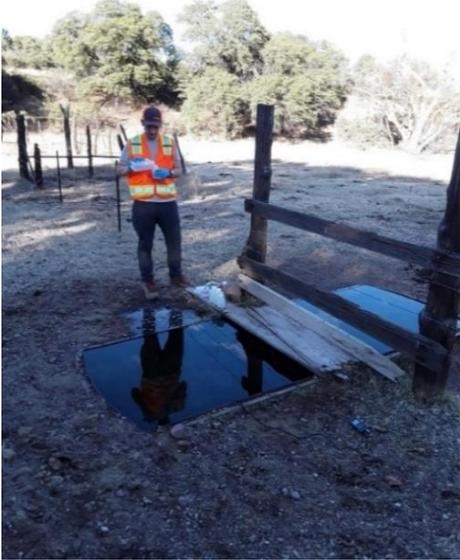
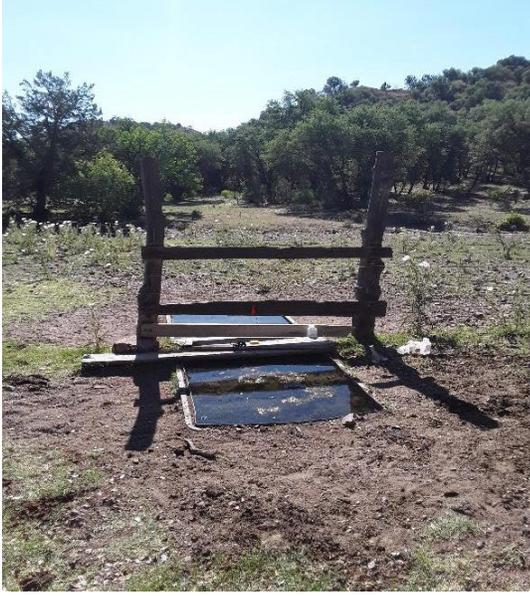
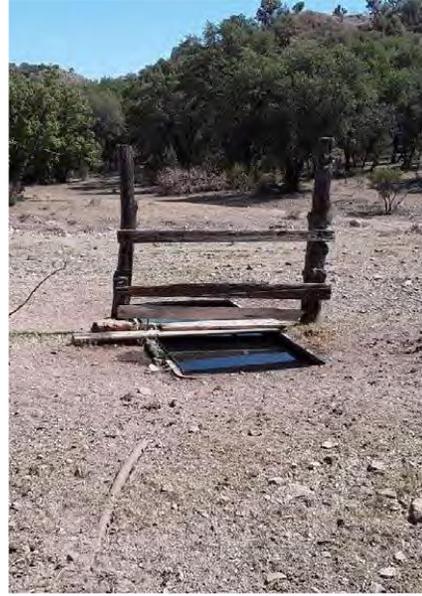
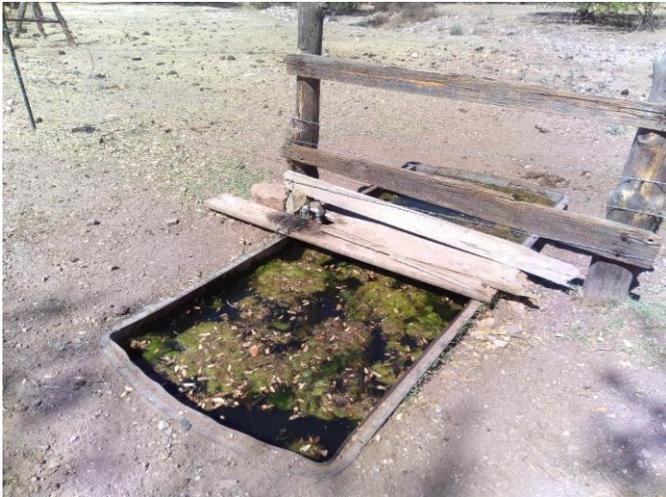
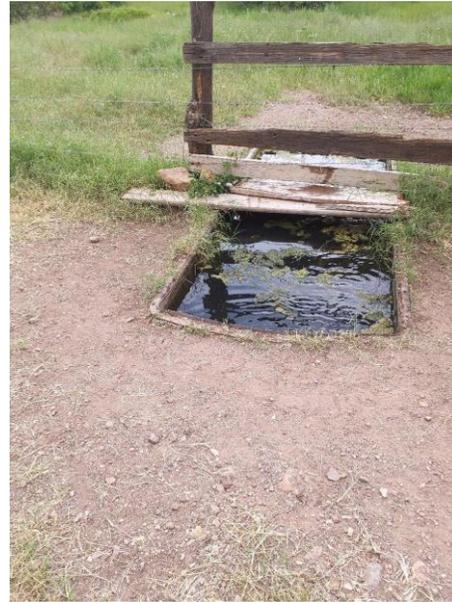
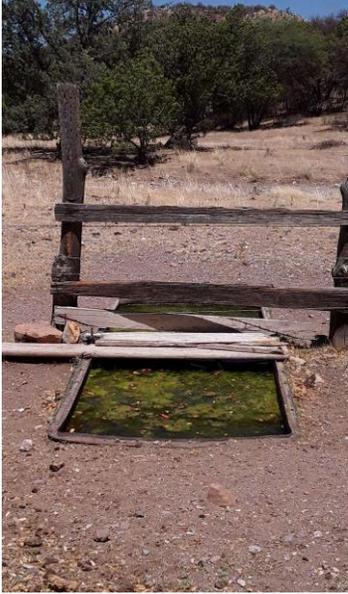
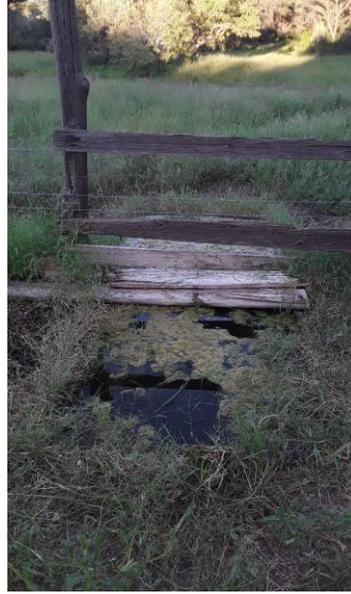
Aquatic and Vegetation Survey Findings: This site is a metal, rectangular stock drinker (approx. 3.8m x 1m) sunk at ground-level, located in Corral Canyon. Submerged algae and *Chara* sp. have been observed within the drinker. Vegetation at the site is predominated by invasive Bermudagrass (*Cynodon dactylon*) and southwestern prickly poppy (*Argemone pleiakantha*) and also includes invasive stinkgrass (*Eragrostis cilianensis*). Cows have been noted at the site. Aquatic invertebrates observed include backswimmers, beetles, boatmen, dragonflies, snails, and leeches. Invasive American bullfrogs (*Lithobates catesbeianus*) have been observed in recent years at this site.

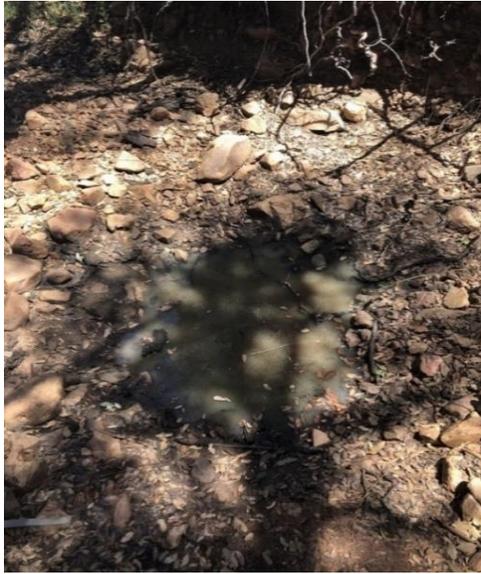
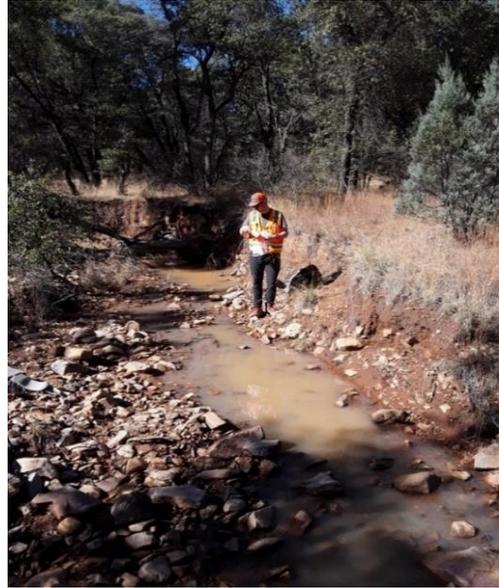
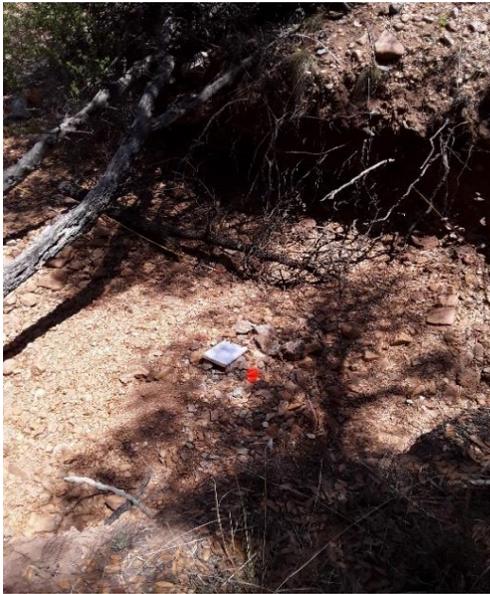
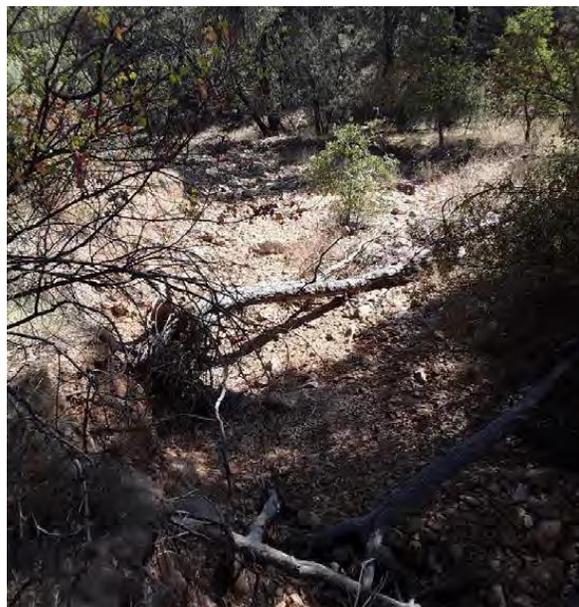
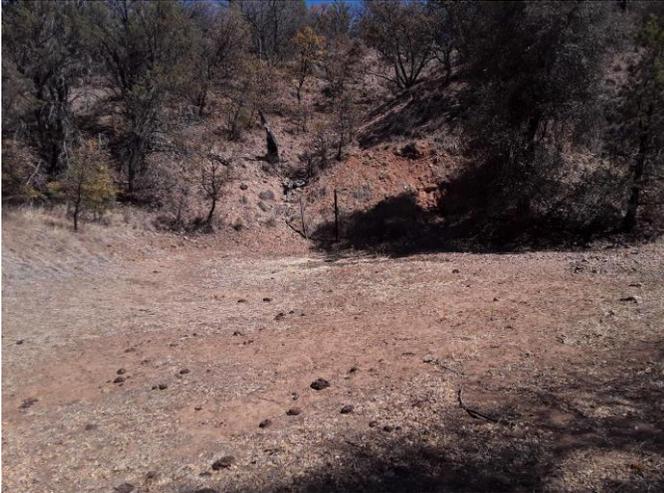
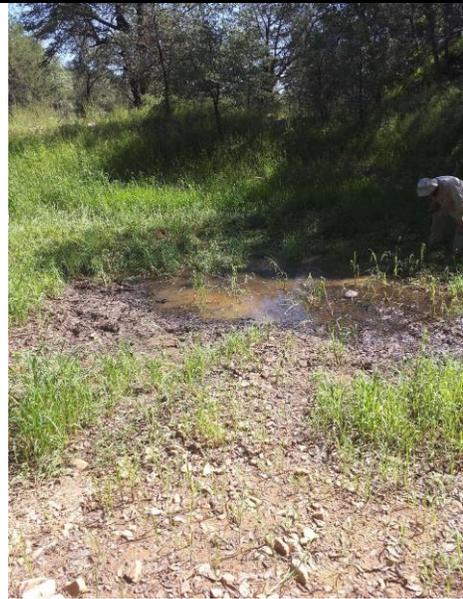
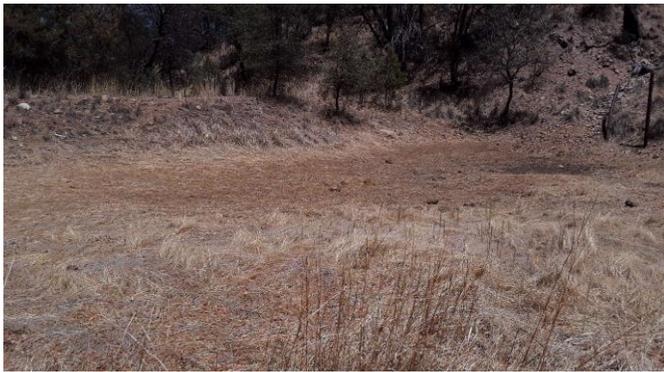
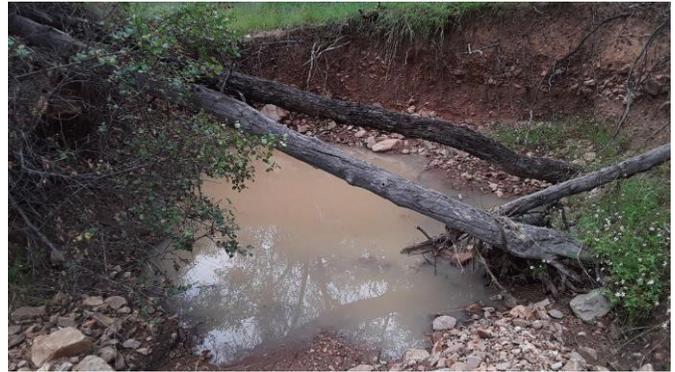
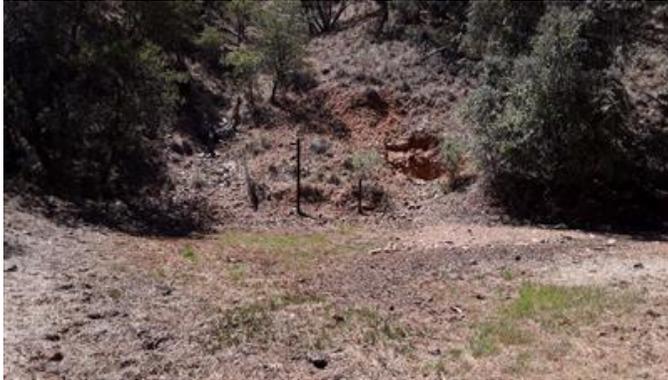
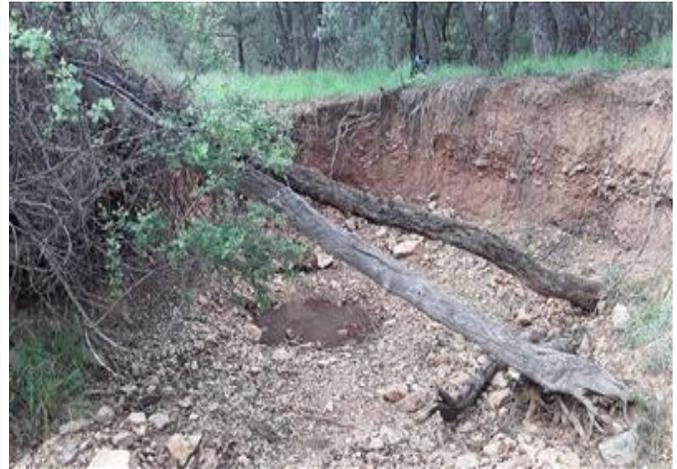
Aquatic and Vegetation Survey Findings: This site occurs in a gravelly/rocky channel of Chino Draw. The overstory vegetation is dominated by Emory oak (*Quercus emoryi*) and alligator juniper (*Juniperus deppeana*). Understory vegetation is dominated by skunkbush sumac (*Rhus trilobata*), pinyon ricegrass (*piptochaetium fimbriatum*), and other grama grasses (*Bouteloua* spp.), and invasive vegetation observed includes Lehmann lovegrass (*Eragrostis lehmanniana*). No aquatic invertebrates or vertebrates have been observed at this site.

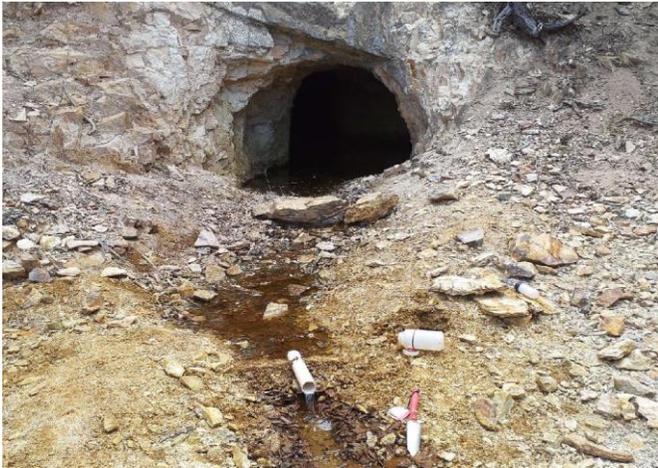
Dry Season Photo (06/01/2021)

Aquatic and Vegetation Survey Findings: Water flows from an adit on the eastern side of the canyon in upper Cox Gulch, staining the ground surface yellow-orange at the adit entrance. The adit entrance is mostly bare of vegetation; however, water present at entrance supports algae. The overstory cover is dominated by Emory oak (*Quercus emoryi*) in the immediate surrounding area. Aquatic beetles have been present at the adit entrance, but no aquatic vertebrates have been observed. Vertebrate wildlife or sign observed included Mearn's quail (*Cyrtonyx montezumae*) and deer.

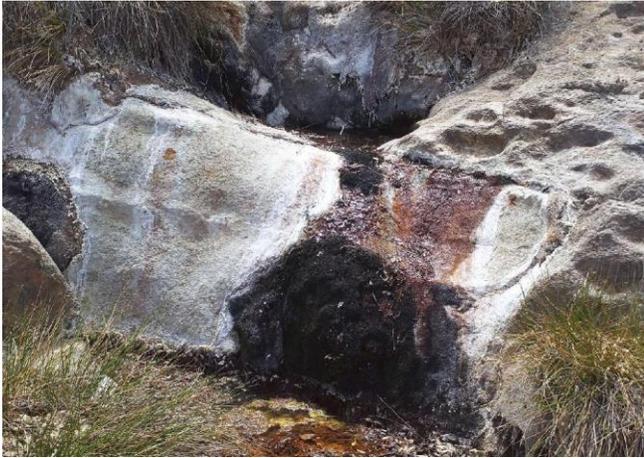
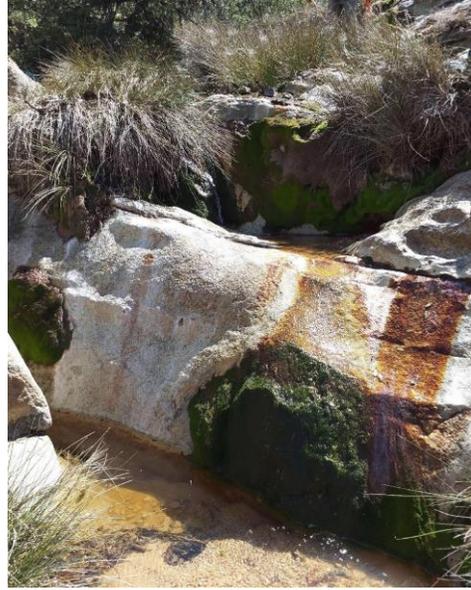
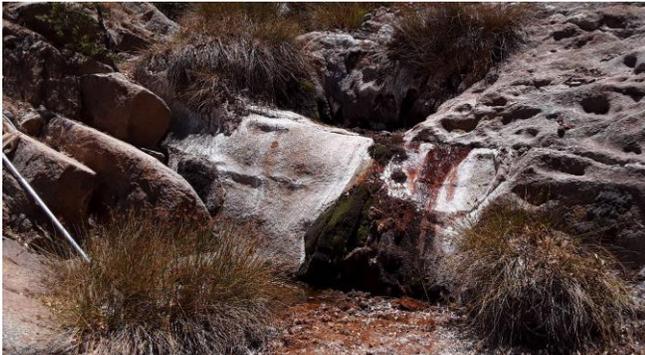
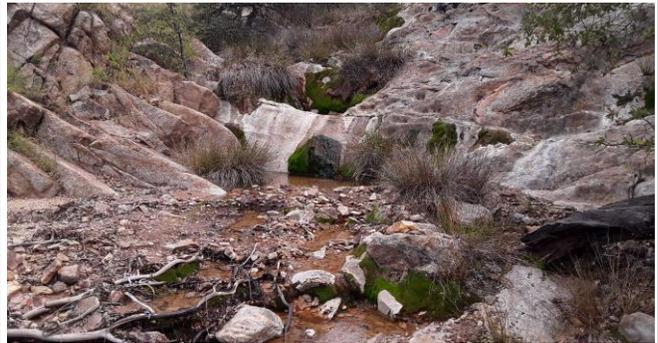
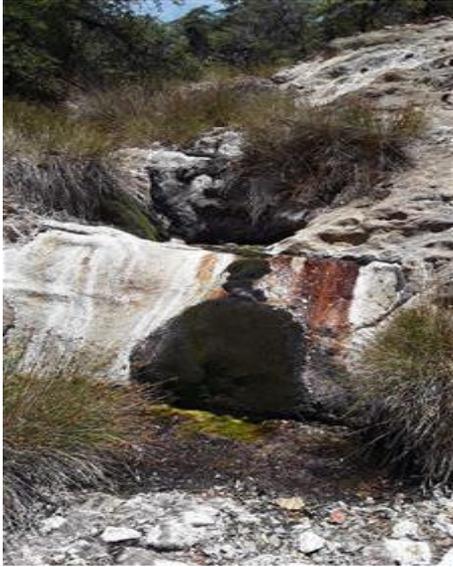
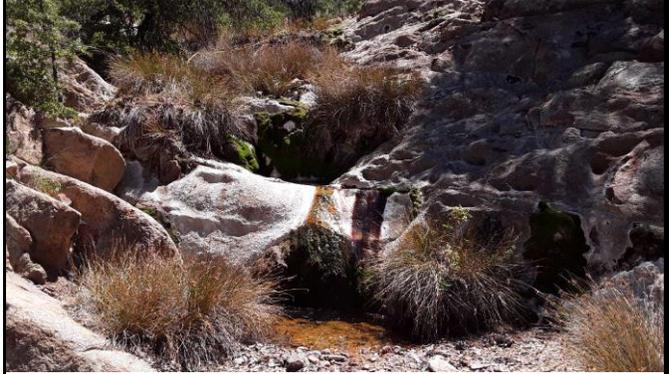
Aquatic and Vegetation Survey Findings: Water seeps from granite joints and flows atop bedrock outcrop in Cox Gulch. Steep and terraced channel with several tinajas. Vegetation is predominantly rushes (*Juncus balticus*) and mosses, with an overstory of Emory oak (*Quercus emoyi*). Invasive Lehmann lovegrass (*Eragrostis lehmanniana*) and invasive natalgrass (*Melinis repens*) occur. Aquatic beetles, water striders, and backswimmers have been present. During the site visit on 06/01/2021, Mexican jays (*Aphelocoma wollweberi*) and dusky-capped flycatchers (*Myiarchus tuberculifer*) were observed in the vicinity.
