Hermosa Spring and Seep Catalog

Hermosa Project Area

SPRING AND SEEP CATALOG Hermosa Project Area

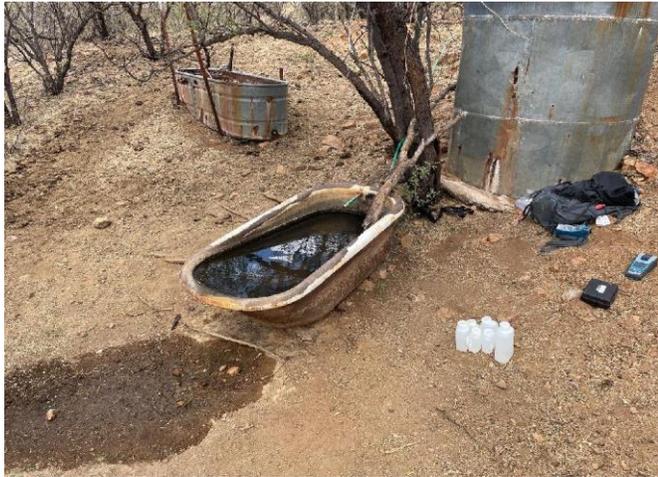
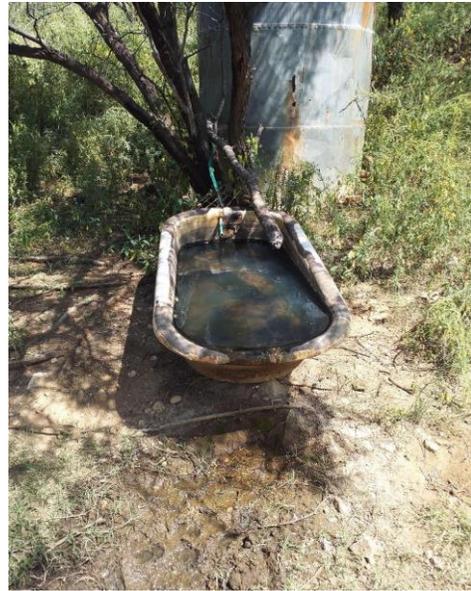
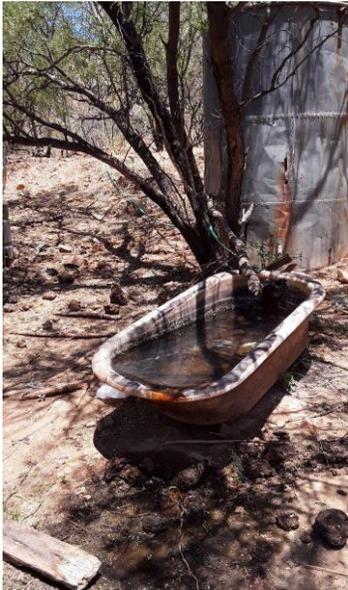
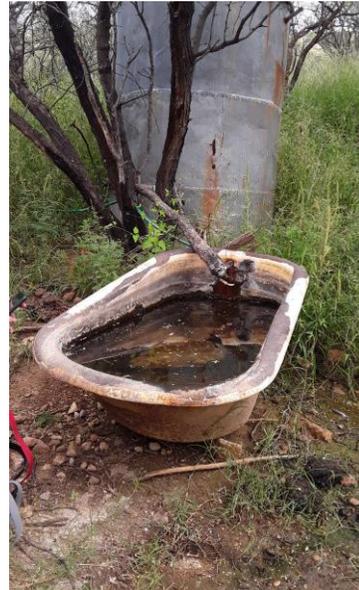
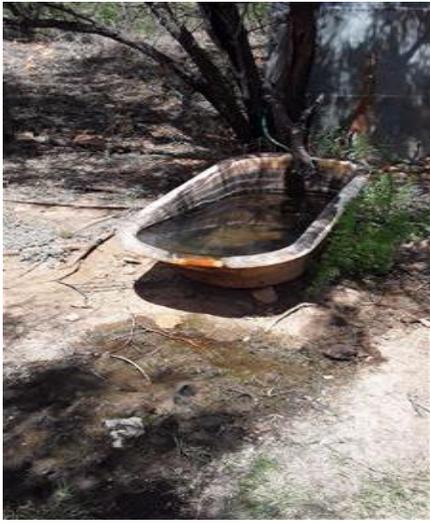
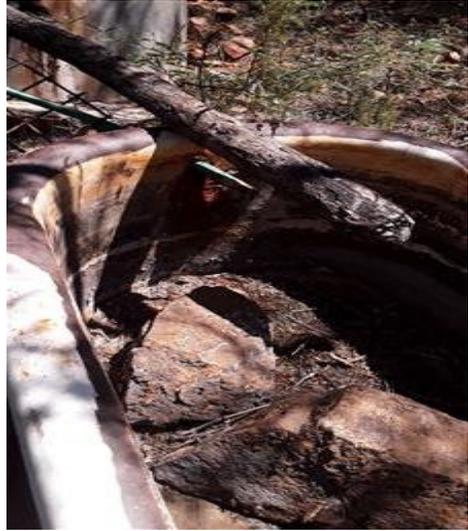
Aquatic and Vegetation Survey Findings: Water flowing into a bathtub fed by an artesian well. During visits, overflow from the bathtub results in wetted stretch of soil typically extending approximately 6 feet. Aquatic beetles have been observed. No aquatic herpetofauna have been observed; evidence of cattle, deer, and coyotes have been observed. Invasive Bermudagrass (*Cynodon dactylon*) occurs.

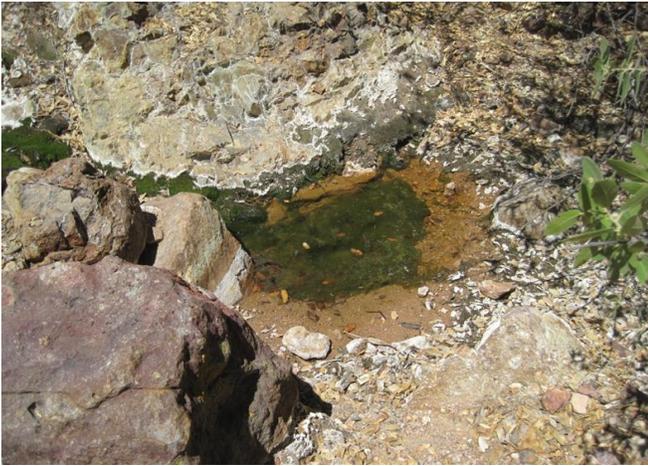
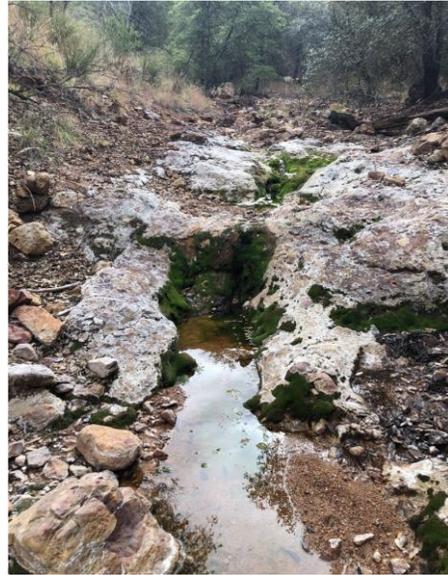
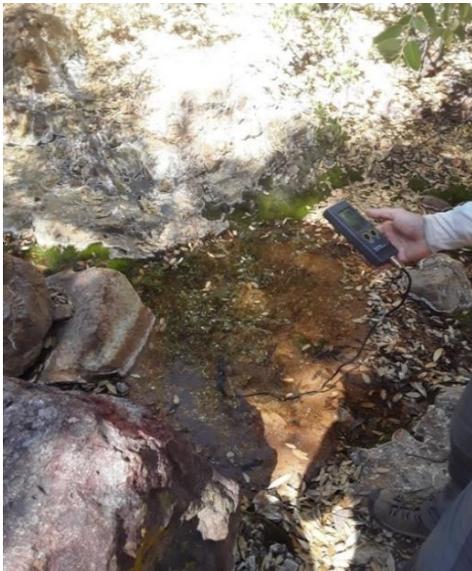
Aquatic and Vegetation Survey Findings: This site is located in rocky and cobbly section of upper Flux Canyon with exposed bedrock. Generally, water is present in shallow pools. Moss is present in the drainage bottom on exposed bedrock. Little to no understory or herbaceous cover exists. Limited overstory tree coverage is dominated by oak (*Quercus* spp.) and Mexican pinyon (*Pinus cembroides*). Aquatic invertebrates previously noted within the Flux Canyon drainage including beetles, boatmen, backswimmers, dragonflies, and damselflies. No aquatic vertebrates have been observed.

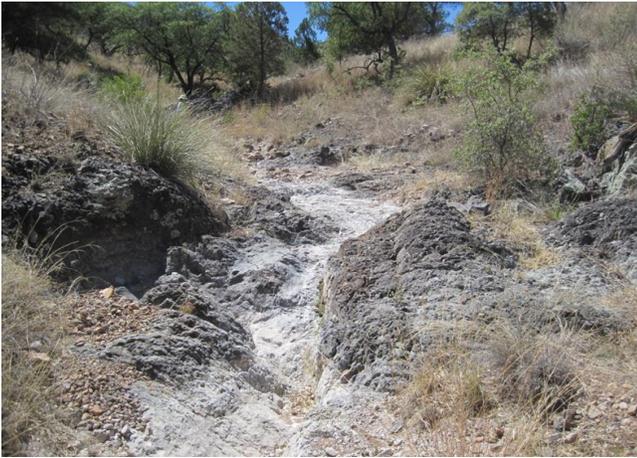
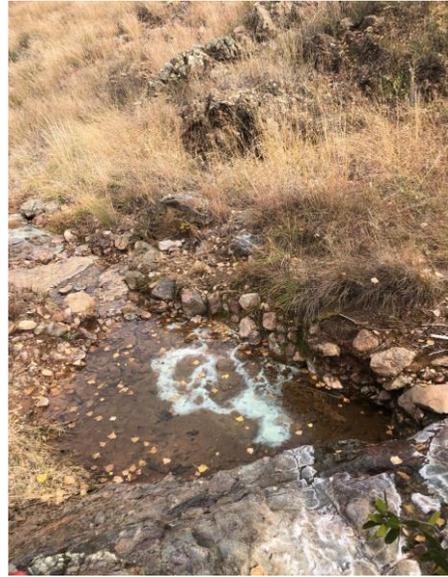
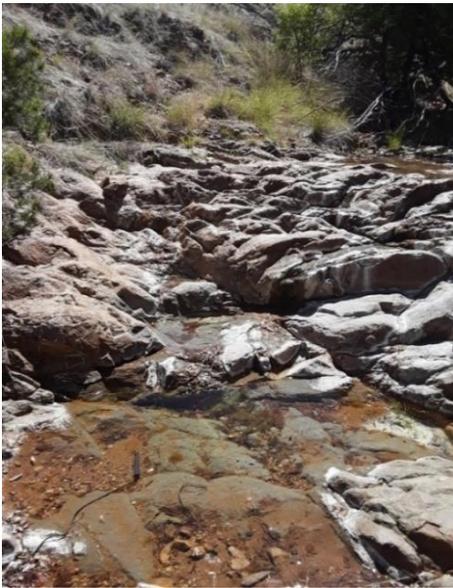
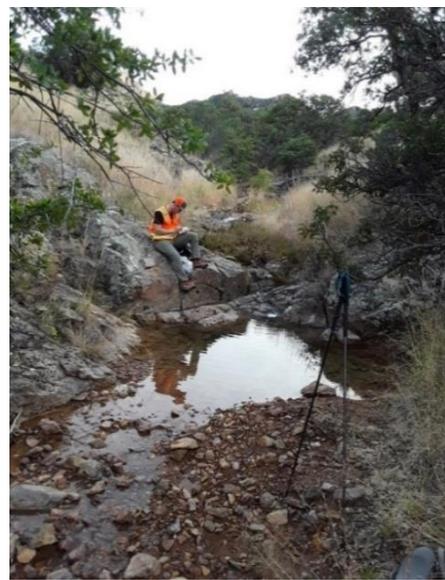
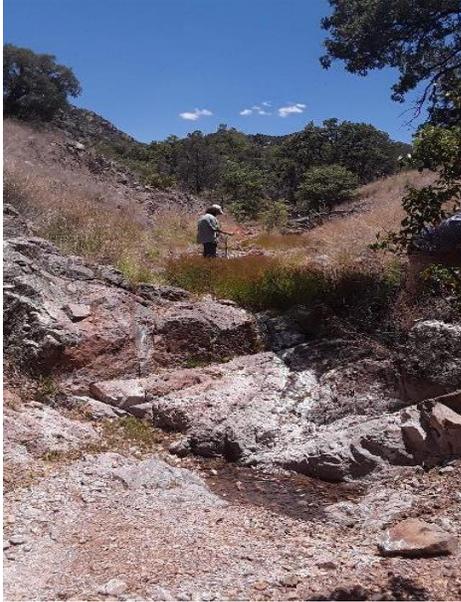
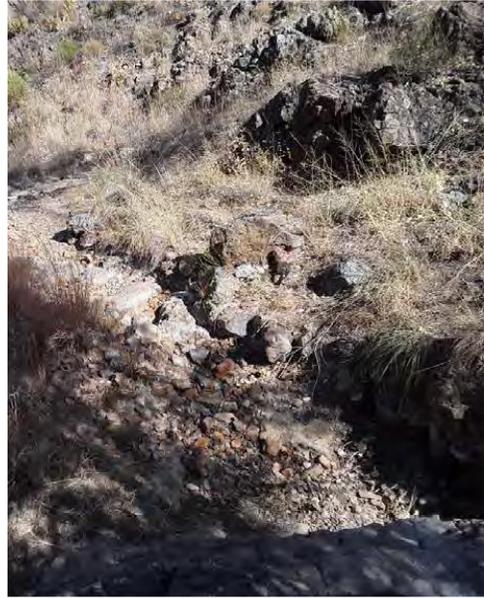
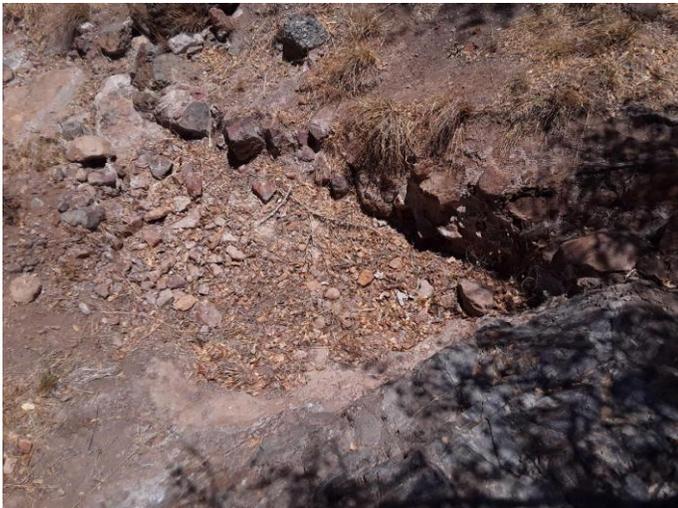
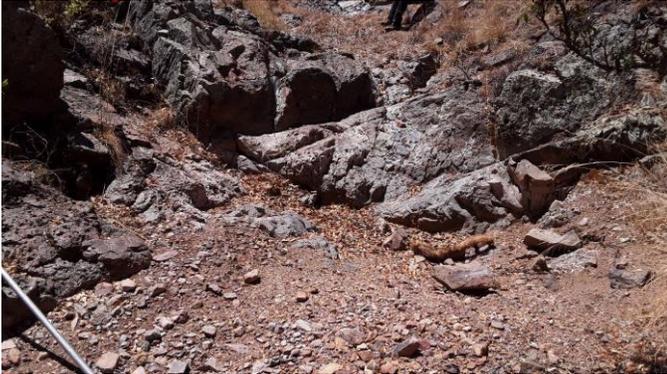
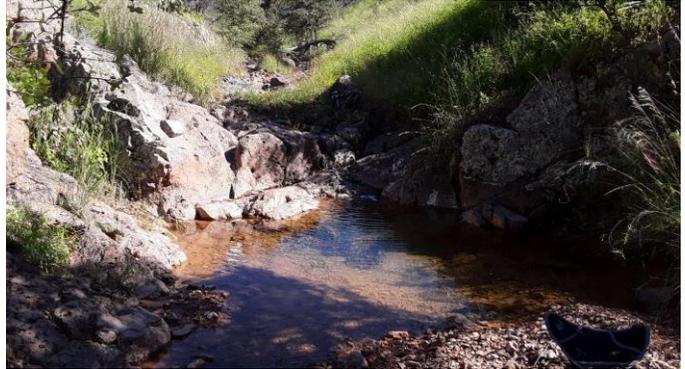
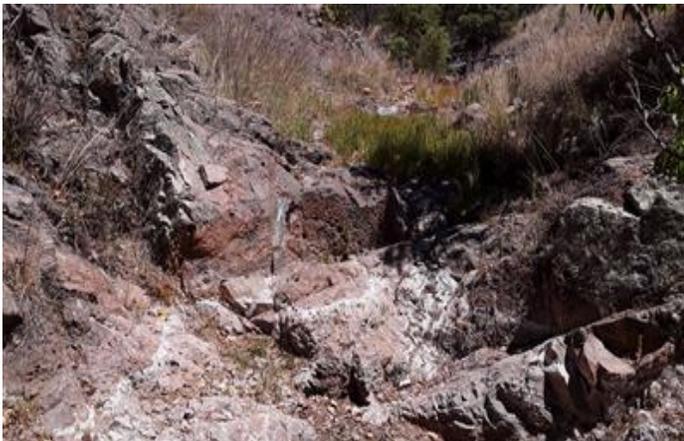
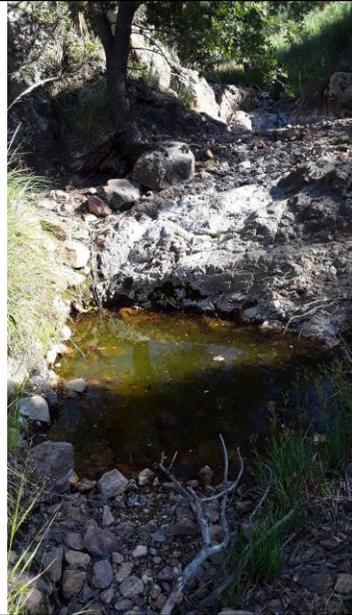
Aquatic and Vegetation Survey Findings: This site is located in cobbly and gravelly section of Flux Canyon with some exposed bedrock. Generally, water is present in shallow, isolated pools near bedrock. Rocky Mountain rush (*Juncus saximontanus*), a riparian obligate species, plains lovegrass (*Eragrostis intermedia*), and bullgrass (*Muhlenbergia emersleyi*) are dominate perimeter vegetation along the drainage bottom. Seep monkeyflower (*Mimulus guttatus*), a wetland associated plant, was noted at this site. Green sprangletop (*Leptochloa dubia*) and other grasses dominate the adjacent hillsides. Arizona white oak (*Quercus arizonica*) provides the limited amount of overstory tree coverage at this site. Invasive plant species observed includes Lehmann lovegrass (*Eragrostis lehmanniana*) and natalgrass (*Melinis repens*). Aquatic invertebrates previously noted within the Flux Canyon drainage including beetles, boatmen, backswimmers, dragonflies, and damselflies. No aquatic vertebrates have been observed.

Site ID	F4-01	Interpretation of Groundwater Age: Little to no evaporation, modern water during the dry season. Little to no evaporation, modern water during the wet season.
Watershed	Flux Canyon	
Monitoring Period	11/2017 - 11/2023	Potential Impacts/Effects: Flows observed at this site have ranged from 0 to 135 gpm. Three dry site visits during the dry season suggest that the site may not be connected with a perennial groundwater source. No changes are predicted at this site.
Number of Visits	20

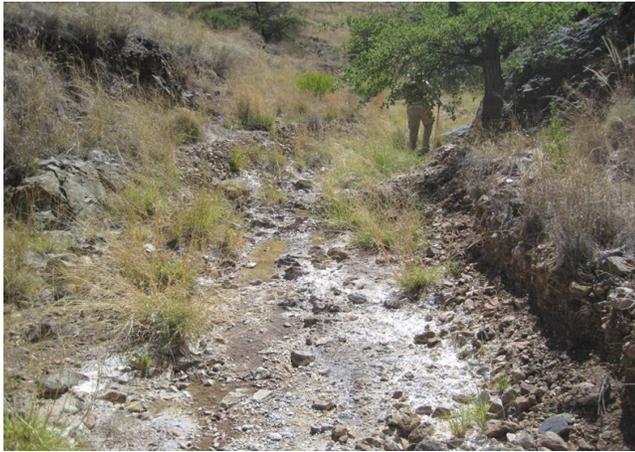
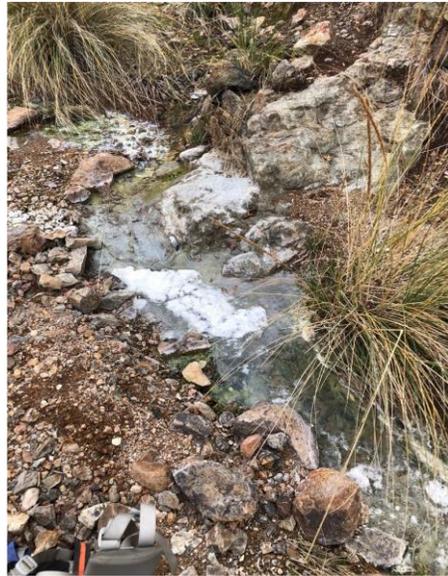
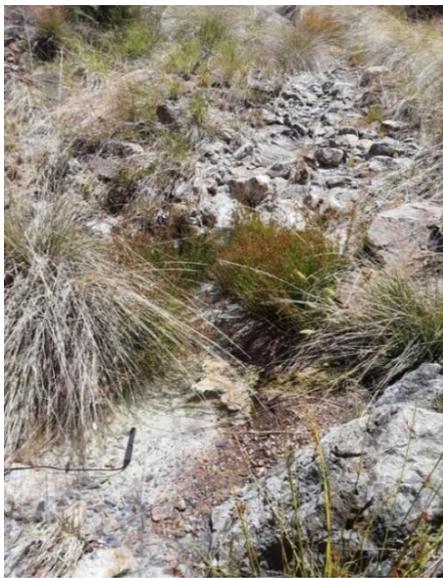
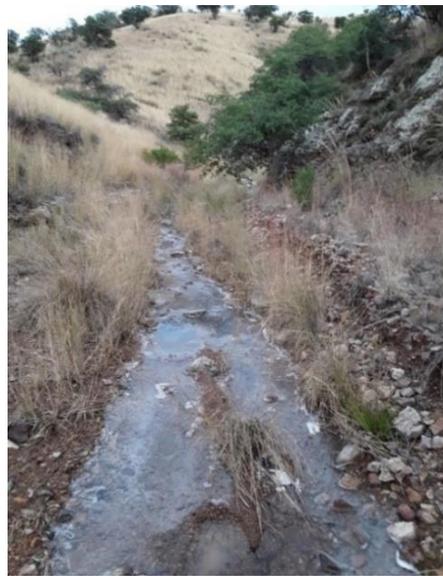
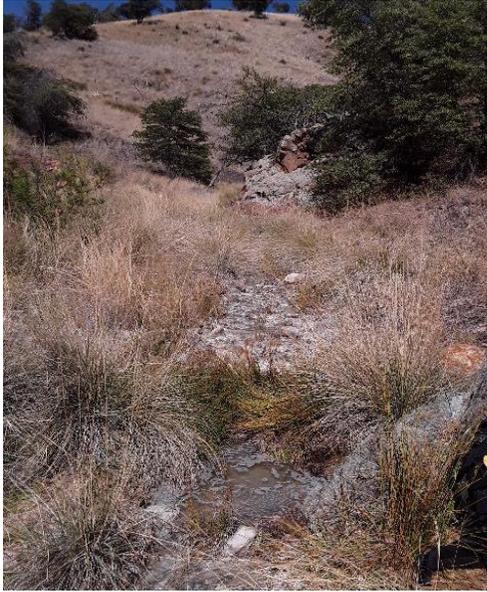
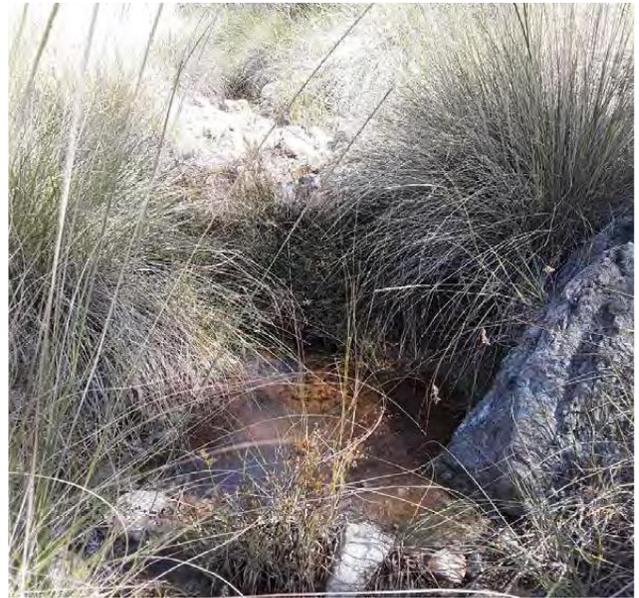
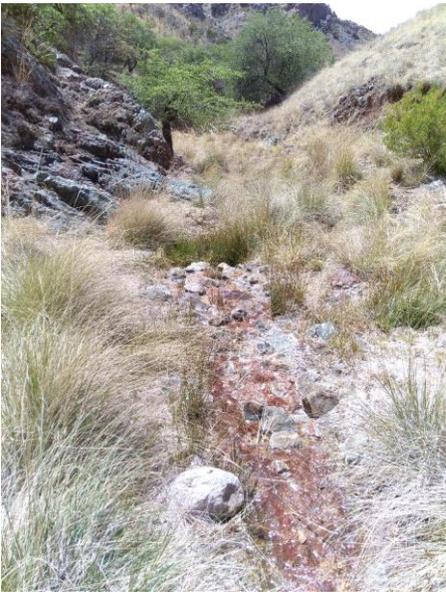
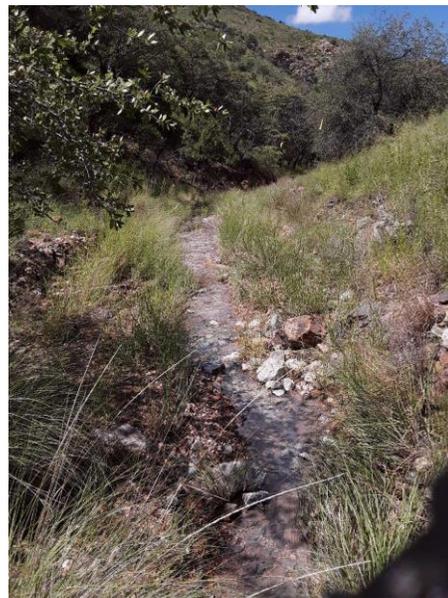
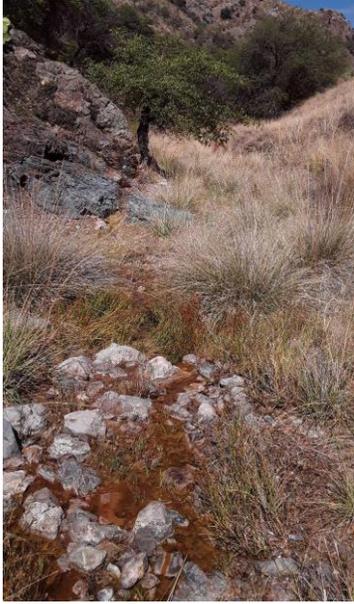
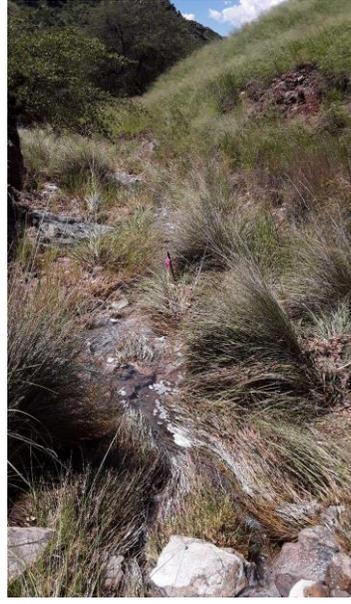
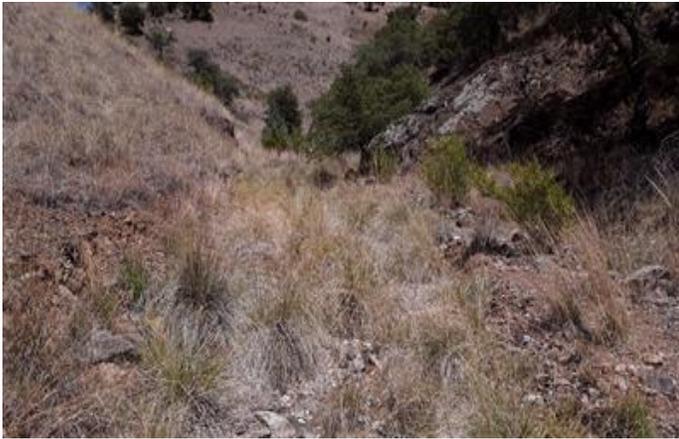
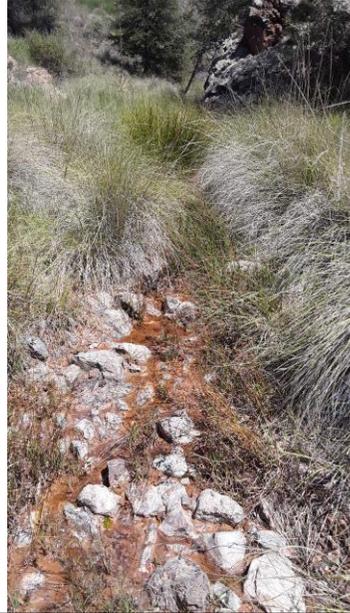
Aquatic and Vegetation Survey Findings: This site is located in rocky and cobbly section of Flux Canyon with exposed bedrock. Generally, water is present in shallow pools. Bullgrass (*Muhlenbergia emersleyi*) and riparian obligate rushes (*Juncus* spp.) are dominate perimeter vegetation along the drainage bottom. Hopbush (*Dodonaea viscosa*) and Texas bluestem (*Schizachyrium cirratum*) occur on the adjacent hillsides. Although there is no overstory canopy at the site, overstory trees along the drainage are dominated by Emory oak (*Quercus emoryi*). Non-native annual rabbitsfoot grass (*Polypogon monspeliensis*) and invasive plants, Lehmann lovegrass (*Eragrostis lehmanniana*) and Johnson grass (*Sorghum halepense*) have been observed. Aquatic invertebrates previously noted within the Flux Canyon drainage including beetles, boatmen, backswimmers, dragonflies, and damselflies. No aquatic vertebrates have been observed.

Site ID	F6-01	Interpretation of Groundwater Age: Little to no evaporation, modern to mixed water during the dry season. Little to no evaporation, modern water during the wet season.
Watershed	Flux Canyon	
Monitoring Period	11/2017 - 11/2023	Potential Impacts/Effects: Flows observed at this site have ranged from 0 to 135 gpm. No changes are predicted at this site.
Number of Visits	20

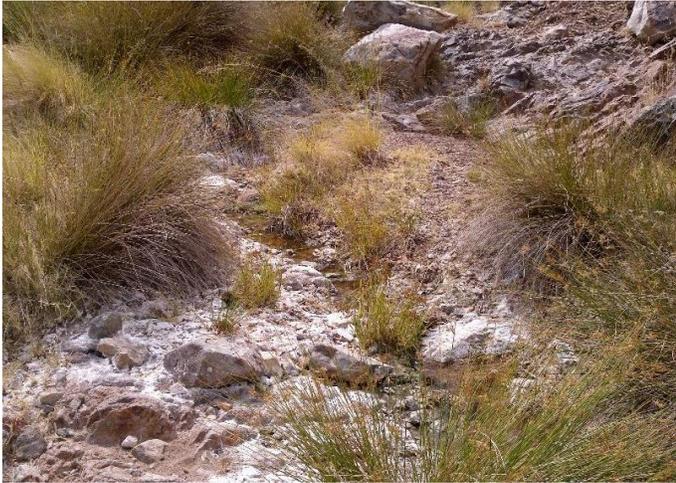
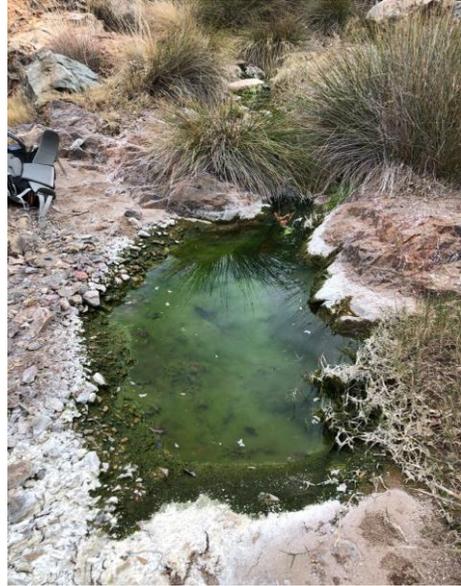
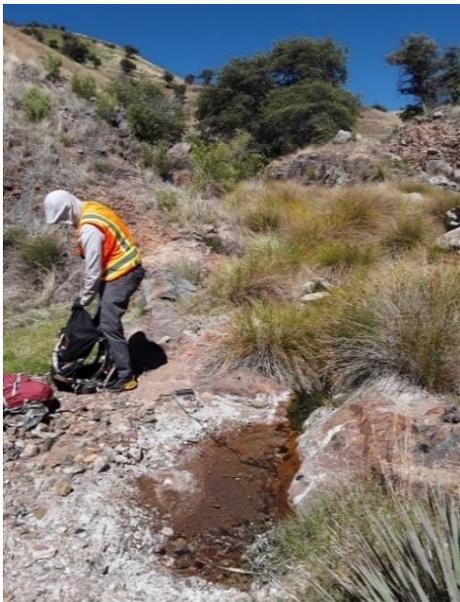
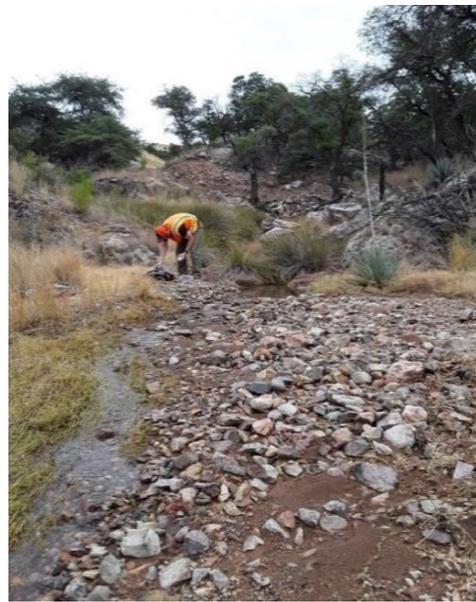
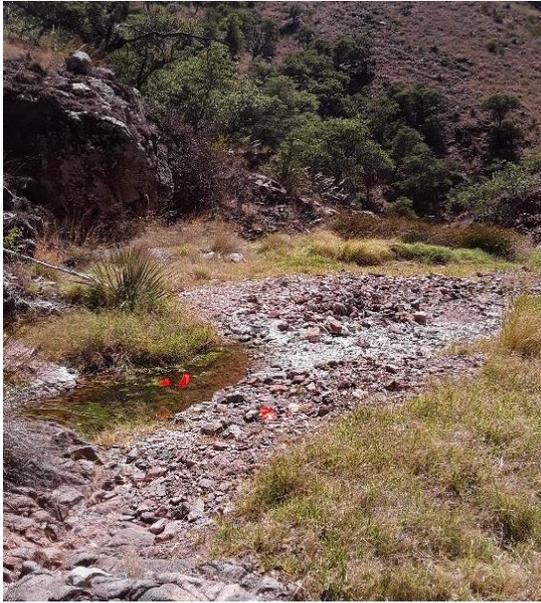
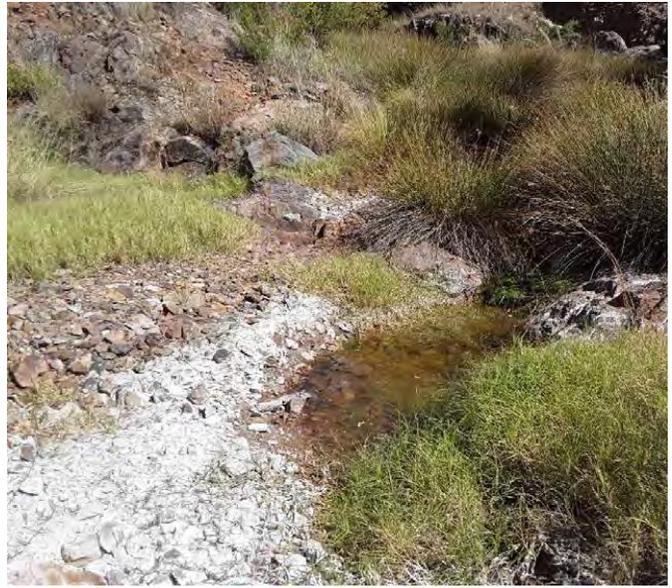
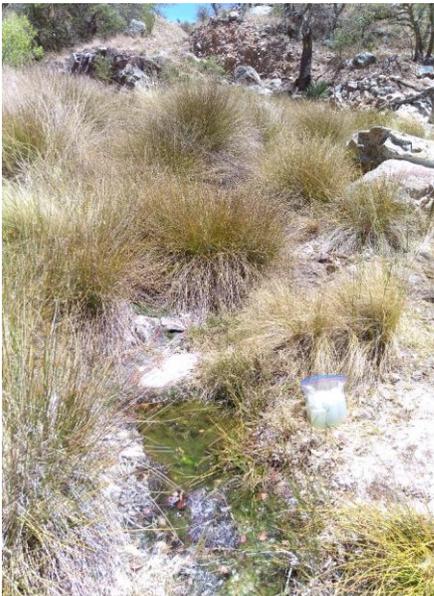
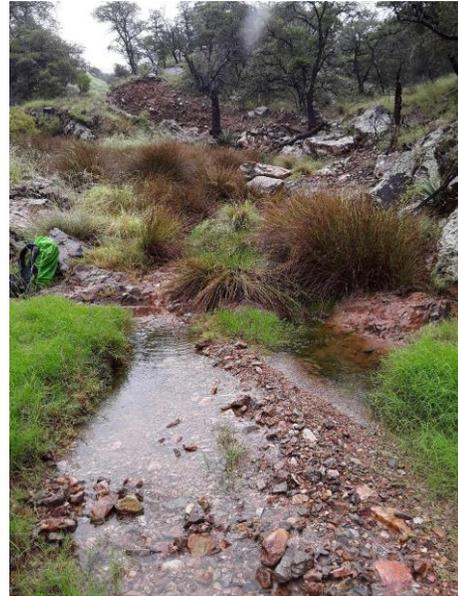
Aquatic and Vegetation Survey Findings: Site is located in rocky and cobbly section of Flux Canyon with exposed bedrock. Generally, water is present in shallow pools. Aquatic invertebrates including beetles, boatmen, and damselflies observed. No aquatic vertebrates have been observed. Livestock (scat) and deer (tracks) sign present. Little to no overstory tree coverage is present within the drainage. Emergent and perimeter vegetation is dominated by riparian obligate rushes (*Juncus* spp.), Bermudagrass (*Cynodon dactylon*), and bullgrass (*Muhlenbergia emersleyi*). Drainage lacks riparian vegetation. North-facing slopes are dominated by upland tree and shrub species (oaks [*Quercus* spp.], junipers [*Juniperus* spp.], and hobbush [*Dodonaea viscosa*]), while south-facing slopes are dominated by grasses with sotol (*Dasyllirion wheeleri*) and Palmer agave (*Agave palmeri*) present. Invasive plant species observed are Bermudagrass (*Cynodon dactylon*) and natalgrass (*Melinis repens*).

Site ID	F6-02	Interpretation of Groundwater Age: Little to no evaporation, modern to mixed water during the dry season. Little to no evaporation, modern water during the wet season.
Watershed	Flux Canyon	
Monitoring Period	11/2017 - 11/2023	Potential Impacts/Effects: Flows observed at this site have ranged from near 0 to 168 gpm.
Number of Visits	20

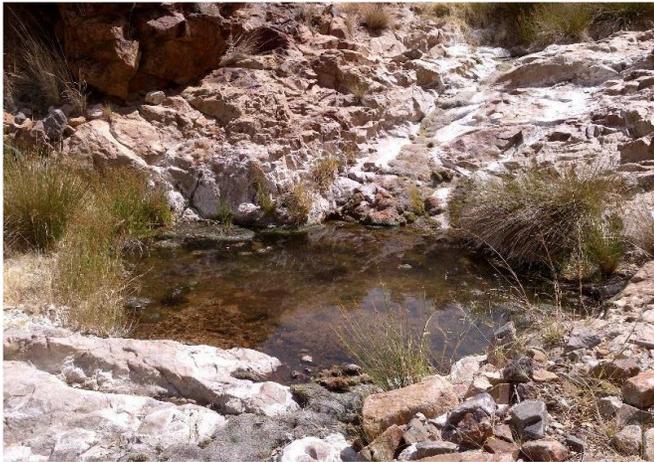
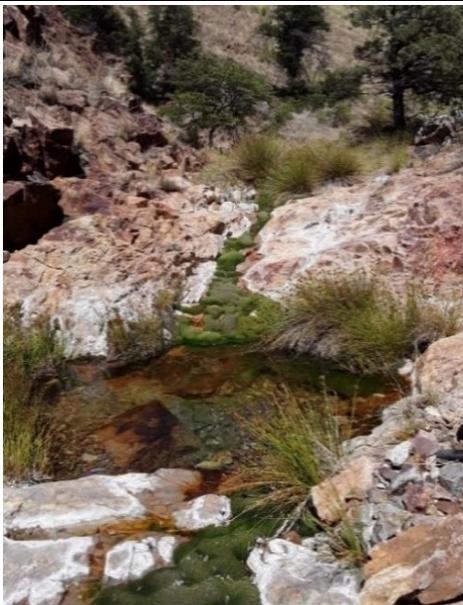
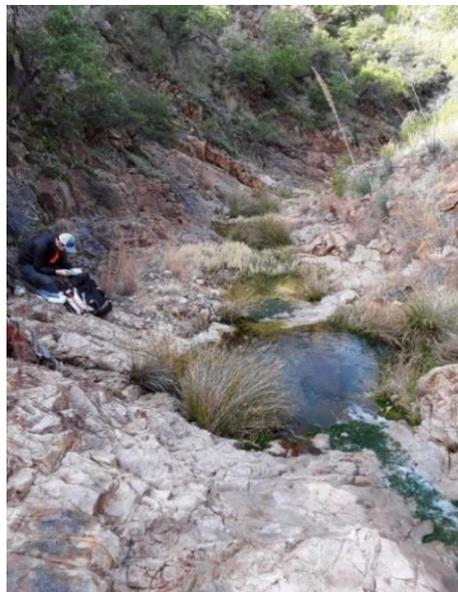
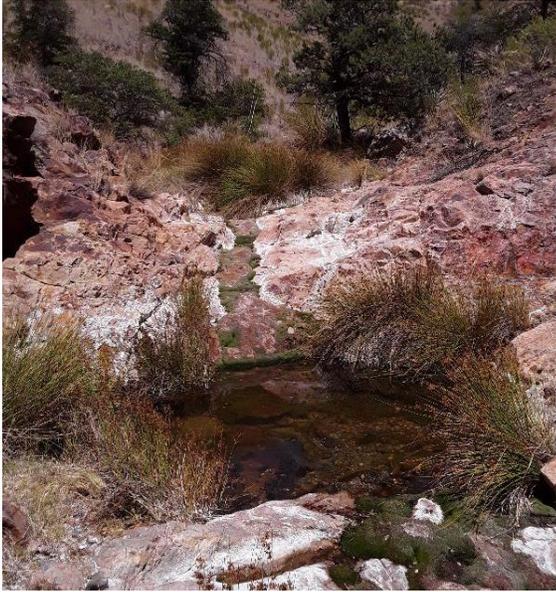
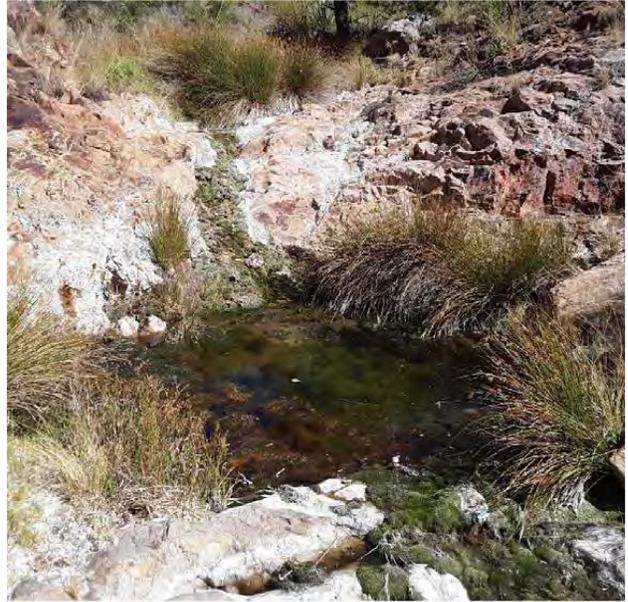
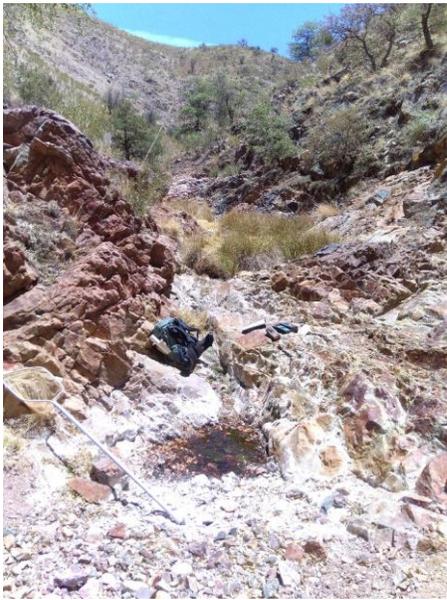
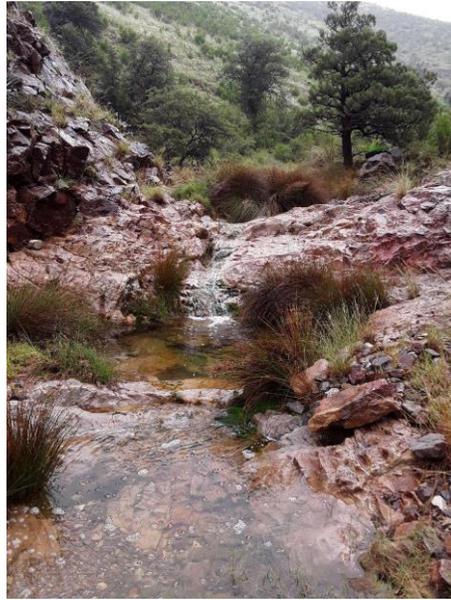
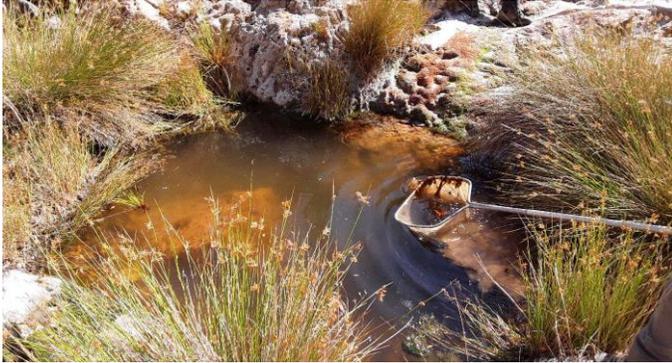
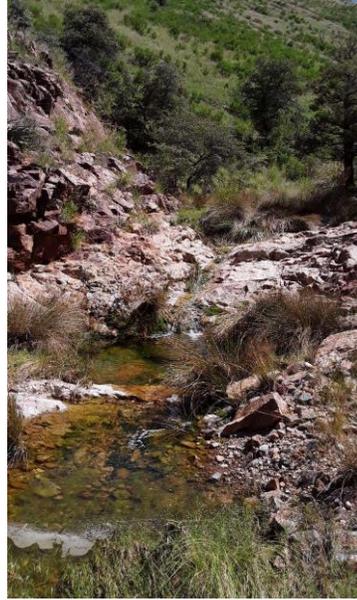
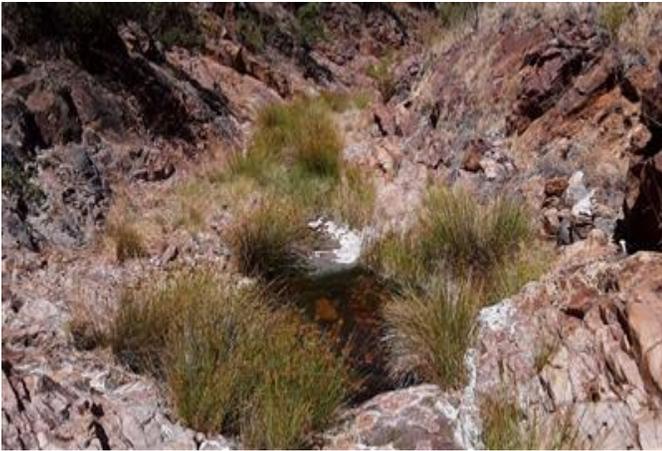
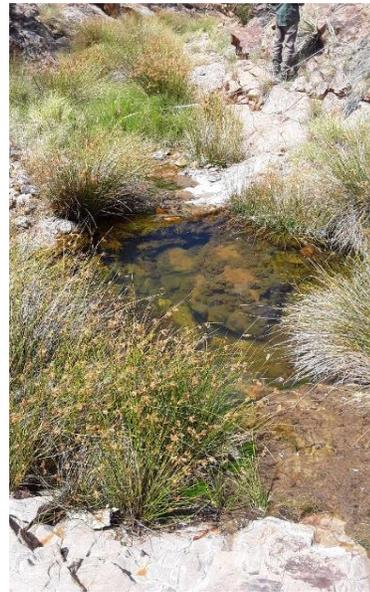
Aquatic and Vegetation Survey Findings: Site is located in bedrock bottom section of Flux Canyon. Generally, water is present in shallow pools. Aquatic beetles and boatmen have been observed. No aquatic vertebrates observed have been observed. Deer tracks have been noted at this site. No overstory tree coverage is present at this site in the drainage. Emergent and perimeter vegetation is dominated by riparian obligate *Juncus* spp., Bermudagrass (*Cynodon dactylon*), and bullgrass (*Muhlenbergia emersleyi*). Drainage lacks riparian tree vegetation. North-facing slopes are dominated by Emory oak (*Quercus emoryii*) and hopbush (*Dodonaea viscosa*), while south-facing slopes are dominated by grasses with sotol (*Dasylirion wheeleri*) and Palmer agave (*Agave palmeri*) present. Invasive plant species observed includes Bermudagrass (*Cynodon dactylon*) and Lehmann lovegrass (*Eragrostis lehmanniana*).

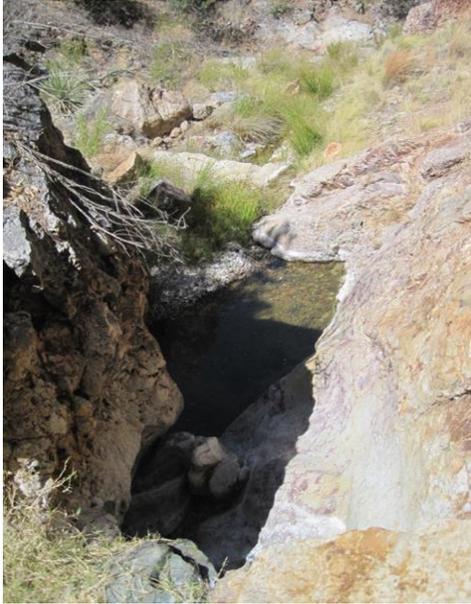
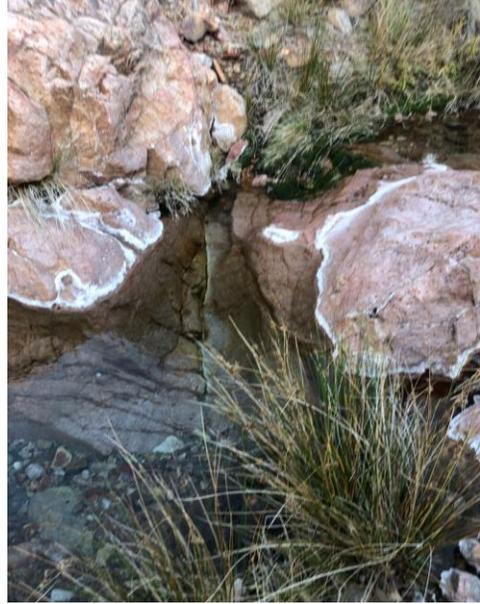
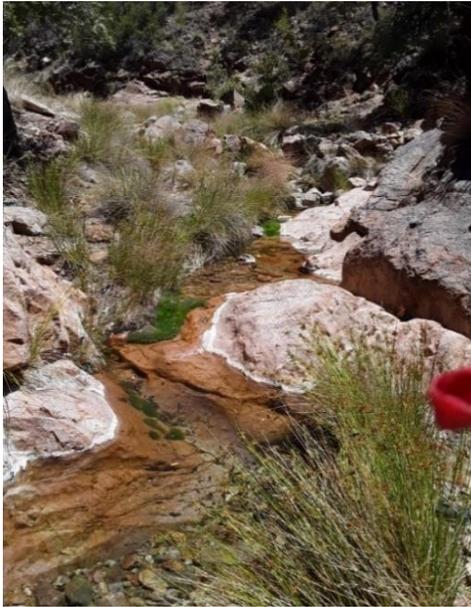
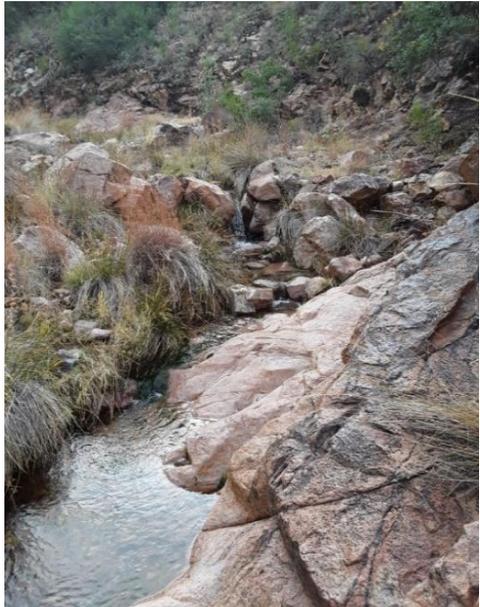
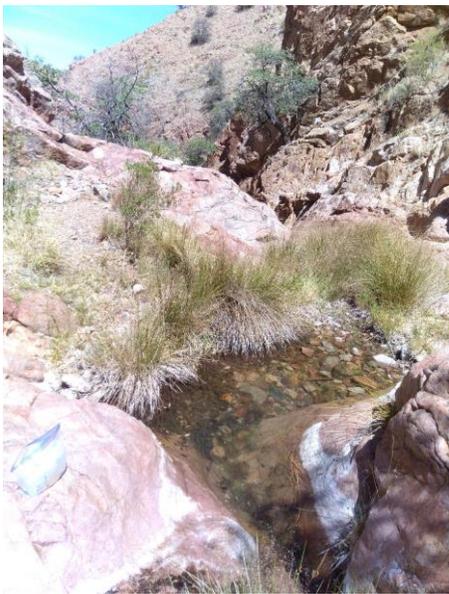
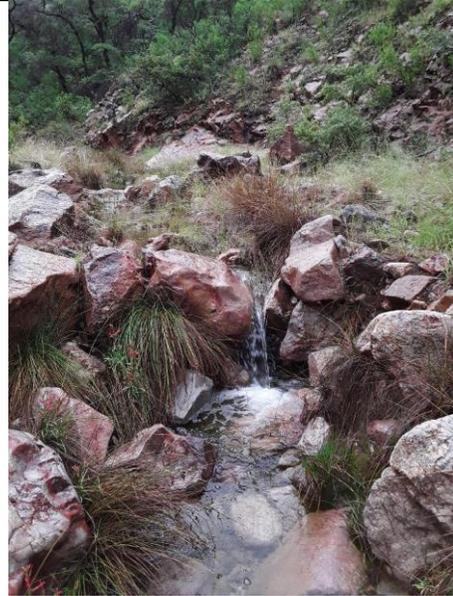
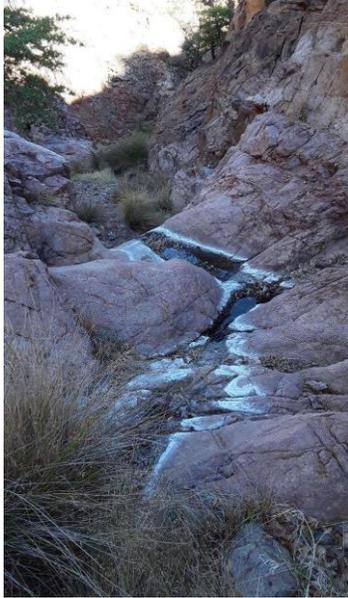
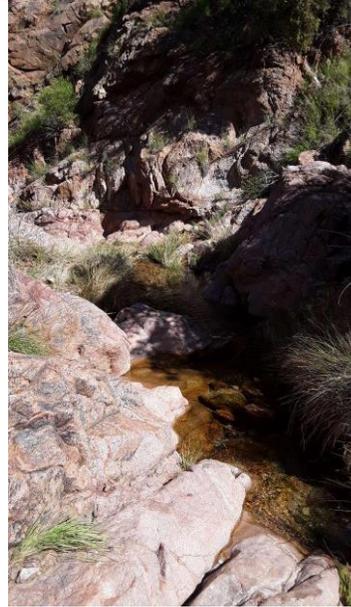
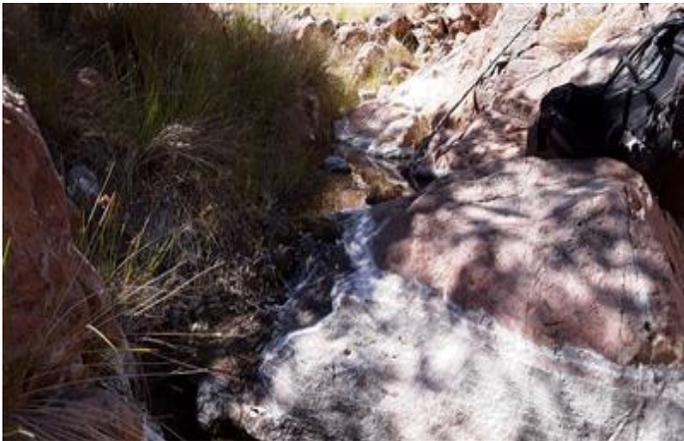
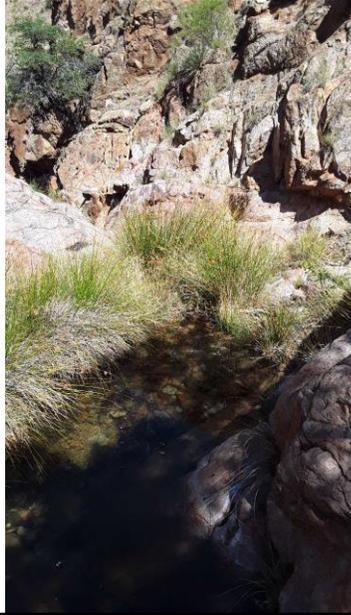
Aquatic and Vegetation Survey Findings: Site is located in rocky and bouldery section of lower Flux Canyon. Generally, water is present in shallow pools. Aquatic beetles and boatmen have been observed. No aquatic vertebrates observed have been observed. Deer tracks have been noted at this site. No overstory tree coverage is present at this site within the drainage. Emergent and perimeter vegetation is dominated by riparian obligate *Juncus* spp., Bermudagrass (*Cynodon dactylon*), bullgrass (*Muhlenbergia emersleyi*), and deergrass (*Muhlenbergia rigens*). Drainage lacks riparian tree vegetation. North-facing slopes are dominated by Emory oak (*Quercus emoryi*) and hopbush (*Dodonaea viscosa*), while south-facing slopes are dominated by grasses. Invasive plant species observed are Lehmann lovegrass (*Eragrostis lehmanniana*) and Bermudagrass (*Cynodon dactylon*).

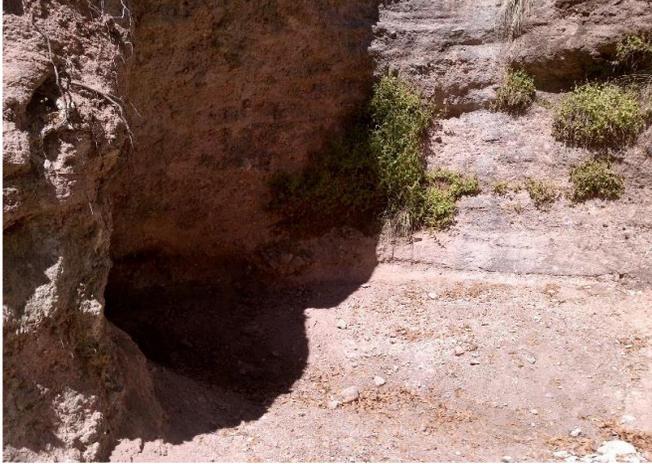
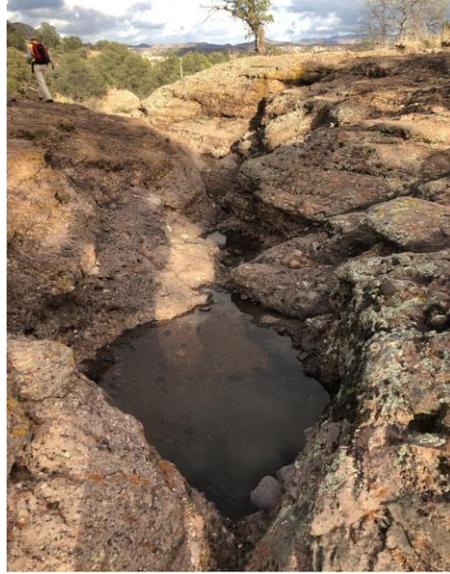
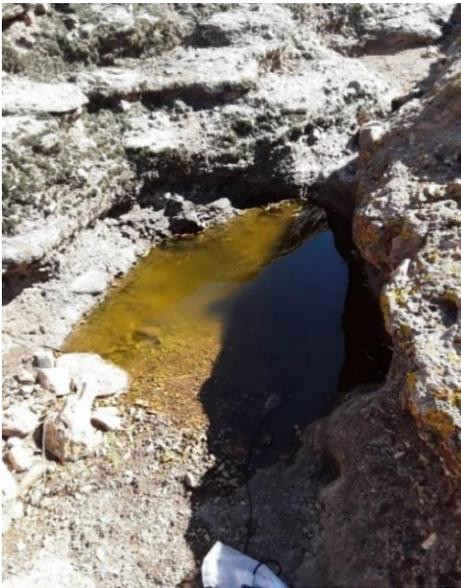
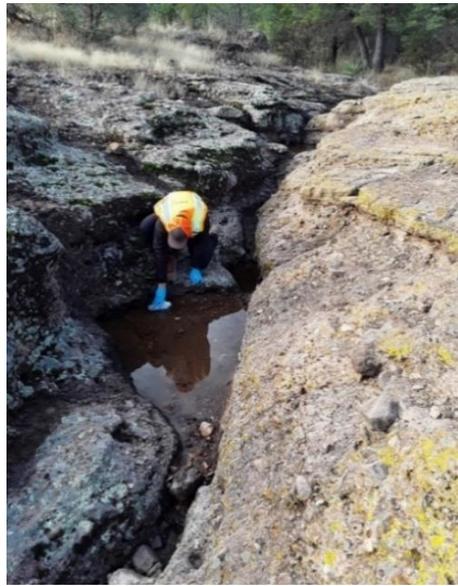
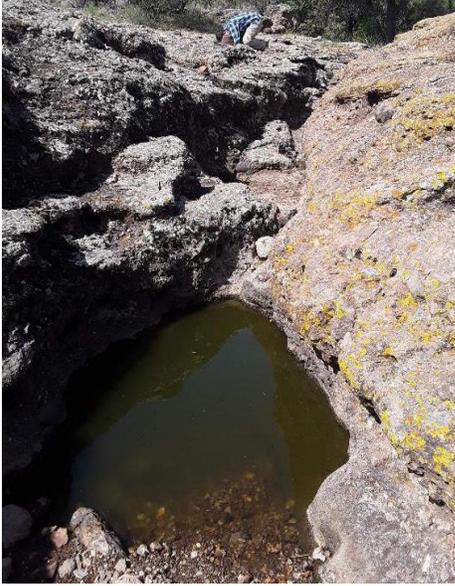
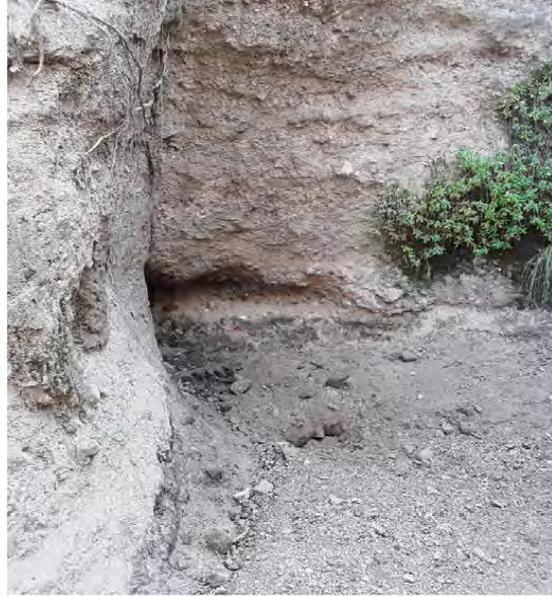
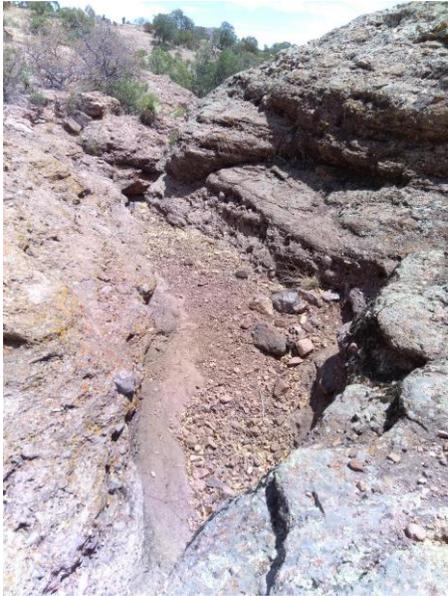
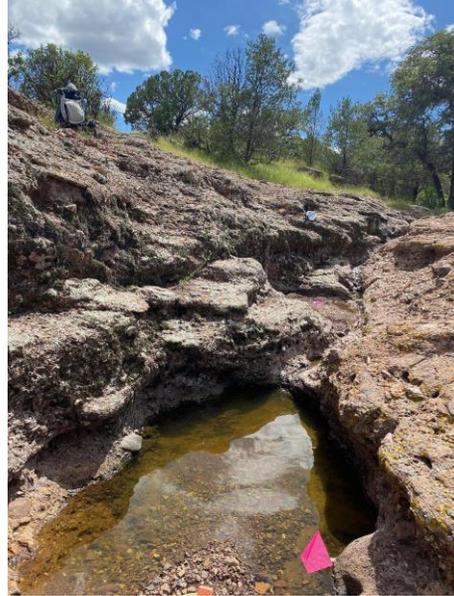
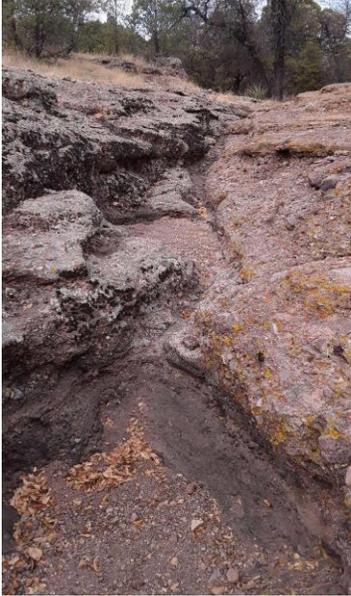
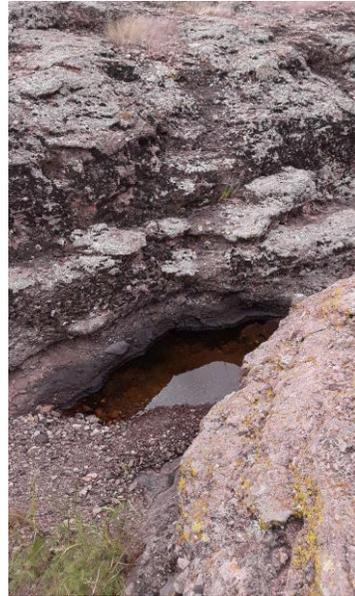
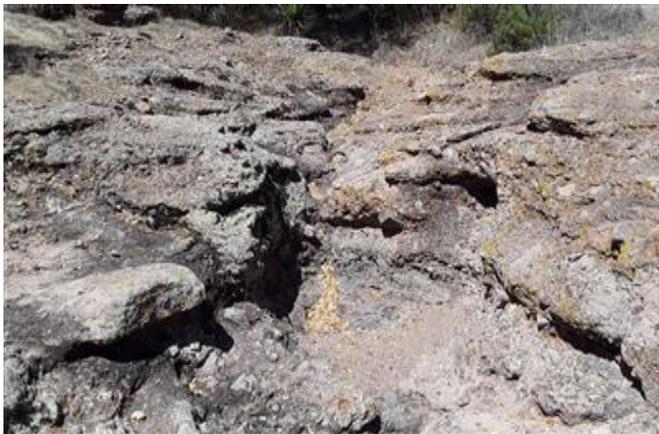
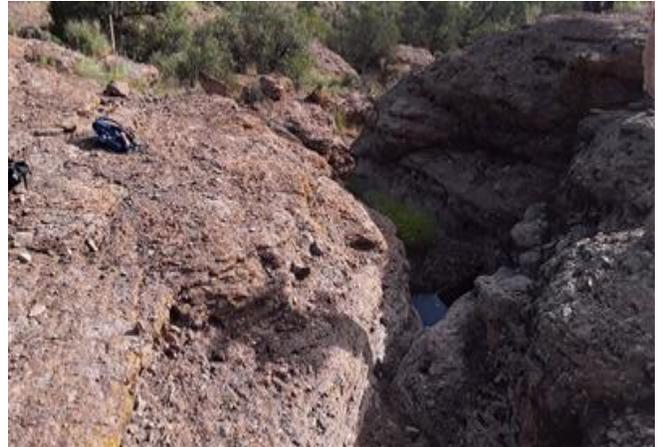
Aquatic and Vegetation Survey Findings: This site is located within exposed bedrock in Goldbaum Canyon. Water is present in series of small tinajas. This site does not support any emergent or perimeter vegetation. No overstory tree species occur at this site. Trace vegetation noted nearby include Ipomopsis (*Ipomopsis* sp.) and deergrass (*Muhlenbergia rigens*). Invasive plant species observed are Lehmann lovegrass (*Eragrostis lehmanniana*). Canyon treefrog (*Hyla arenicolor*) and red spotted toads (*Anaxyrus rufipunctatus*) have been observed at this site.

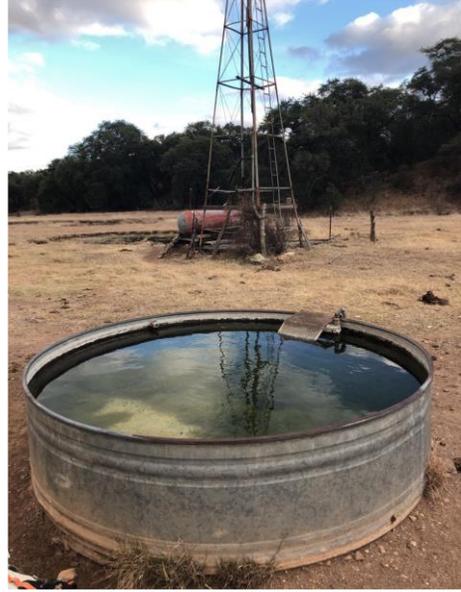
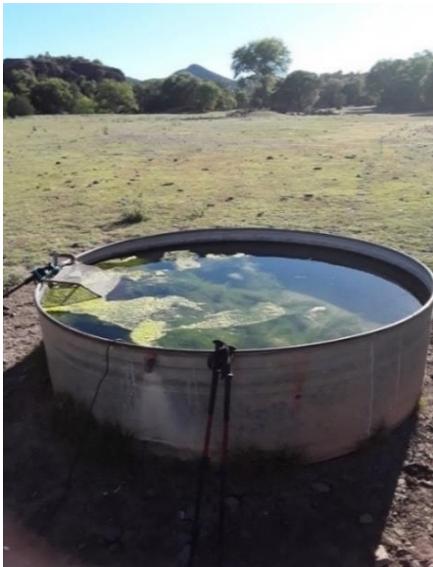
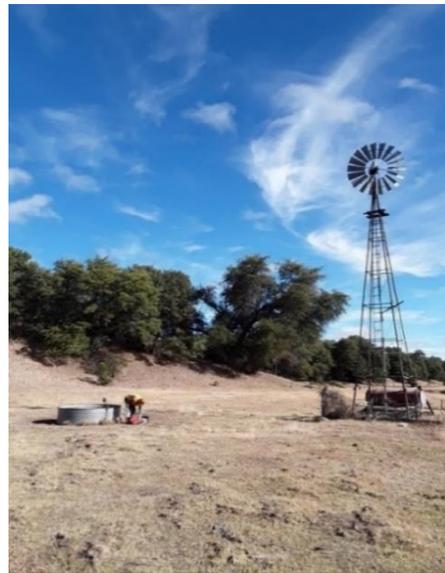
Aquatic and Vegetation Survey Findings: This site consists of a metal, circular stock drinker (approx. 1.8m in diameter) located in Goldbaum Canyon. The drinker is fed by an adjacent windmill and well. There is some accumulated silt along the bottom of the drinker. Submerged algae (*Chara* sp.) is typically present in this drinker. No overstory vegetation is present. Invasive Bermudagrass (*Cynodon dactylon*) and invasive stinkgrass (*Eragrostis cilianensis*) occurs around the base of the drinker. Aquatic invertebrates observed include beetles, backswimmers, boatmen, dragonflies, water scorpion, leeches, and snails. No aquatic vertebrates or herpetofauna have been observed. Livestock has been observed around the stock tank and the site is heavily grazed.
