Hermosa Spring and Seep Catalog

Hermosa Project Area

SPRING AND SEEP CATALOG Hermosa Project Area

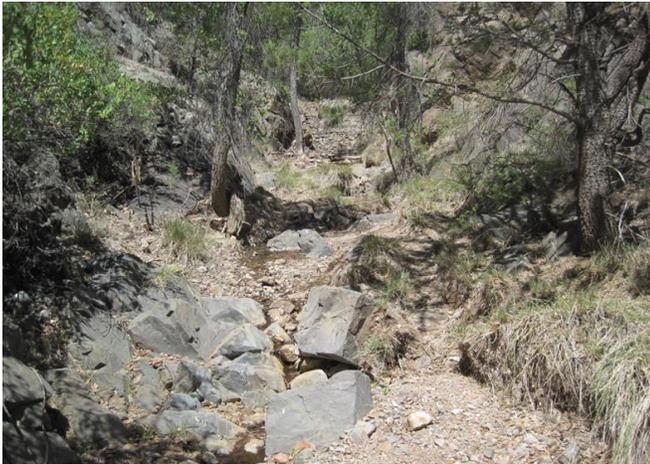
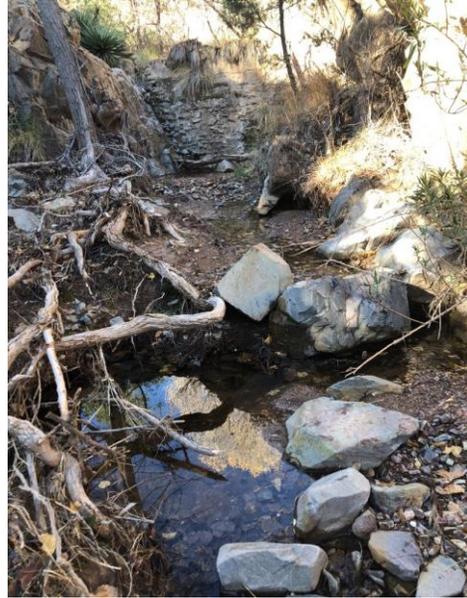
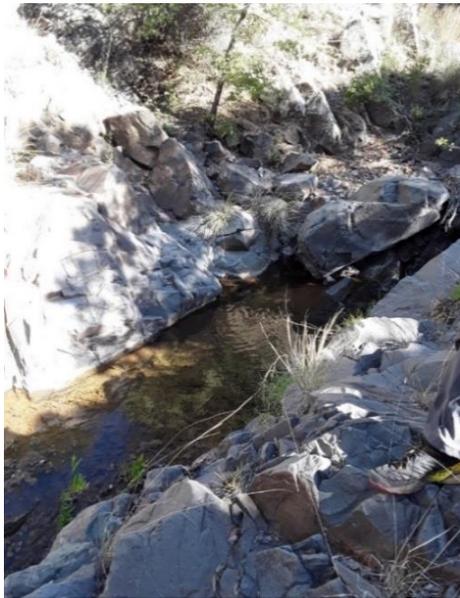
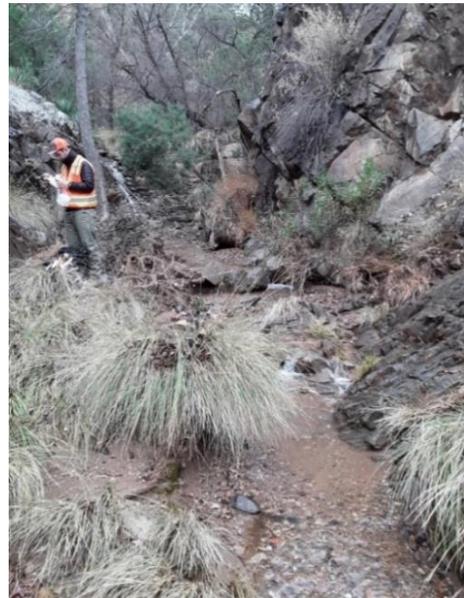
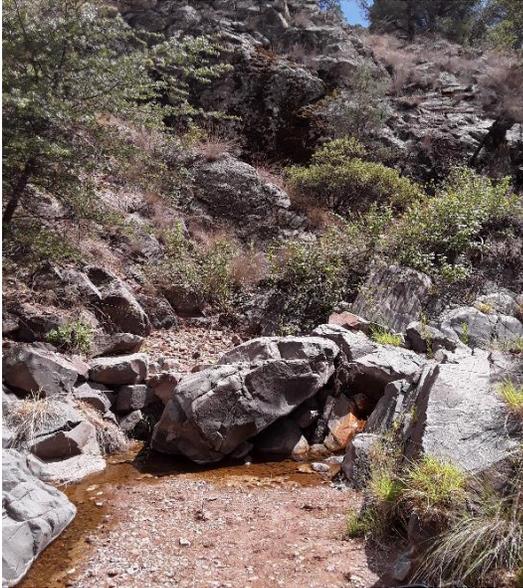
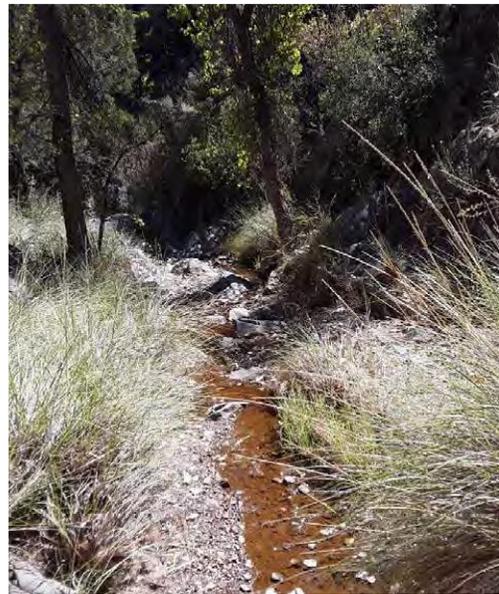
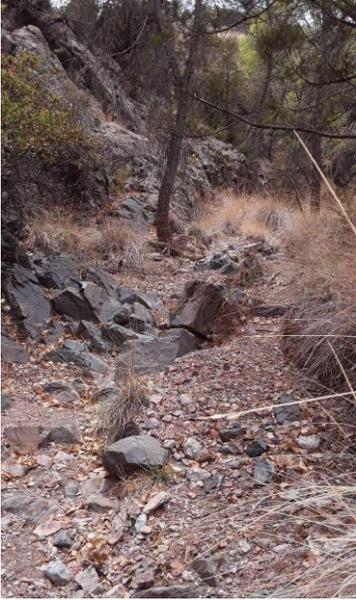
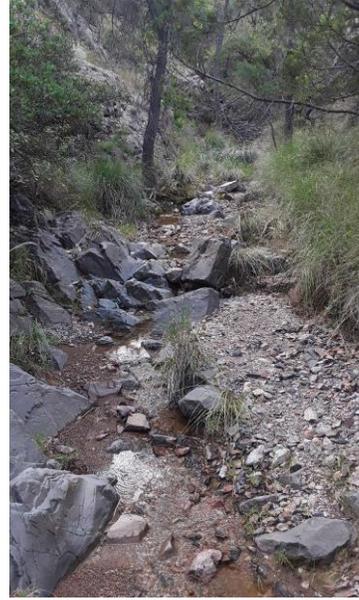
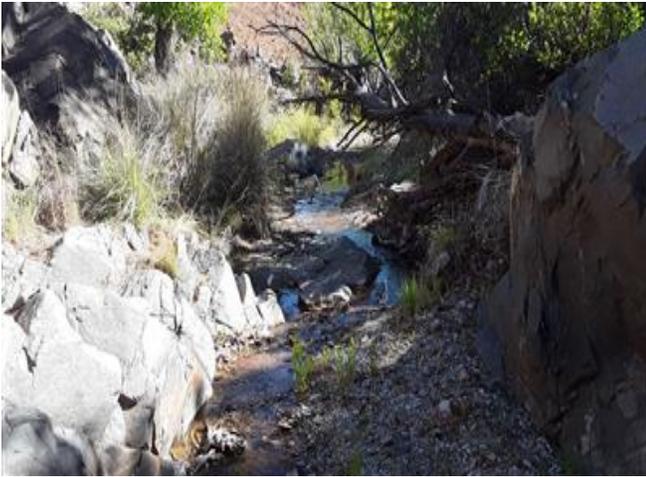
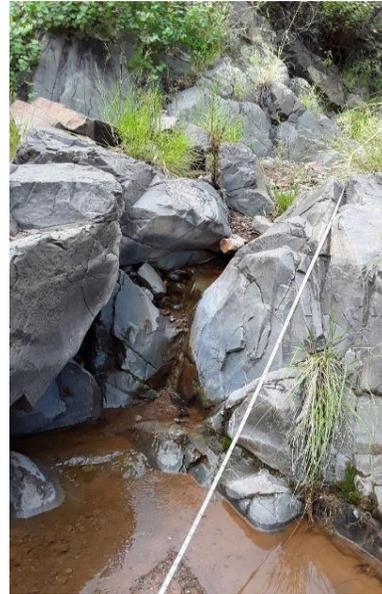
Aquatic and Vegetation Survey Findings: Feature consists of a relic dam that has silted in along Harshaw Creek. A pipe driven into the bottom of the dam allows for the passage of water within the alluvium behind the dam to the downstream drainage. During monsoons, flowing water is consistently present below the dam. Aquatic invertebrates include damselflies, backswimmers, and beetles. No aquatic vertebrates have been observed. Drainage substrate is mix of bedrock, boulders, gravel, and sand. Arizona white oak (*Quercus arizonica*), alligator juniper (*Juniperus deppeana*), and Fremont cottonwood (*Populus fremontii*) dominate the overstory. Understory vegetation includes deergrass (*Muhlenbergia rigens*), silktassel (*Garrya wrightii*), Arizona grape (*Vitis arizonica*), seepwillow (*Baccharis salicifolia*), and skunkbush sumac (*Rhus trilobata*). Invasive weeping lovegrass (*Eragrostis curvula*) have been observed.

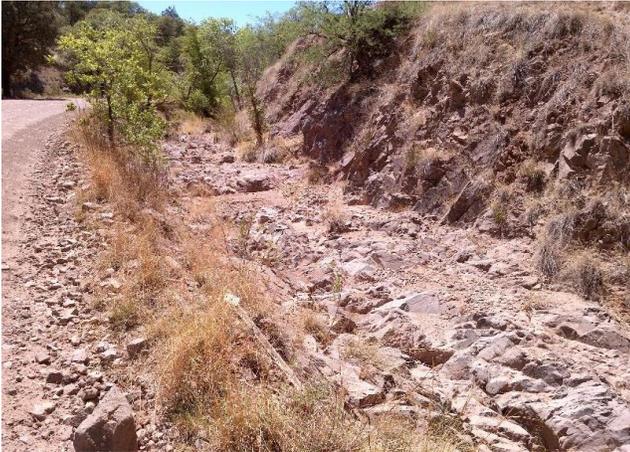
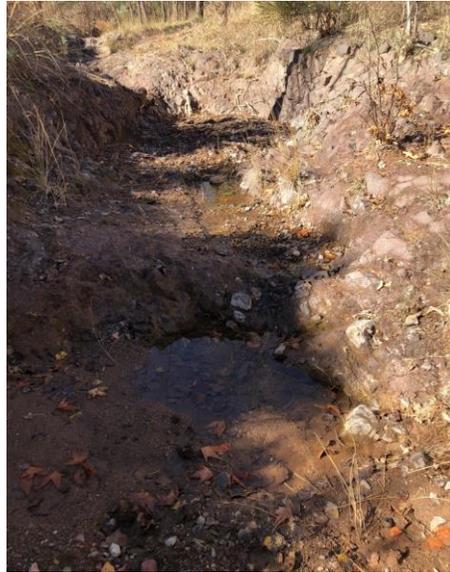
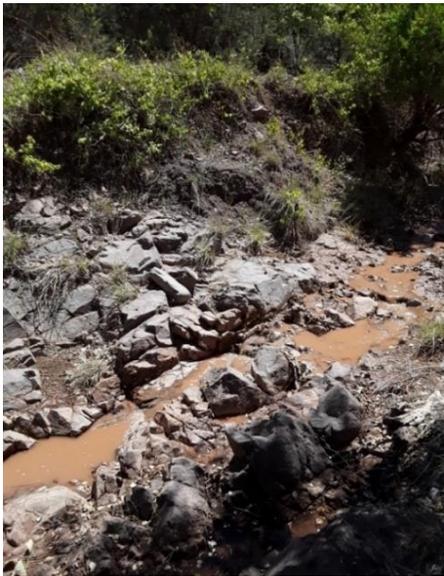
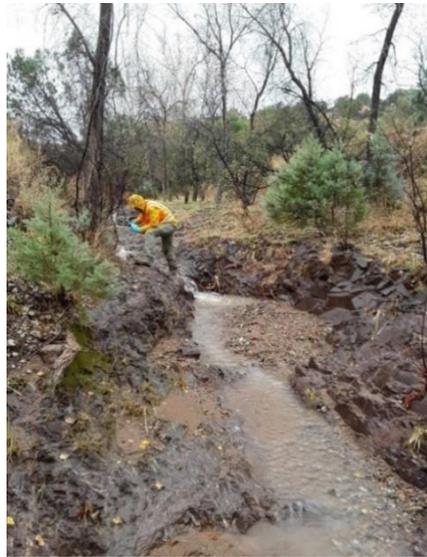
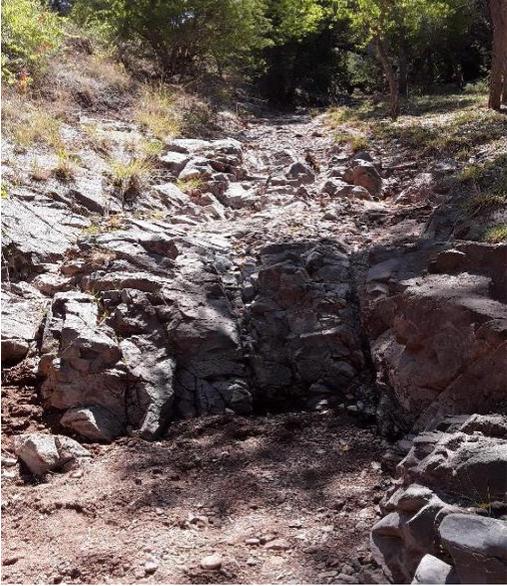
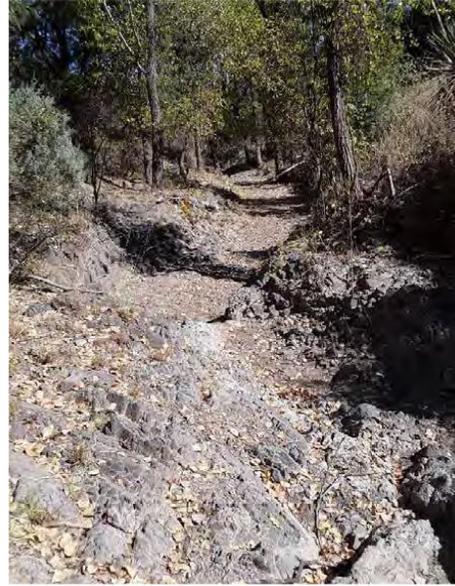
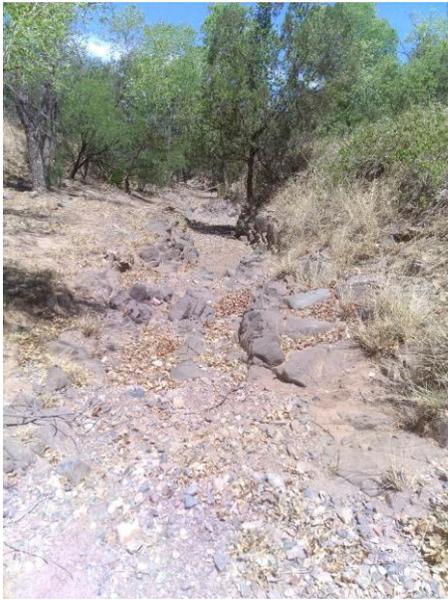
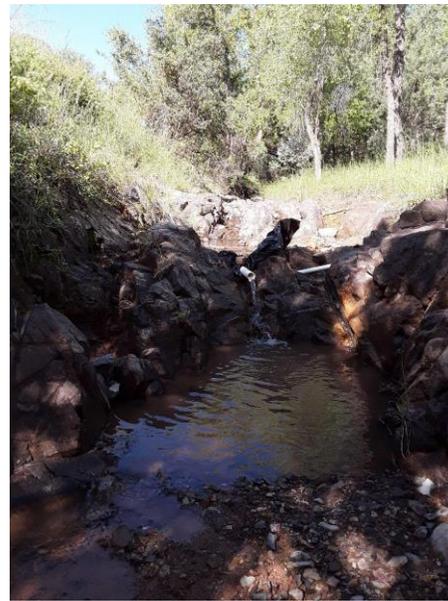
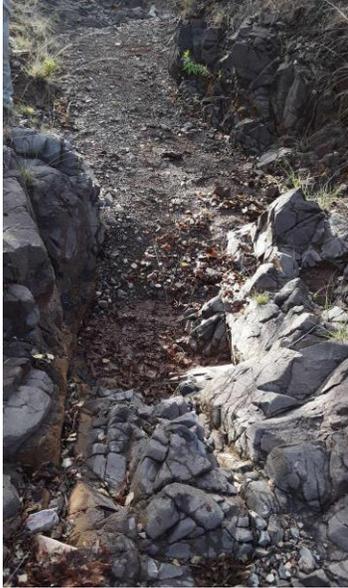
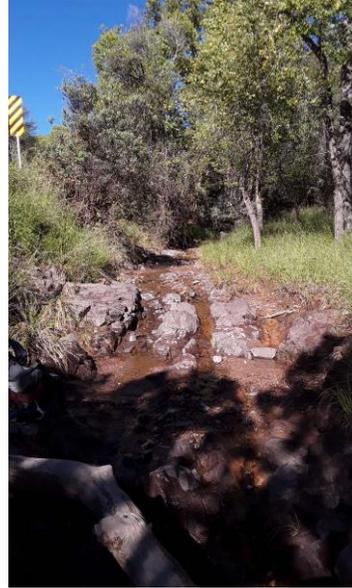
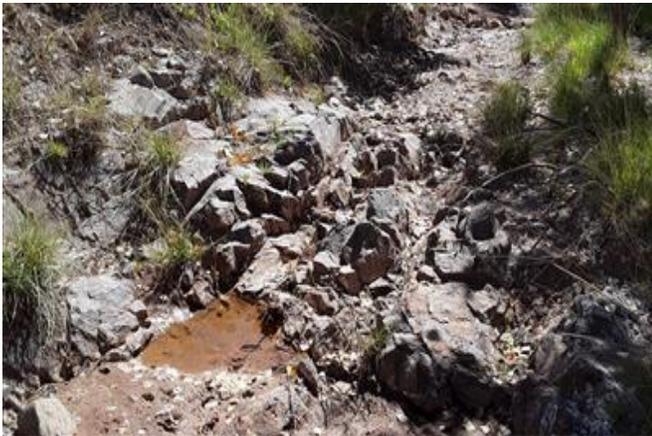
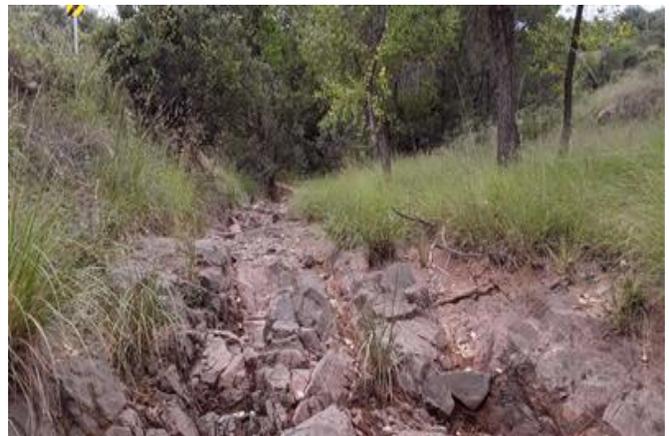
Aquatic and Vegetation Survey Findings: This site is located in a section of Harshaw Creek with gravely, sandy substrate and bedrock constrictions. When water is present, it is typically available in shallow pools. Limited herbaceous vegetation cover is dominated by deergrass (*Muhlenbergia rigens*) and other perennial grasses (*Poaceae* family). Riparian overstory tree cover is dominated by Fremont cottonwood (*Populus fremontii*) and Arizona sycamore (*Platanus wrightii*). Velvet mesquite (*Prosopis velutina*) and alligator juniper (*Juniperus deppeana*) are also present in the midstory. Non-native annual rabbitsfoot grass (*Polypogon monspeliensis*) has been observed. Aquatic invertebrates along this section of the drainage generally include boatmen, damselflies, beetles and water striders. No aquatic vertebrates have been observed.

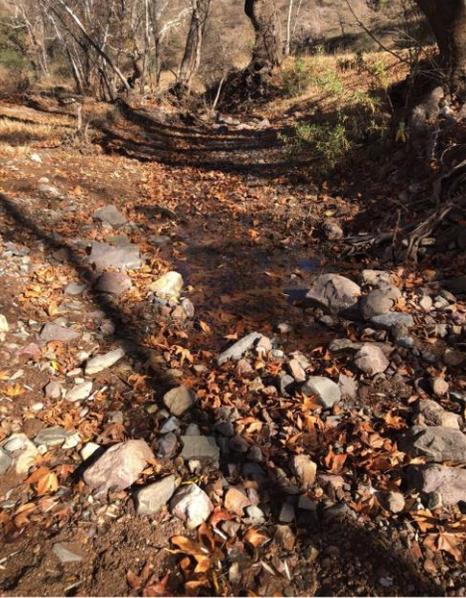
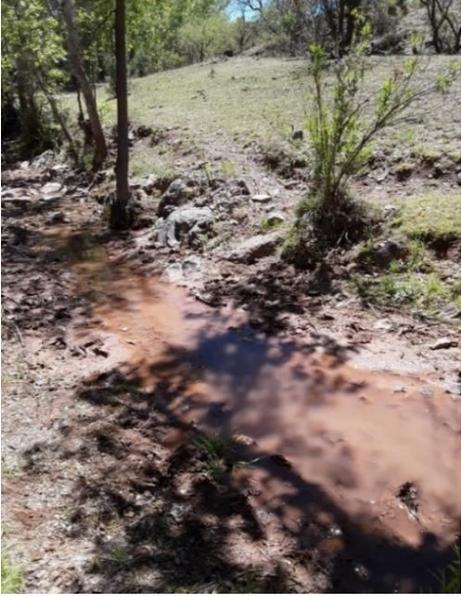
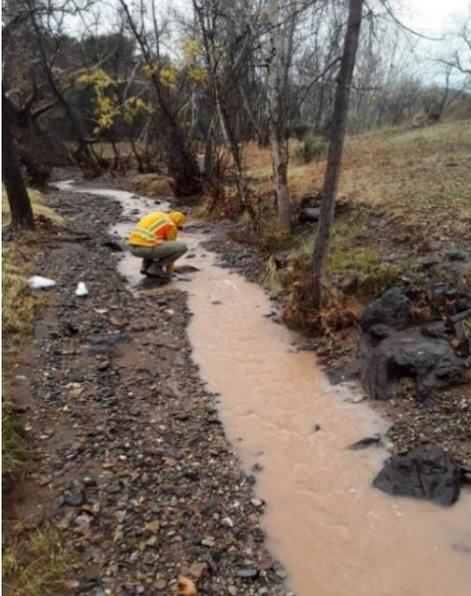
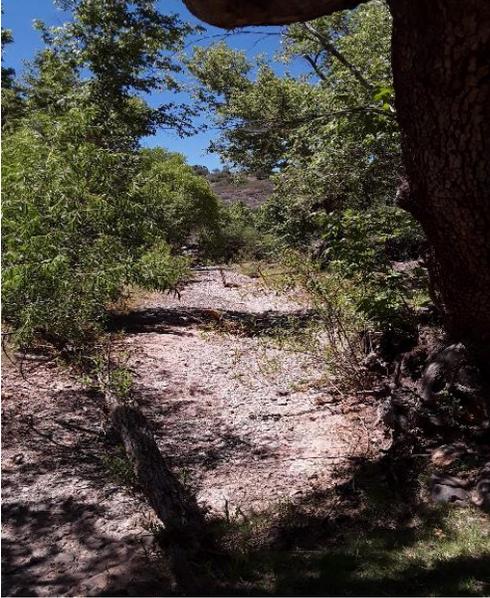
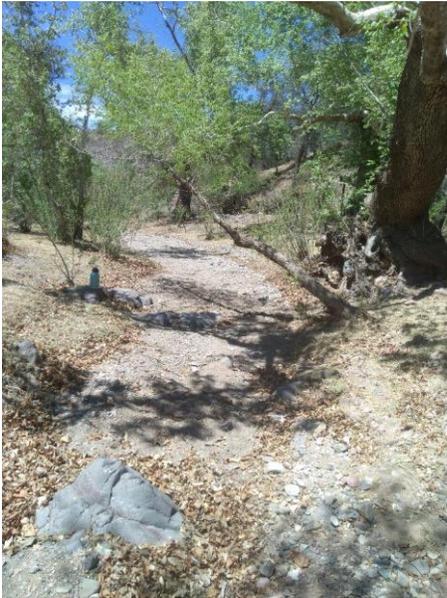
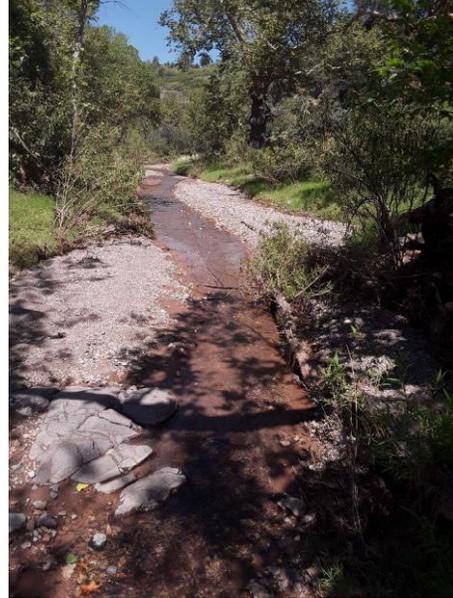
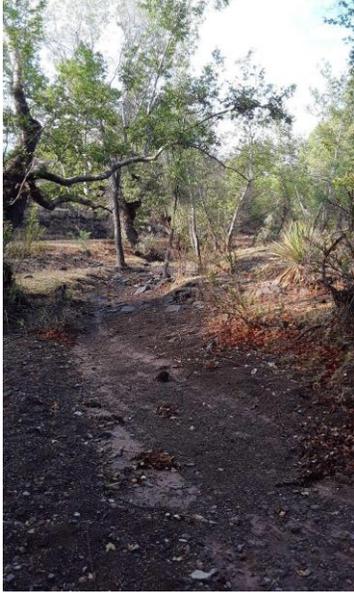
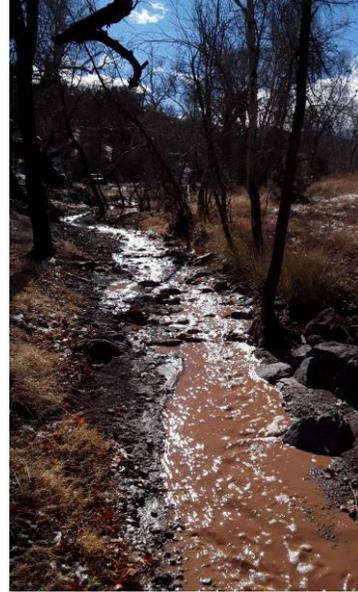
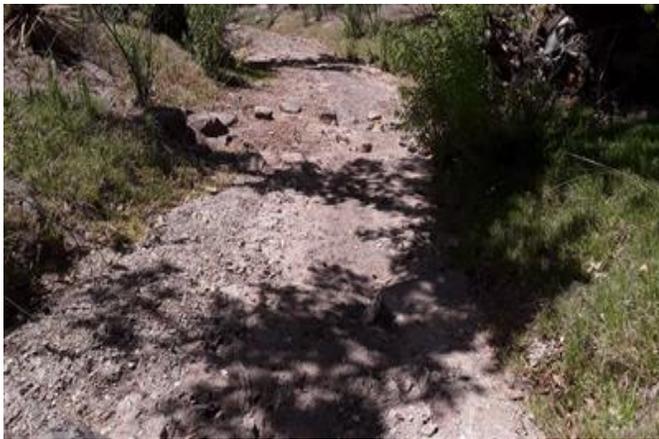
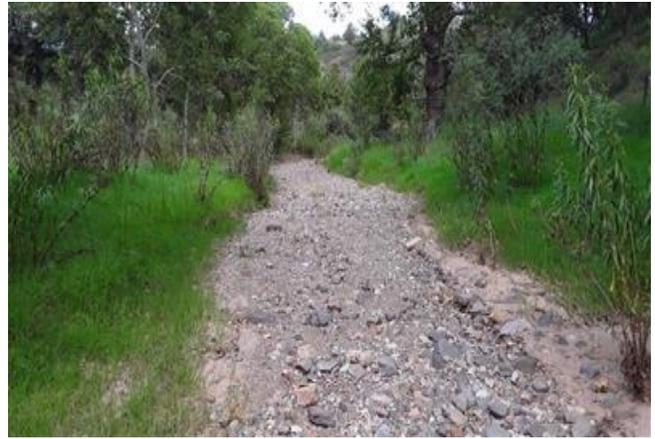
Aquatic and Vegetation Survey Findings: This site is located in a rocky, gravelly, and sandy section of Harshaw Creek with some bedrock constrictions. Riparian tree species including Fremont cottonwood (*Populus fremontii*) and Arizona sycamore (*Platanus wrightii*) dominate the overstory vegetation. Bonpland willow (*Salix bonplandiana*) is also present. Understory vegetation includes deergrass (*Muhlenbergia rigens*), Arizona grape (*Vitis arizonica*), and narrowleaf willow (*Salix exigua*). Non-native annual rabbitsfoot grass (*Polypogon monspeliensis*) and beardless rabbitsfoot grass (*Polypogon viridis*) have been observed along with invasive Bermudagrass (*Cynodon dactylon*). No aquatic invertebrates or vertebrates have been observed.

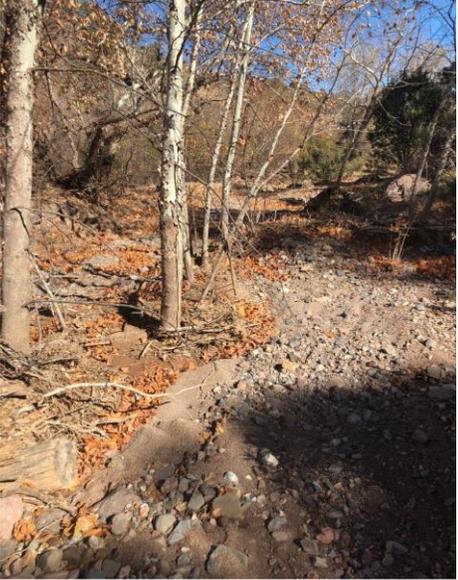
Dry Season Photo	Wet Season Photo (12/3/2018)
<p data-bbox="342 478 537 506">No photo taken.</p>

Aquatic and Vegetation Survey Findings: This site is located in a rocky, gravelly, and sandy section of Harshaw Creek. This site was dry during both pre-monsoon and monsoon visits in 2020. Arizona sycamore (*Platanus wrightii*), a preferential riparian tree species, dominates the overstory tree canopy with alligator juniper (*Juniperus deppeana*) also present. Understory vegetation is limited and includes Arizona grape (*Vitis arizonica*) and seepwillow (*Baccharis salicifolia*). Invasive plant species observed include Bermudagrass (*Cynodon dactylon*) and common mullein (*Verbascum thapsus*). No aquatic vertebrates have been observed.

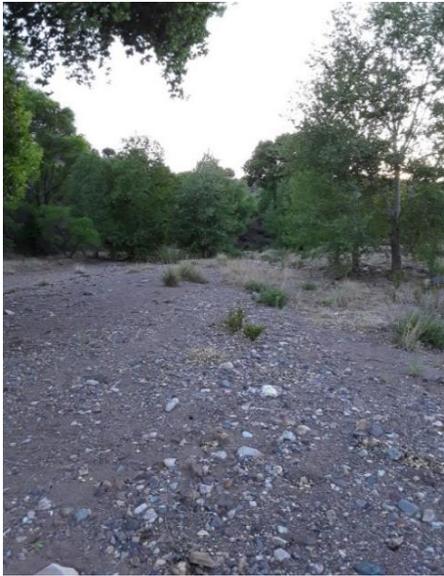
Dry Season Photo (5/23/2019)

Aquatic and Vegetation Survey Findings: This site is located in a wide, sandy and gravelly section of Harshaw Creek. The overstory tree canopy is dominated by riparian trees including Fremont cottonwood (*Populus fremontii*) and Goodding's willow (*Salix goodingii*). Seepwillow (*Baccharis salicifolia*) occurs sparingly at the channel edges. Seep monkeyflower (*Mimulus guttatus*), a wetland associated plant, was noted at this site. Non-native annual rabbitsfoot grass (*Polypogon monspeliensis*) and invasive plants, common mullein (*Verbascum thapsus*), Johnson grass (*Sorghum halepense*), and Lehmann lovegrass (*Eragrostis lehmanniana*), have been observed.

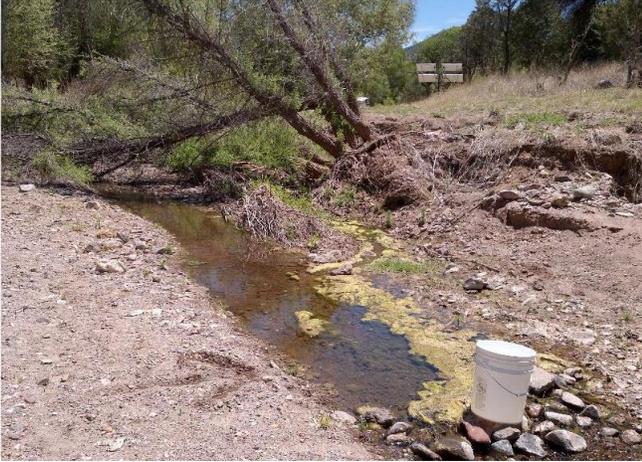
Dry Season Photo (5/16/2018)

Water is present during pre-monsoon and monsoon surveys. Longfin dace (*Agosia chrysogaster*), canyon tree frog (*Hyla arenicolor*) tadpoles, and black-necked gartersnakes (*Thamnophis cyrtopsis*) have been observed along this wetted stretch of Harshaw. Aquatic beetles, boatmen, backswimmers, dragonflies, damselflies, mayflies, water scorpions, belostomatids, and snails have been observed. Invasive plants noted include Johnsongrass (*Sorghum halepense*), common mullein (*Verbascum thapsus*), Bermudagrass (*Cynodon dactylon*), gummy lovegrass (*Eragrostis curtipeccellata*), Lehmann lovegrass (*Eragrostis lehmanniana*), cockspur grass (*Echinochloa* spp.), yellow bluestem (*Bothriochloa ischaemum*), Sahara mustard (*Brassica tournefortii*), and saltcedar (*Tamarisk* spp.).

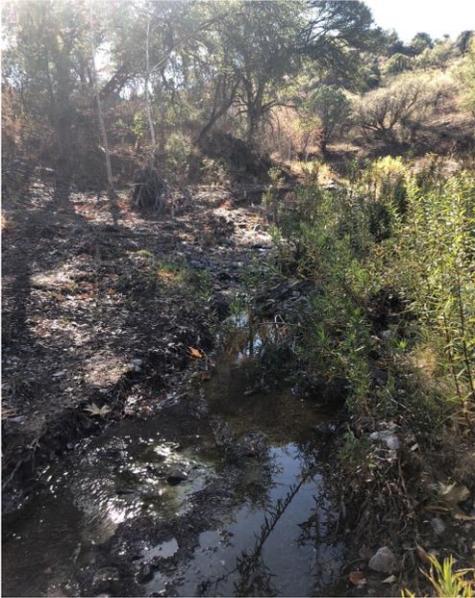
Dry Season Photo (5/16/2018)	Wet Season Photo (12/3/2018)
<p data-bbox="370 478 565 506">No Photo Taken</p>

Aquatic and Vegetation Survey Findings: This site is located in a wetted section of Harshaw Creek with gravelly and sandy substrate. Water is available in shallow riffles and runs. Goodding's willow (*Salix gooddingii*) and Fremont cottonwood (*Populus fremontii*) are the dominant riparian overstory tree species while seepwillow (*Baccharis salicifolia*) and riparian obligate spikerush (*Eleocharis* sp.) are dominant emergent vegetation. Wetland associated plants, cattail (*Typha* sp.) and monkeyflower (*Mimulus* sp.), have been observed. Non-native annual rabbitsfoot grass (*Polypogon monspeliensis*) and invasive plants, Johnsongrass (*Sorghum halepense*), Bermudagrass (*Cynodon dactylon*), Lehmann lovegrass (*Eragrostis lehmanniana*), and saltcedar (*Tamarix ramossisima*), have been noted. Canyon treefrog (*Hyla arenicolor*), black-necked gartersnake (*Thamnophis cyrtopsis*), and longfin dace (*Agosia chrysogaster*) have been observed in this portion of Harshaw Creek. Aquatic beetles, boatmen, backswimmers, dragonflies, damselflies, mayflies, water scorpions, belostomatids, water striders, and snails have been observed.

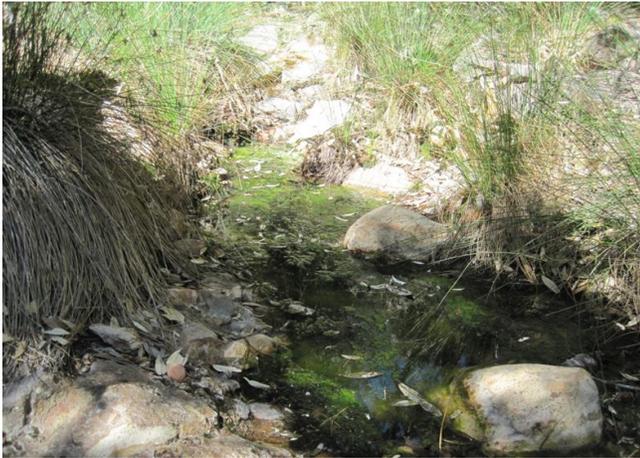
Dry Season Photo (5/23/2018)

Aquatic and Vegetation Survey Findings: This feature is located at a well-head in Humboldt Canyon where seepage results in a shallow surface water in the road and discharges to adjacent drainage. Riparian obligate Baltic rush (*Juncus balticus*), submerged algae, and moss are the predominate vegetation cover at the site. Silverleaf oak (*Quercus hypoleucoides*) and Chihuahua pine (*Pinus leiophylla*) provide overstory cover. Non-native annual rabbitsfoot grass (*Polypogon monspeliensis*) has been noted. Aquatic beetles and dragonfly larvae have been observed. No aquatic vertebrates have been observed.

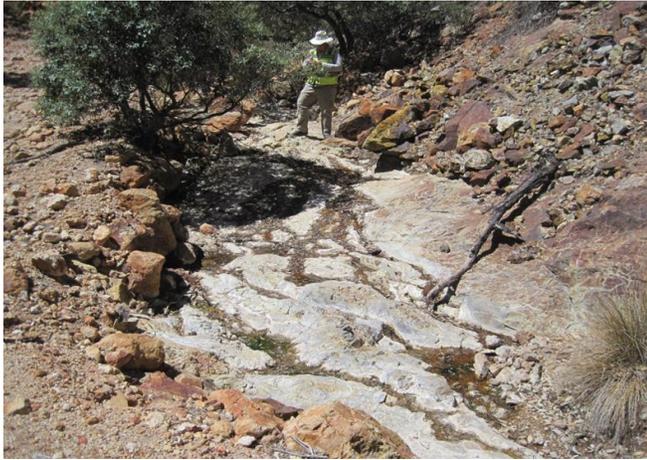
Dry Season Photo (5/23/2018)

Aquatic and Vegetation Survey Findings: This shallow seep is located in a section of exposed bedrock in Humboldt Canyon. Riparian obligate Baltic rush (*Juncus balticus*), algae, and moss are the predominate vegetation cover at the site. Silverleaf oak (*Quercus hypoleucoides*) provides overstory cover at the site. Aquatic invertebrates observed include boatmen and beetles. No aquatic vertebrates have been observed.

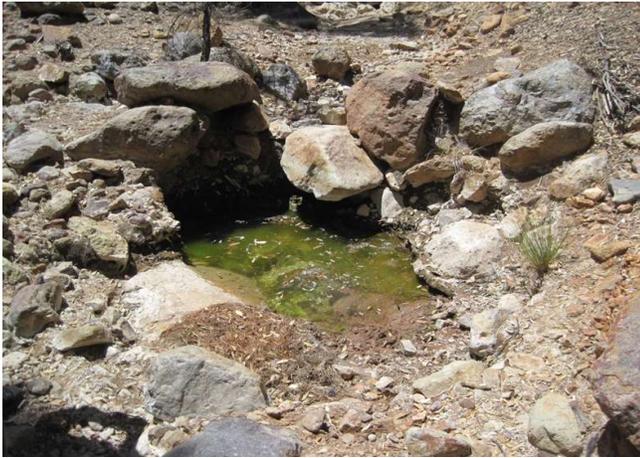
Dry Season Photo (5/23/2018)

Aquatic and Vegetation Survey Findings: This site is located within a rocky and bouldery section of Humboldt Canyon. Water is typically present in shallow runs with small pools in the drainage. Riparian obligate Baltic rush (*Juncus balticus*), algae, and moss are the predominate herbaceous cover at the site. Silverleaf oak (*Quercus hypoleucoides*) and Chihuahuah pine (*Pinus leiophylla*) provide overstory cover. Aquatic beetles and backswimmers have been observed along this drainage. No aquatic vertebrates were observed.

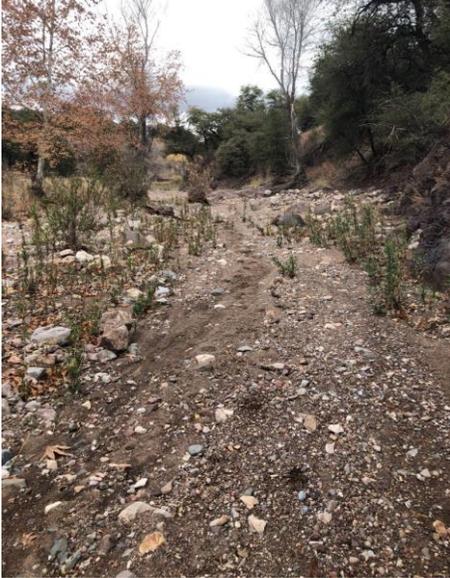
<p style="text-align: center;">Dry Season Photo</p> <p style="text-align: center;">No photo taken.</p>	<p style="text-align: center;">Wet Season Photo (12/2/2018)</p>

Aquatic and Vegetation Survey Findings: This site is located within a silty/sandy section of the East Fork of Harshaw Creek. Understory vegetation at the site is dominated by seep willow (*Baccharis salicifolia*), sideoats grama (*Bouteloua curtipendula*), and deergrass (*Muhlenbergia rigens*). Overstory vegetation is dominated by Fremont cottonwood (*Populus fremontii*), a preferential riparian species, with velvet mesquite (*Prosopis velutina*), desert willow (*Chilopsis linearis*), and Bonpland willow (*Salix bonplandiana*) also present. Invasive weeping lovegrass (*Eragrostis curvula*) has been observed. Aquatic beetles have been observed. No aquatic invertebrates or vertebrates have been observed.

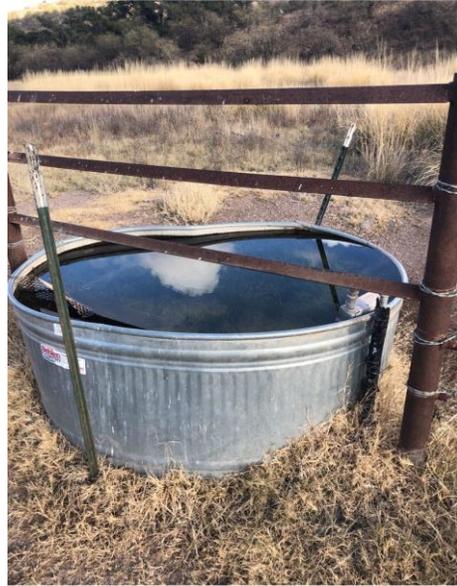
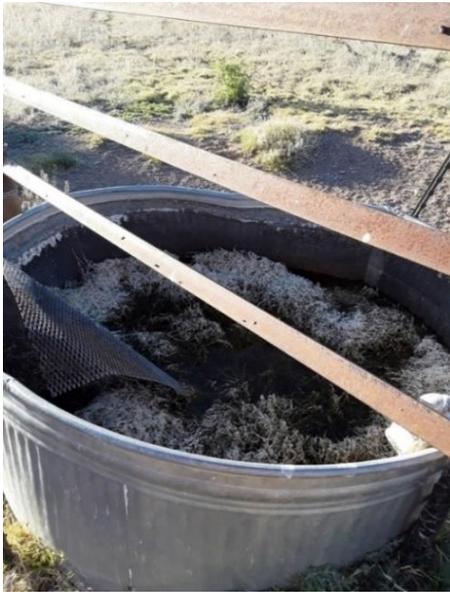
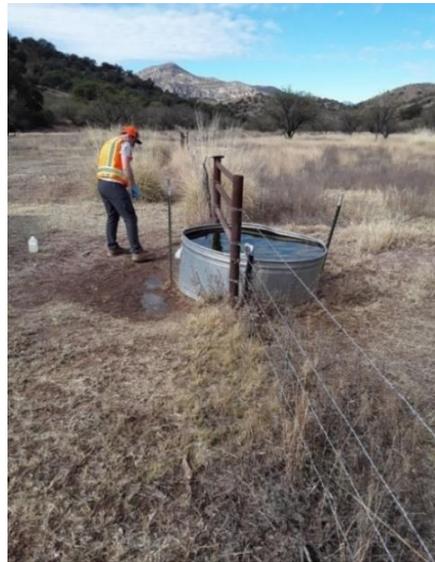
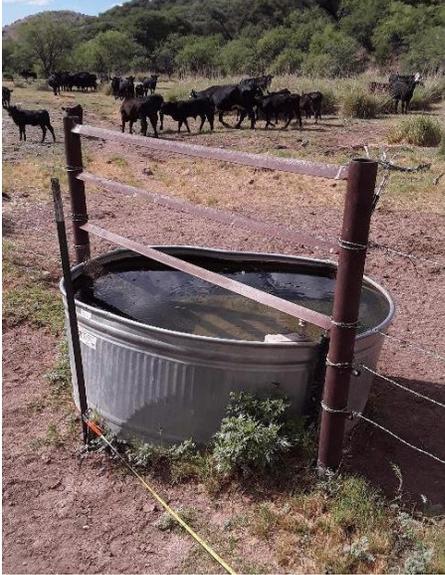
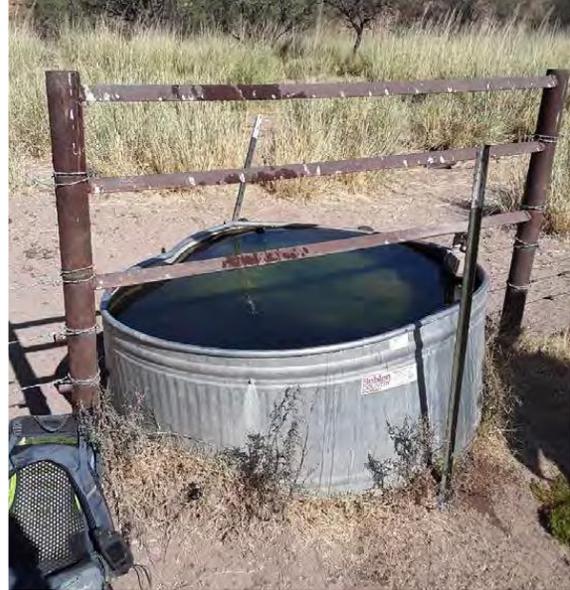
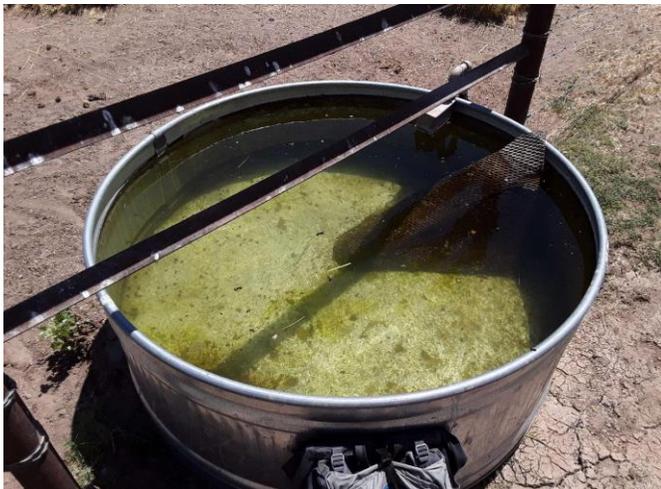
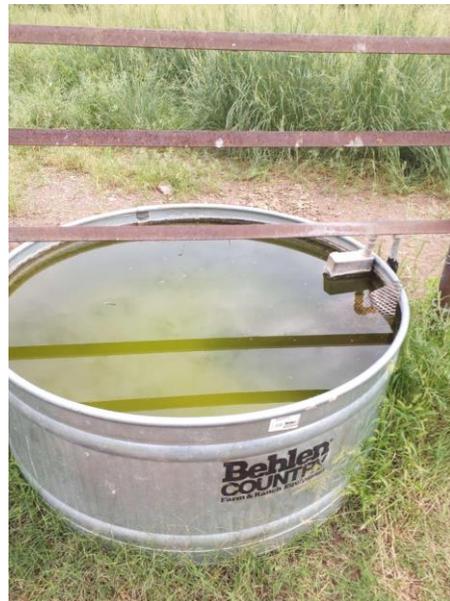
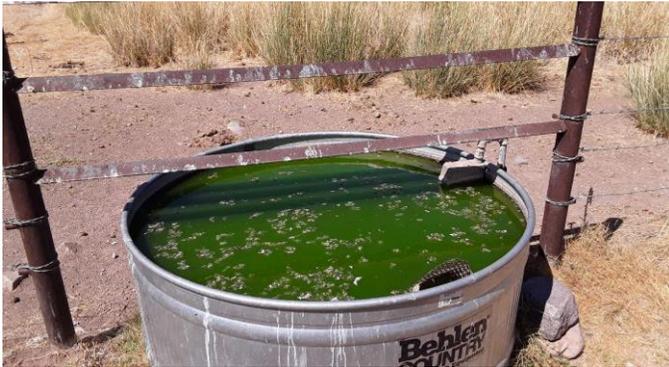
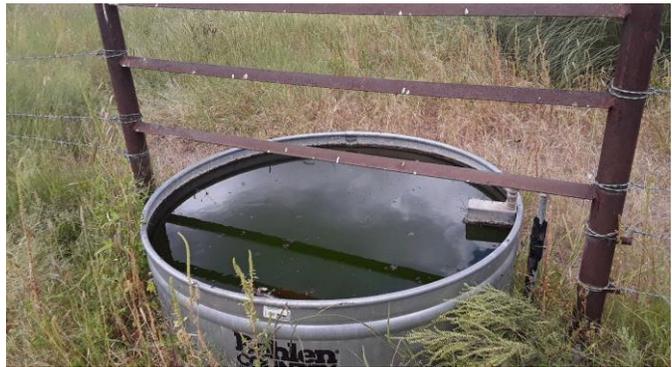
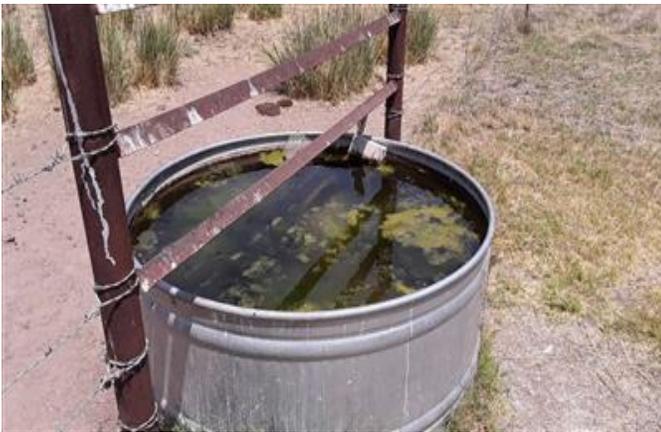
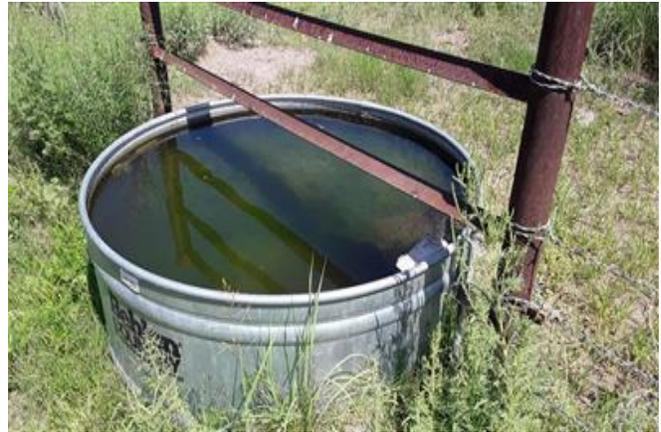
Aquatic and Vegetation Survey Findings: This site is a metal stock drinker associated with an adjacent solar well and closed cistern, located within the East Fork of Harshaw Creek. Invasive Bermudagrass (*Cynodon dactylon*) dominates the site with alkali sacaton (*Sporobolus airoides*) and invasive stinkgrass (*Eragrostis cilianensis*) also present. No overstory canopy cover occurs at the site. Aquatic invertebrates observed in this drinker include backswimmers, boatmen, beetles, and dragonflies. No aquatic vertebrates have been observed. Cattle and grazing are present on adjacent land.

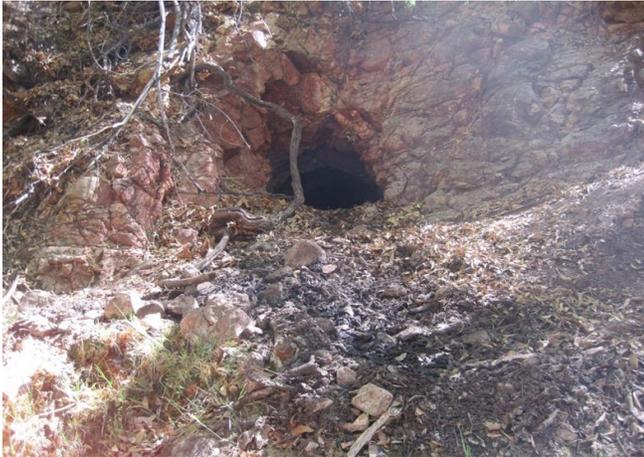
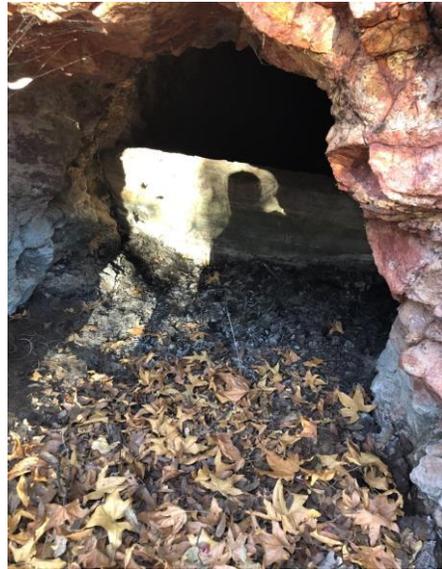
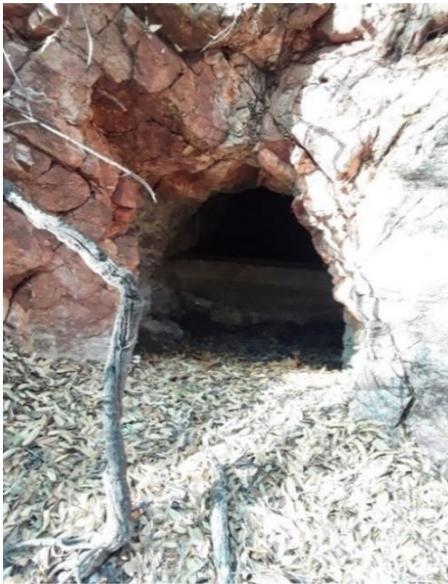
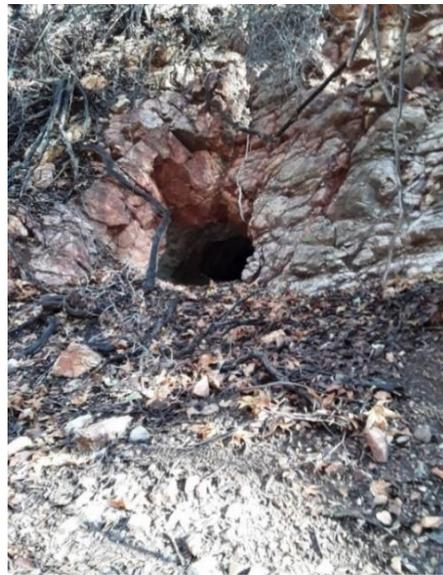
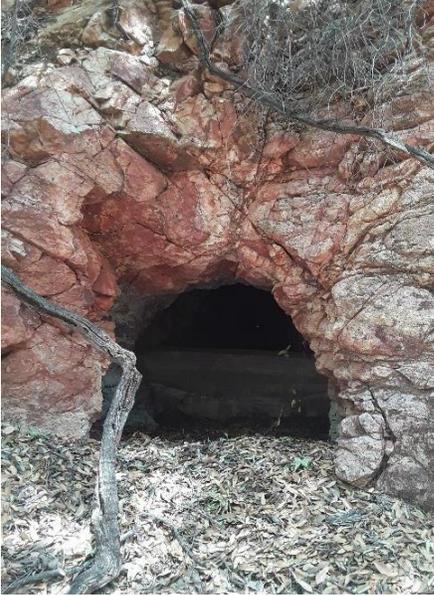
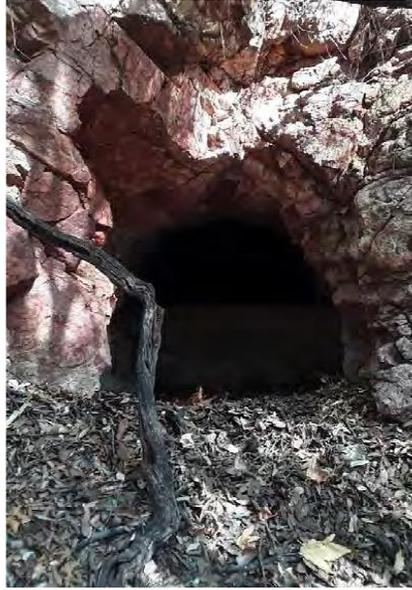
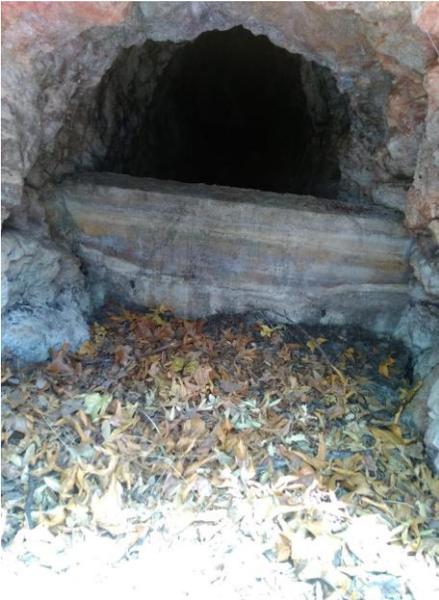
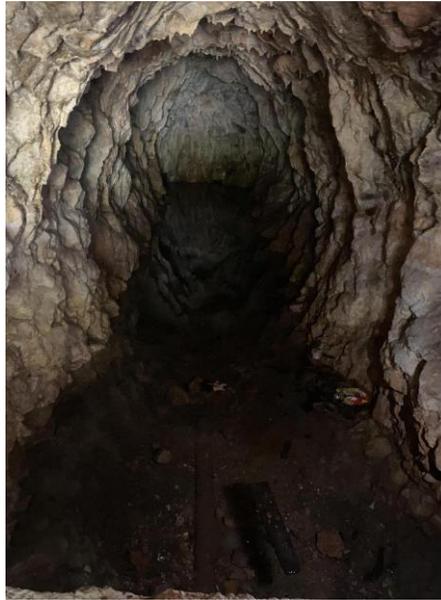
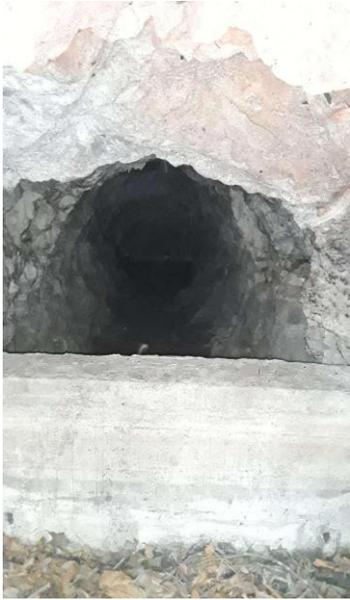
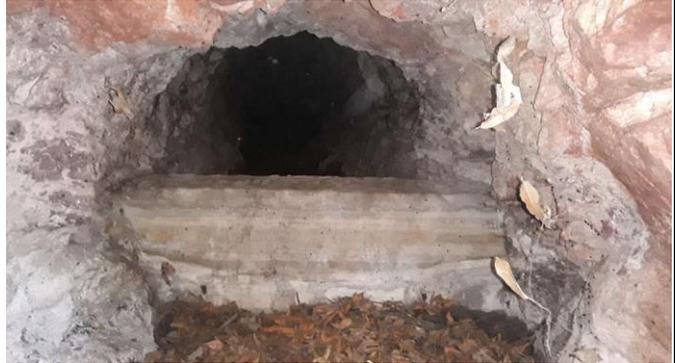
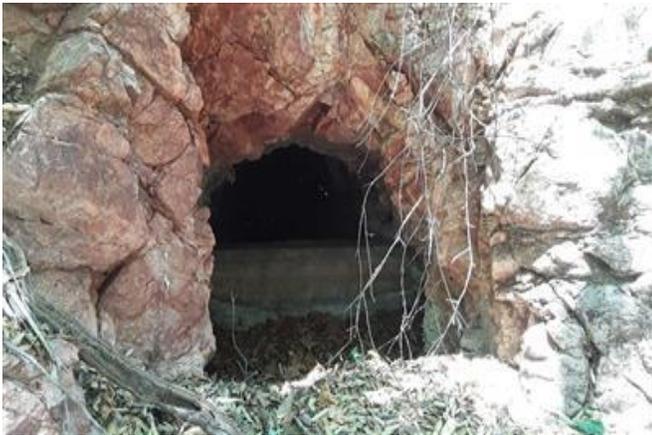
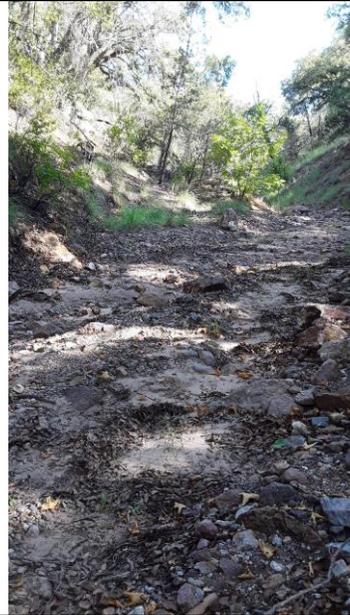
Aquatic and Vegetation Survey Findings: This site is located at an adit along the eastern wall of Hermosa Canyon with a built-in spring box. This site was dry during site visits in 2019 and 2020. The moss mat at the adit entrance is desiccated. Bullgrass (*Muhlenbergia emersleyi*), canyon grape (*Vitis arizonica*), and California buckthorn (*Frangula californica*) dominate the limited herbaceous cover within the drainage bottom. Overstory tree cover is dominated by Arizona sycamore (*Platanus wrightii*), a preferential riparian tree species, and netleaf hackberry (*Celtis reticulata*). No aquatic invertebrates, or vertebrates have been observed in recent years.

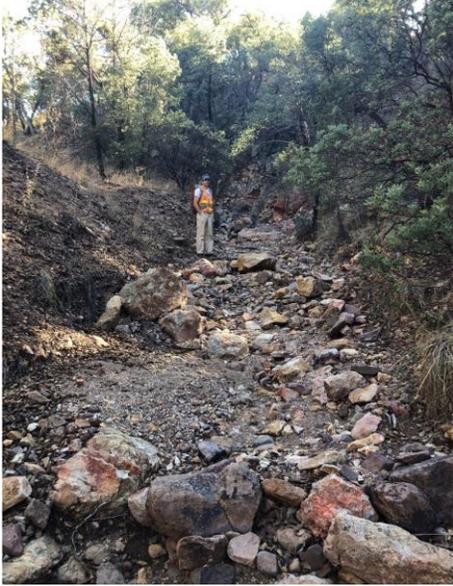
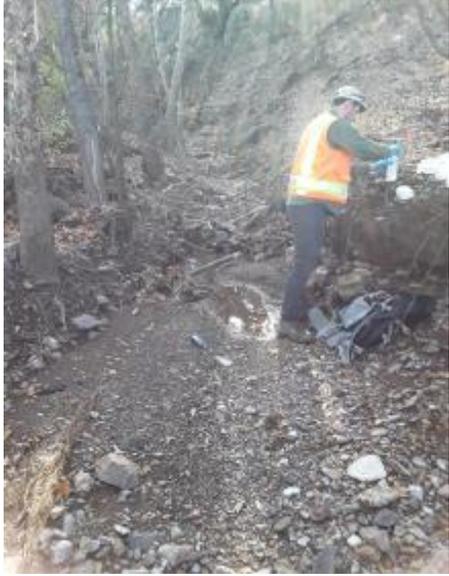
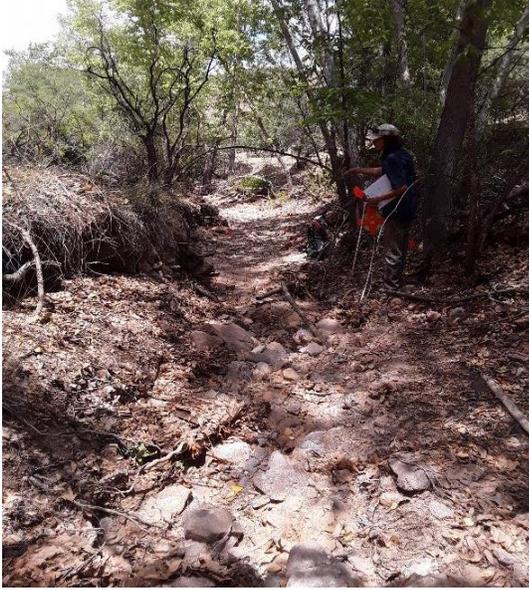
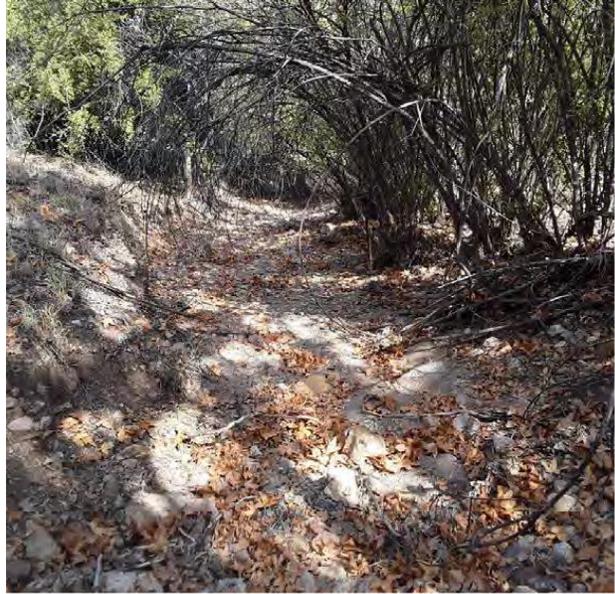
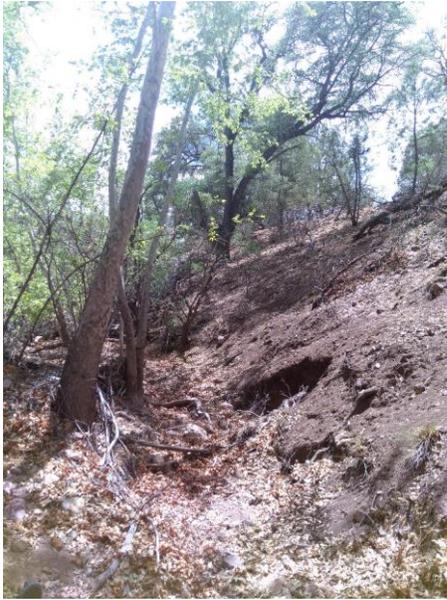
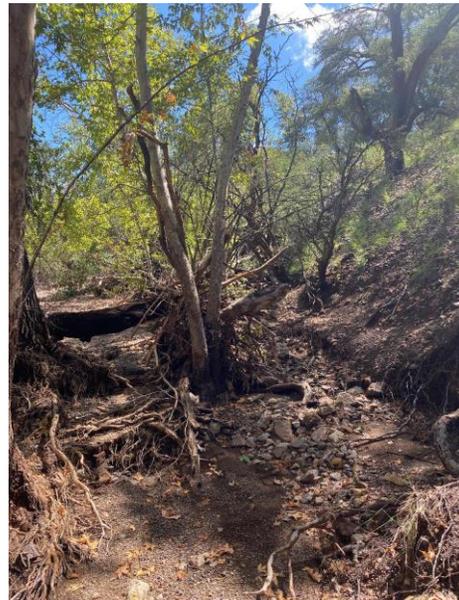
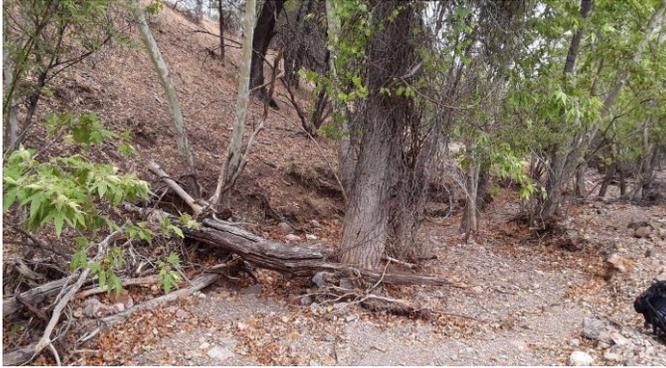
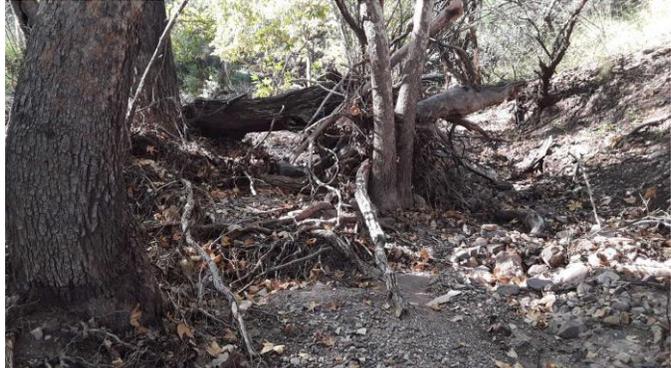
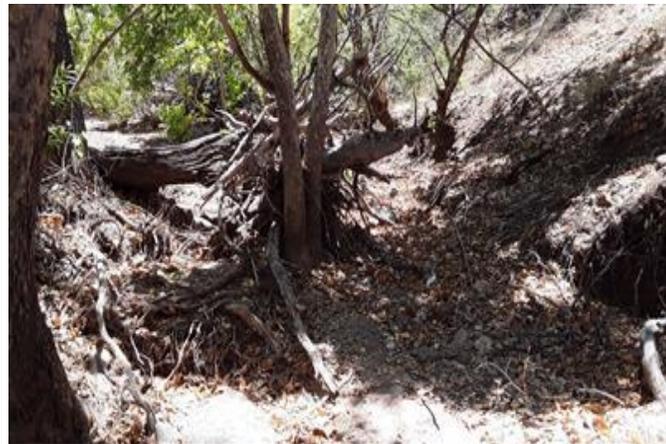
Aquatic and Vegetation Survey Findings: This site is located within a silty and cobbly portion of Hermosa Canyon. The site contains little herbaceous cover, limited to perennial grasses (*Poaceae* family). Overstory vegetation is dominated by riparian trees including Arizona sycamore (*Platanus wrightii*), Fremont cottonwood (*Populus fremontii*), and coyote willow (*Salix exigua*). Invasive tree-of-heaven (*Ailanthus altissima*) has been observed. No aquatic invertebrates or vertebrates have been observed at this site.
