Hermosa Spring and Seep Catalog

Hermosa Project Area

SPRING AND SEEP CATALOG Hermosa Project Area

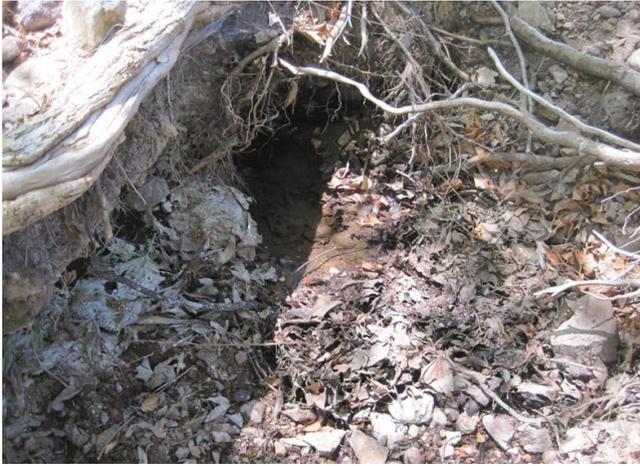
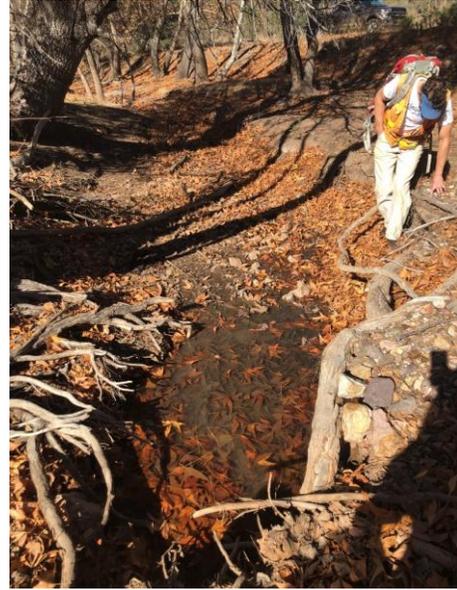
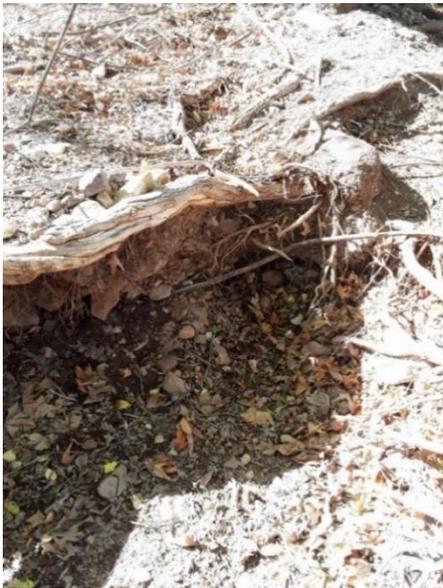
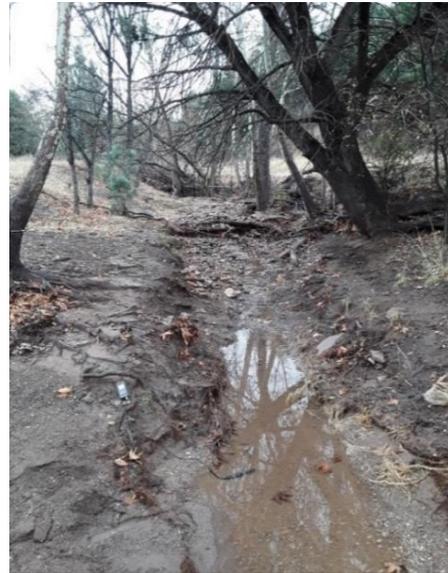
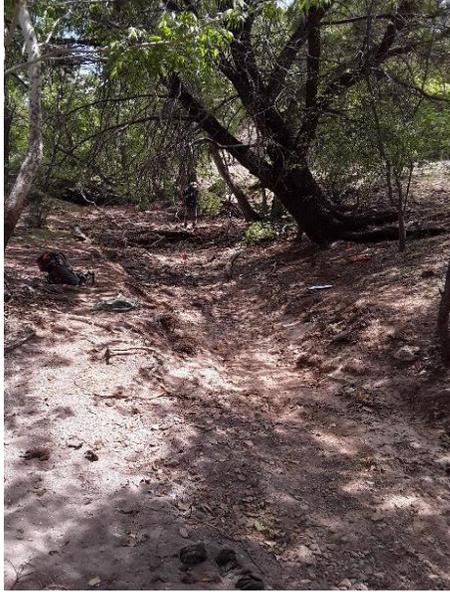
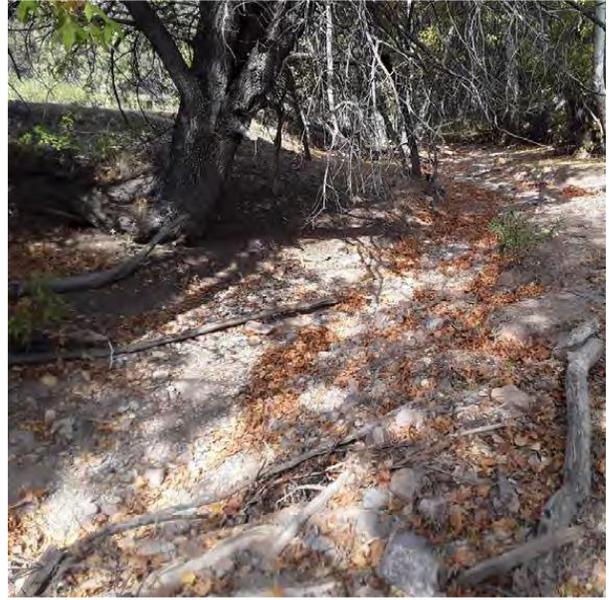
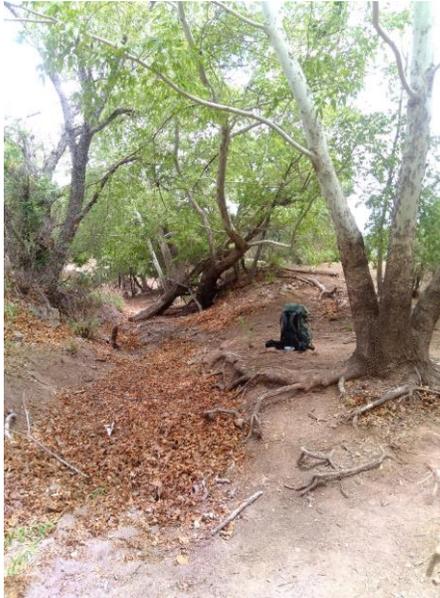
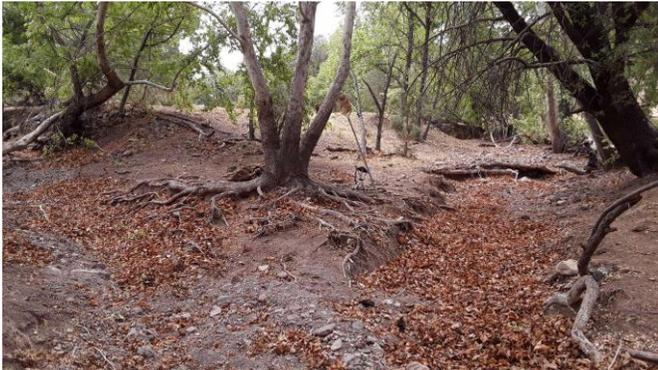
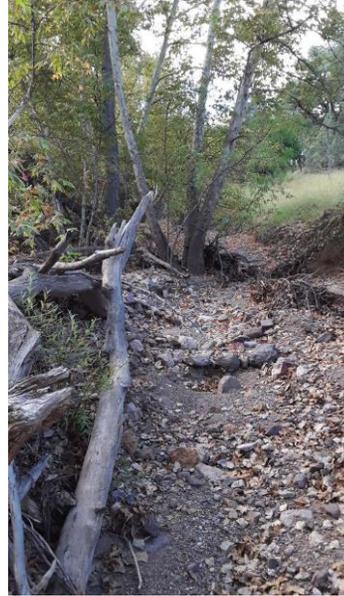
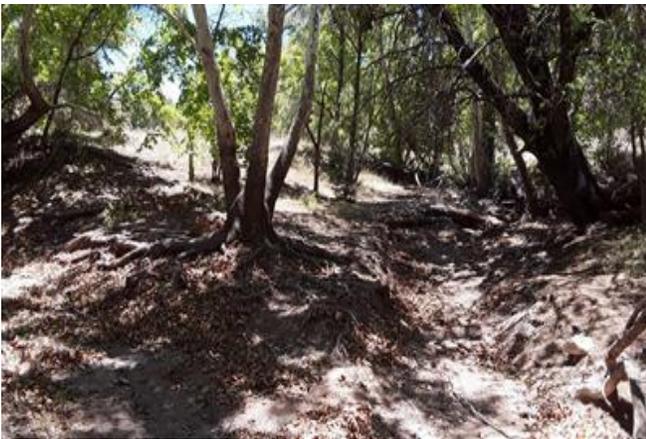
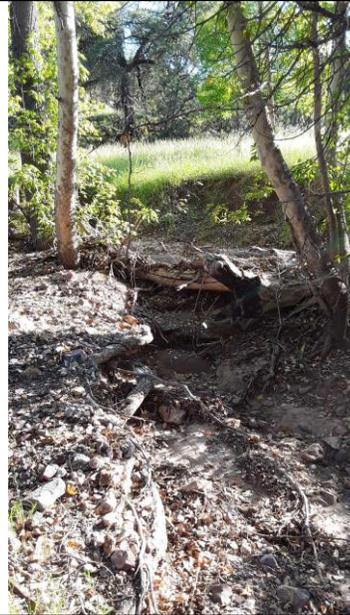
Site ID	HM8-02	Interpretation of Groundwater Age: Little to no evaporative, premodern water during the dry season; little to no evaporative, mixed water during the wet season.
Watershed	Hermosa Canyon	
Monitoring Period	01/2017 - 11/2023	Potential Impacts/Effects: Flows observed at this site have ranged from 0 to 15 gpm.
Number of Visits	21

Aquatic and Vegetation Survey Findings: Site located at downstream end of Hermosa Canyon. Overstory riparian tree cover includes Arizona sycamore (*Platanus wrightii*), Arizona walnut (*Juglans major*), Arizona ash (*Fraxinus velutina*), and coyote willow (*Salix exigua*). Nettleleaf hackberry (*Celtis reticulata*) and alligator juniper (*Juniperus deppeana*) are also present overstory tree species. Bermudagrass (*Cynodon dactylon*) occurs.

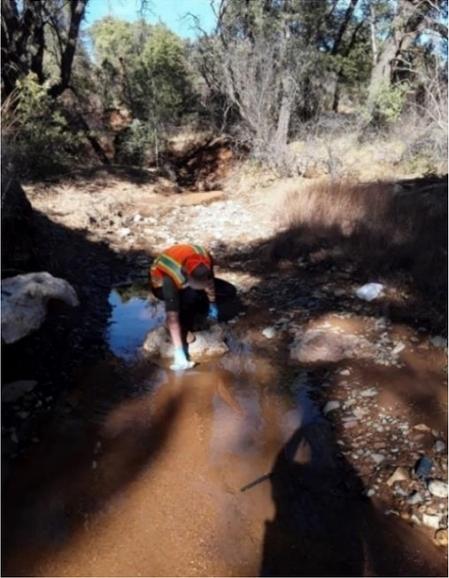
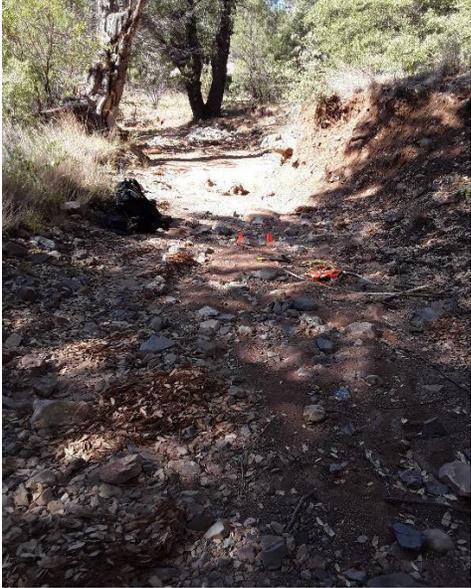
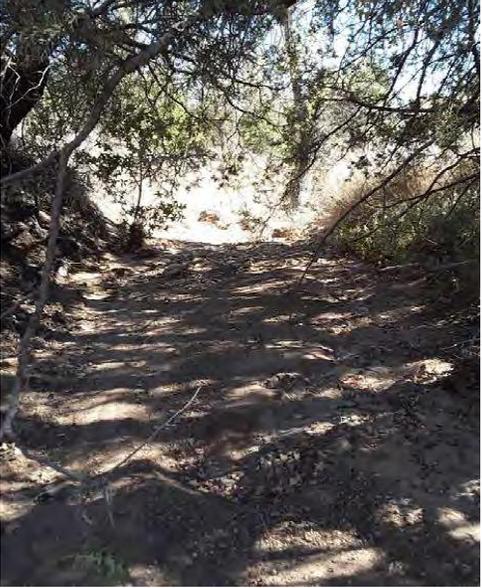
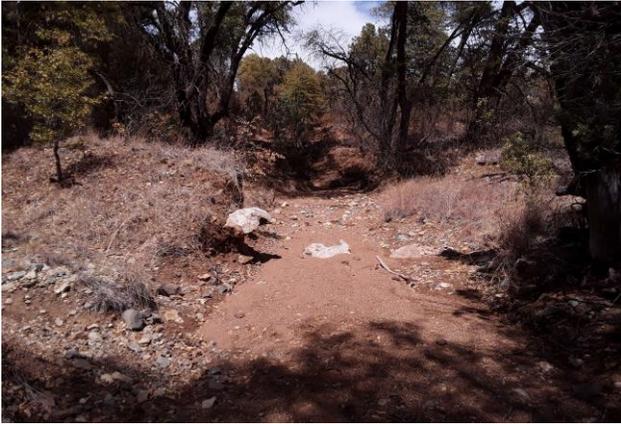
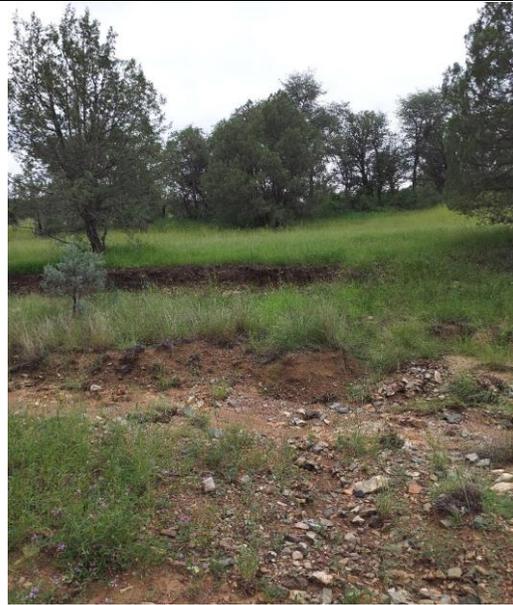
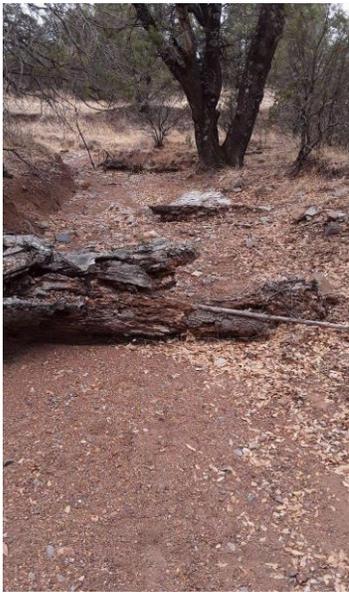
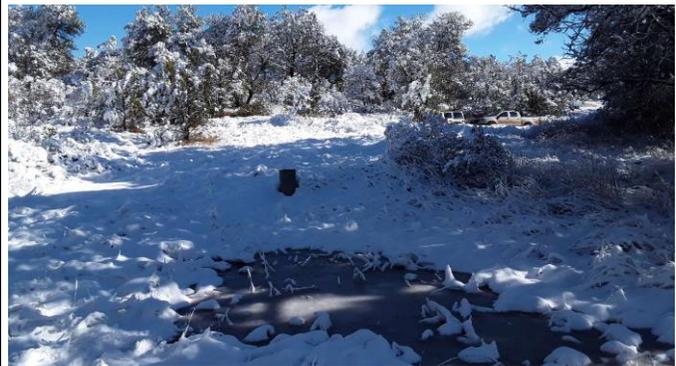
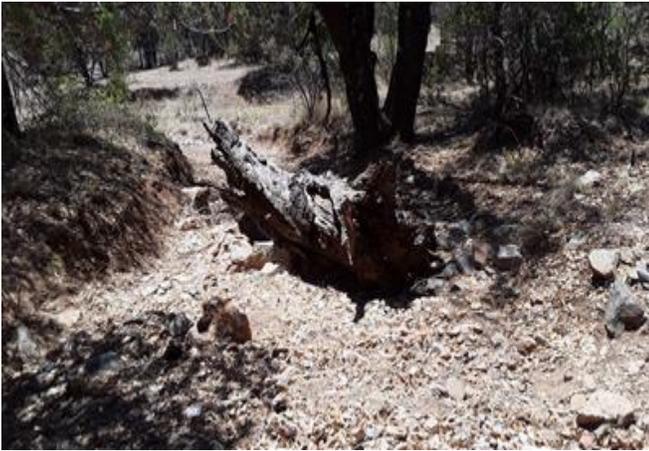
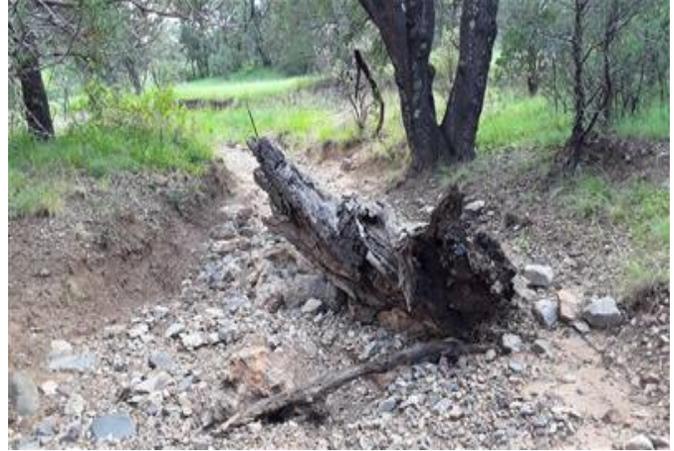
Site ID	MW1-01	Interpretation of Groundwater Age: Little to no evaporative, modern water during the wet season.
Watershed	Mowry Wash	
Monitoring Period	12/2019 - 11/2023	Potential Impacts/Effects: This site has been dry during most site visits except for 1 visit where flow was recorded at 4.75 gpm, suggesting the site may not be in connection with a perennial groundwater source. No changes are predicted at this site.
Number of Visits	16

Aquatic and Vegetation Survey Findings: This site is located within a cobbly and silty section of north Mowry Wash. The site contains little herbaceous cover with dominate species being Texas bluestem (*Schizachyrium cirratum*), ticktrefoil (*Desmodium* sp.), and lovegrass (*Eragrostis* sp.). Overstory vegetation is dominated by Emory oak (*Quercus emoryi*). Aquatic beetles have been observed. No aquatic invertebrates or vertebrates have been observed at this site.

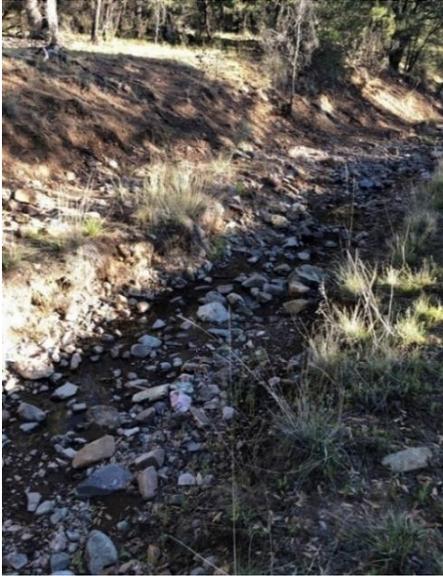
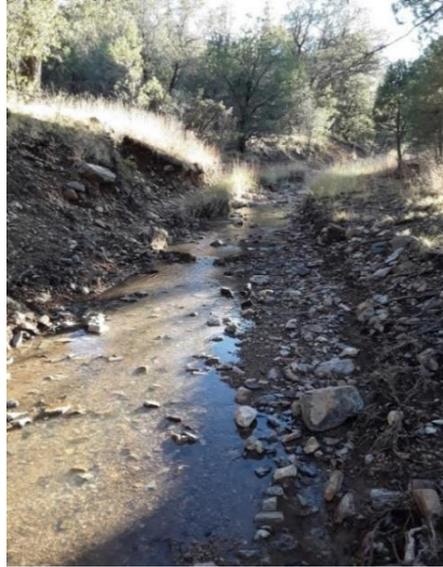
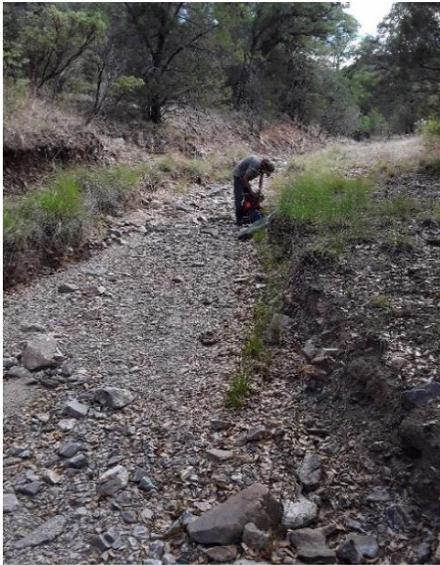
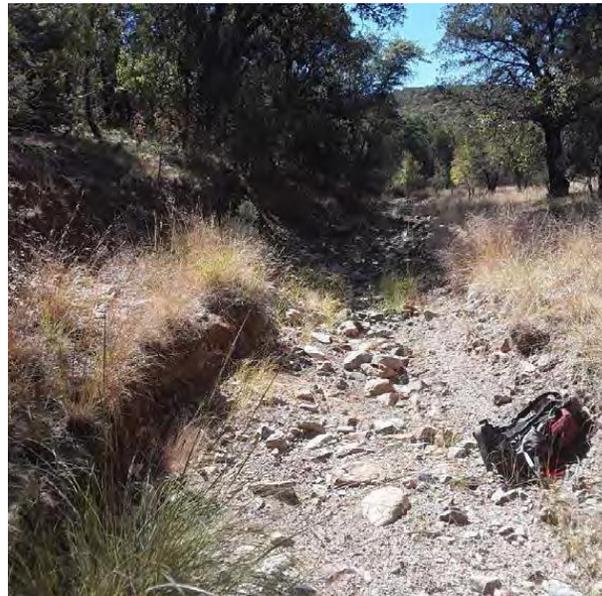
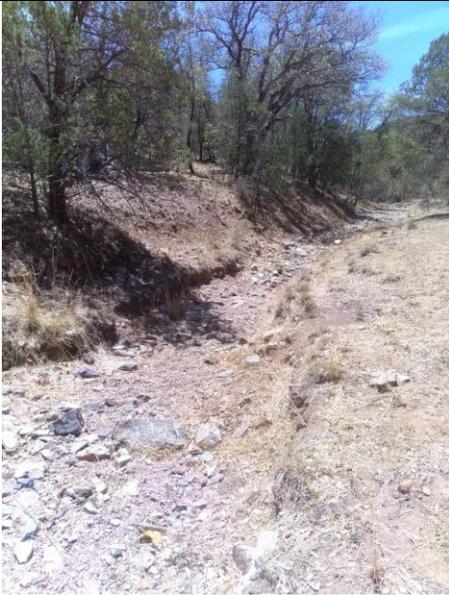
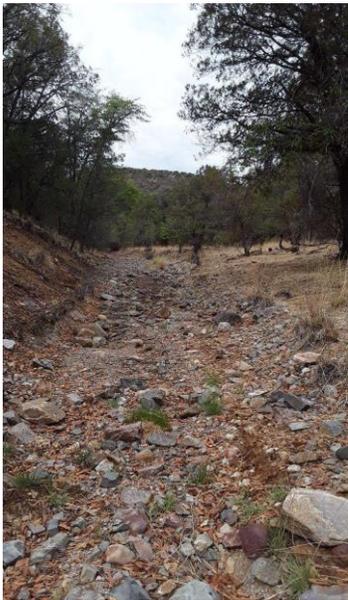
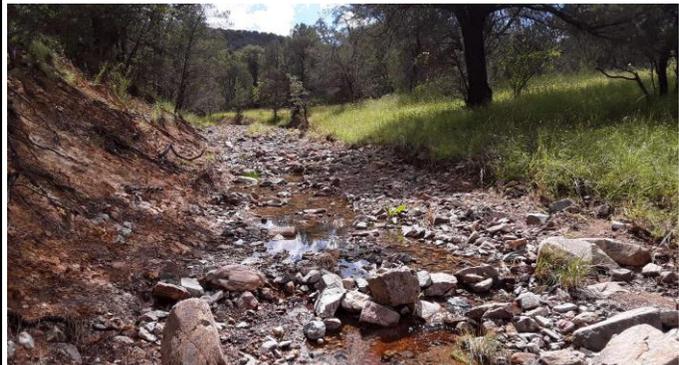
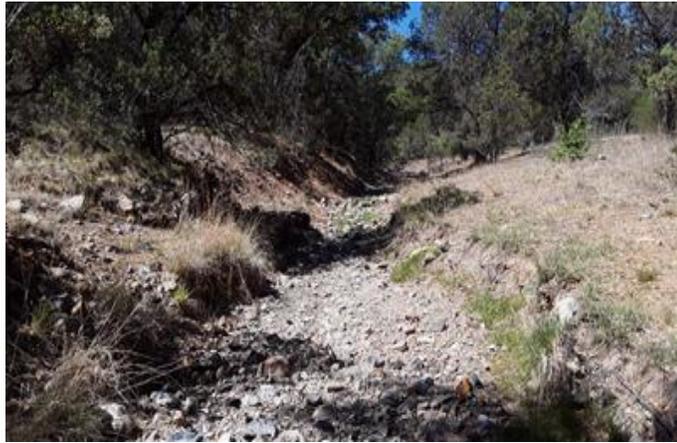
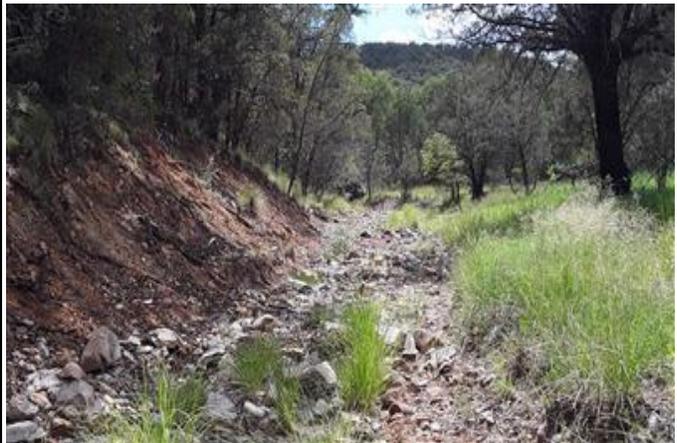
Site ID	MWS1-01	Interpretation of Groundwater Age: Little to no evaporative, modern water during the dry season; little to no evaporative, mixed water during the wet season.
Watershed	Mowry Wash South	
Monitoring Period	5/2019 - 11/2023	Potential Impacts/Effects: Flows observed at this site have ranged from 0 to 84 gpm.
Number of Visits	17

Aquatic and Vegetation Survey Findings: This site is located within rocky/gravelly section of south Mowry Wash. Deergrass (*Muhlenbergia rigens*) is the dominate perimeter vegetation at this site with pinyon ricegrass (*piptochaetium fimbriatum*), and riparian obligates, spikerush (*Eleocharis* sp.), rushes (*Juncus* spp.), and seep monkeyflower (*Mimulus guttatus*), are also present. Other understory shrub vegetation noted include skunkbush (*Rhus trilobata*) and Wright's silktassel (*Garrya wrightii*). Overstory vegetation is dominated by alligator juniper (*Juniperus deppeana*), Emory oak (*Quercus emoryi*), and Mexican pinyon (*Pinus cembroides*). Non-native annual rabbitsfoot grass (*Polypogon monspeliensis*) and invasive weeping lovegrass (*Eragrostis curvula*), Lehmann lovegrass (*Eragrostis lehmanniana*), and natalgrass (*Melinis repens*) have been observed. Aquatic invertebrates observed along this drainage include beetles, water striders, and backswimmers. No aquatic vertebrates have been observed at this site.

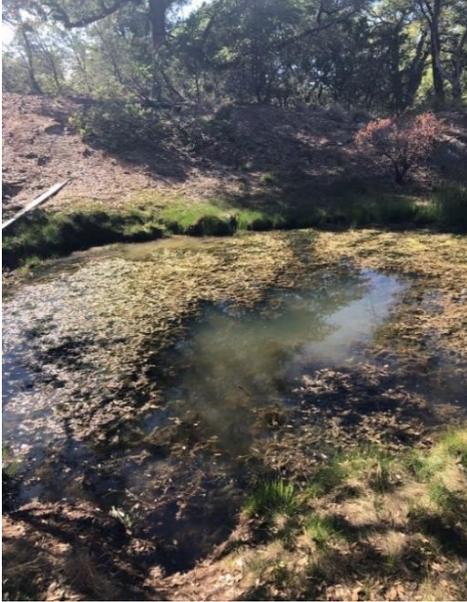
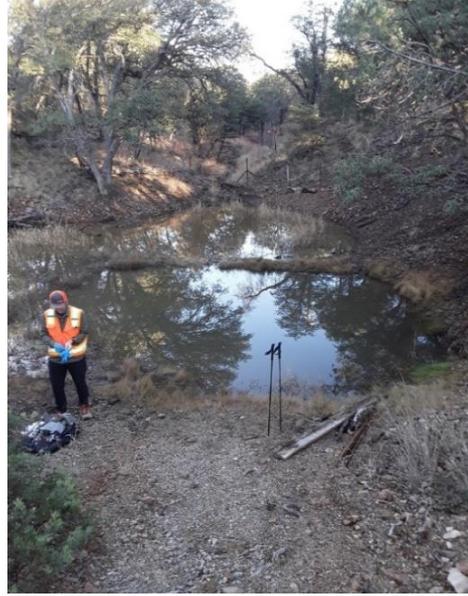
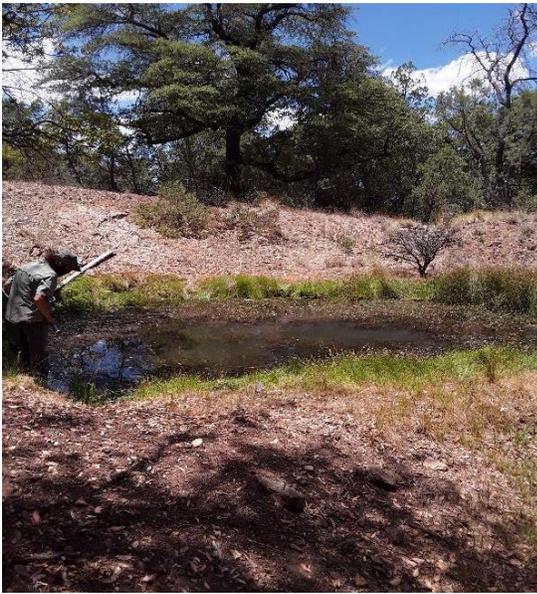
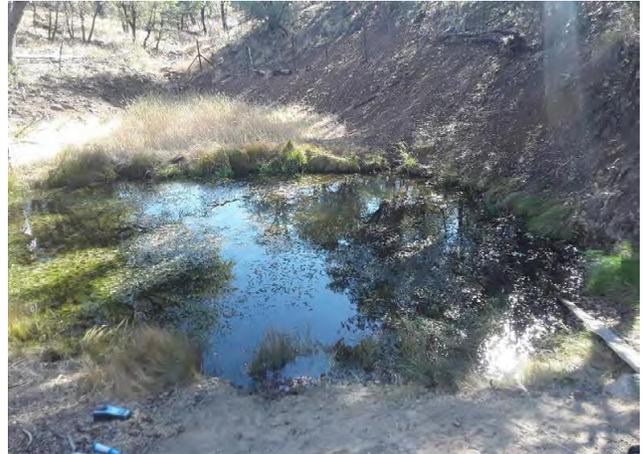
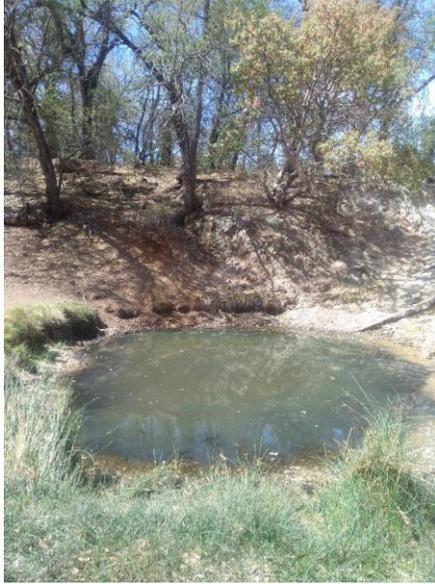
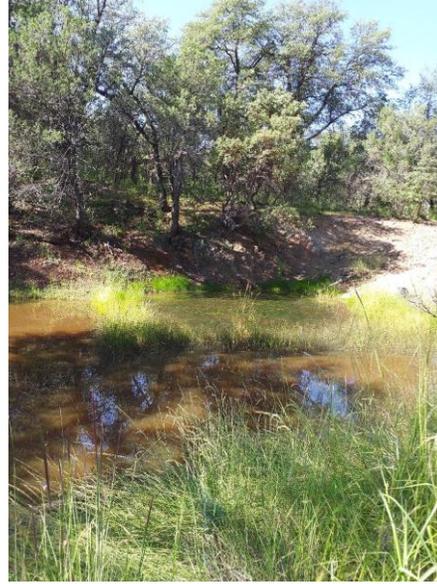
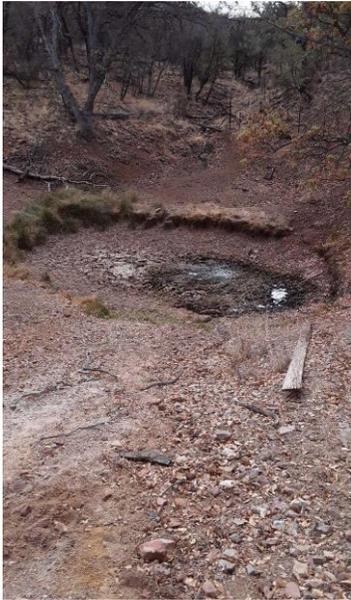
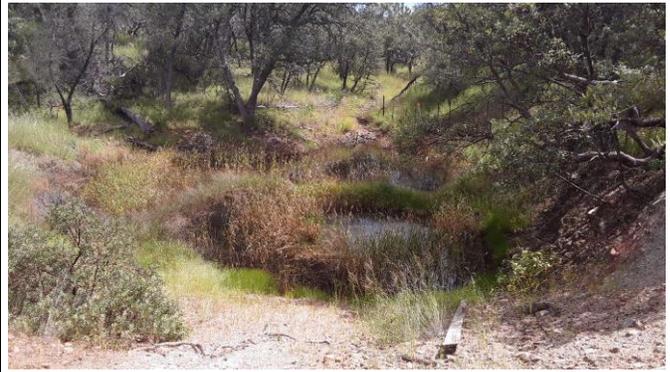
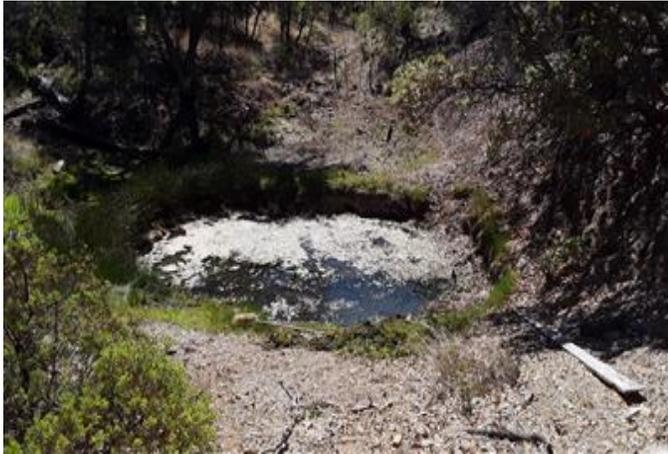
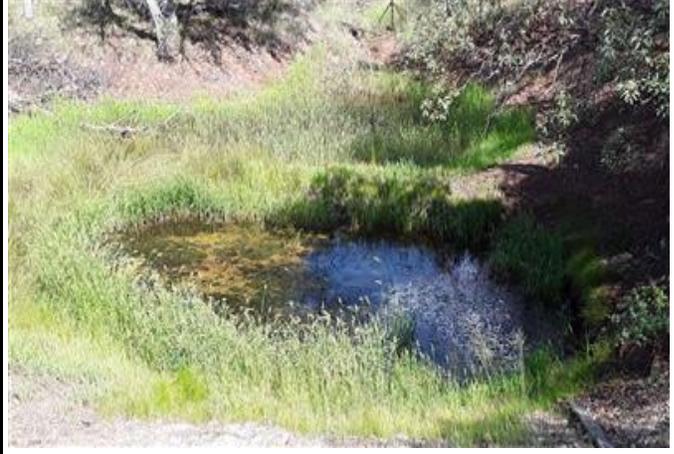
Site ID	MWS1-02	Interpretation of Groundwater Age: Little to no evaporative, premodern water during the dry season; little to no evaporative, mixed water during the wet season.
Watershed	Mowry Wash South	
Monitoring Period	05/2019 - 11/2023	Potential Impacts/Effects: No surface flow has been observed at this site during site visits, rather it exists as a still pond.
Number of Visits	17

Aquatic and Vegetation Survey Findings: Tank dug out against hillside, potentially fed by groundwater. Water present year-round with riparian obligate plant species including rushes (*Juncus* spp.) and aquatic vegetation including non-native Brazilian waterweed (*Egeria densa*). Nonnative fish and bullfrogs (*Lithobates catesbeianus*) have been observed. Aquatic invertebrates including beetles, boatmen, backswimmers, damselflies, and leeches, as well as snails, have been observed. Invasive plants, water milfoil (*Myriophyllum* sp.) barnyardgrass (*Echinochloa crus-galli*), Lehmann lovegrass (*Eragrostis lehmanniana*), and Johnsongrass (*Sorghum halepense*) have been observed.

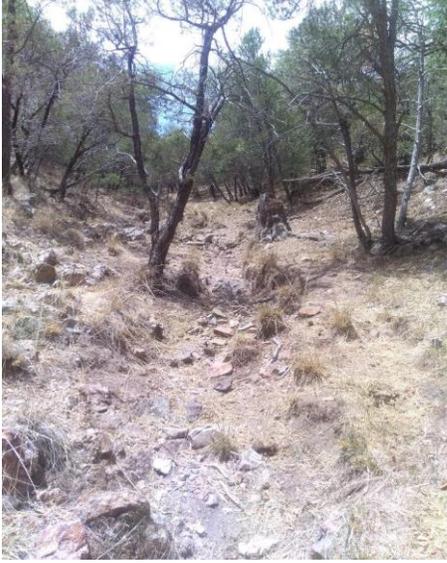
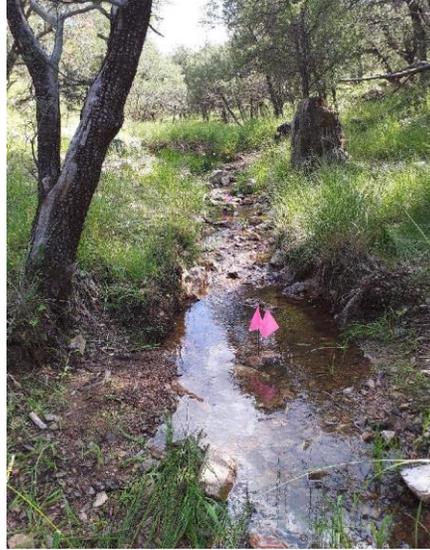
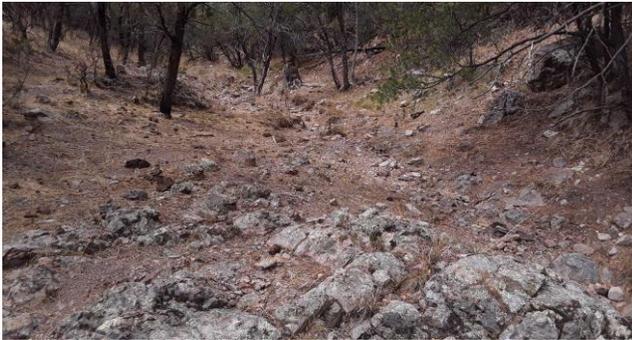
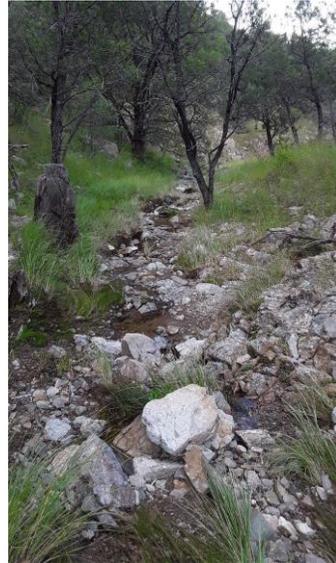
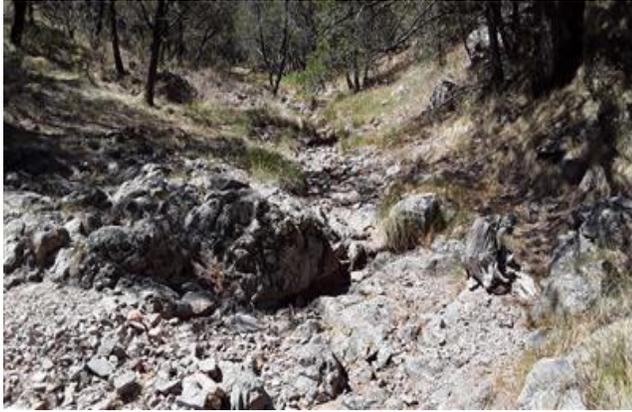
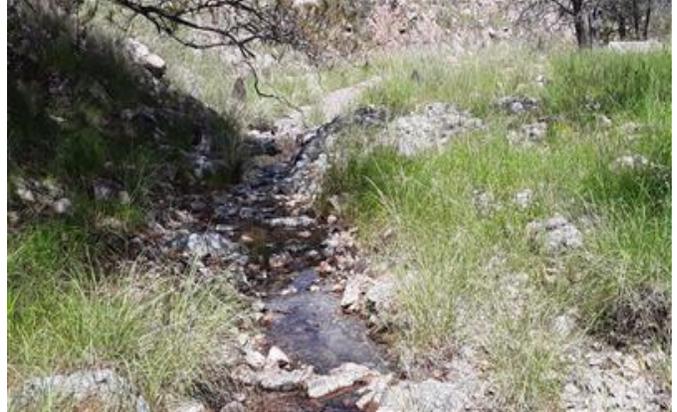
Date	Parameter				Date	Parameter			
3/25/2021	No Exceedances				9/10/2021	Isotopes samples collected			
5/26/2021	Dry				11/29/2021	Dry			
6/17/2022	Dry				12/8/2022	No Exceedances			
6/15/2023	Dry				11/22/2023	Dry			
Reference Table 1 for EPA Primary Maximum Contaminant Levels (MCL)									
<p>Aquatic and Vegetation Survey Findings: Water seeps from alluvium behind the concrete dam and flows atop volcanic bedrock/alluvium channel. This is a surface water section of Mowry Wash. Aquatic beetles, waterstriders, and backswimmers have been observed. The dominant vegetation is Madrean oak woodland, dominated by alligator juniper (<i>Juniperus deppeana</i>) and Mexican pinyon (<i>Pinus cembroides</i>). Invasive Lehmann lovegrass (<i>Eragrostis lehmanniana</i>) has been observed. Deer and javelina tracks and livestock sign have been noted.</p>

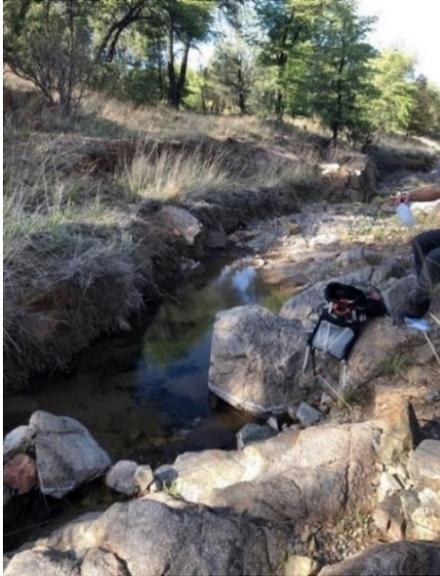
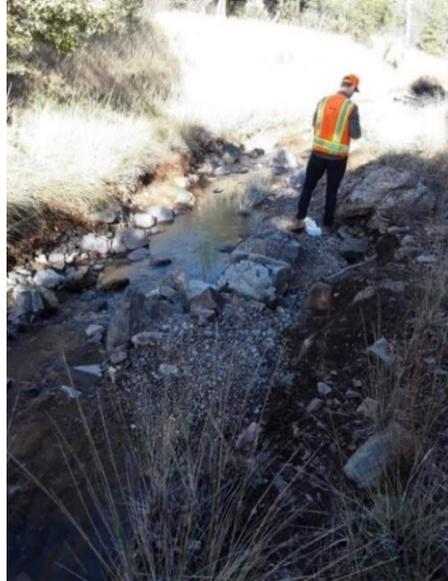
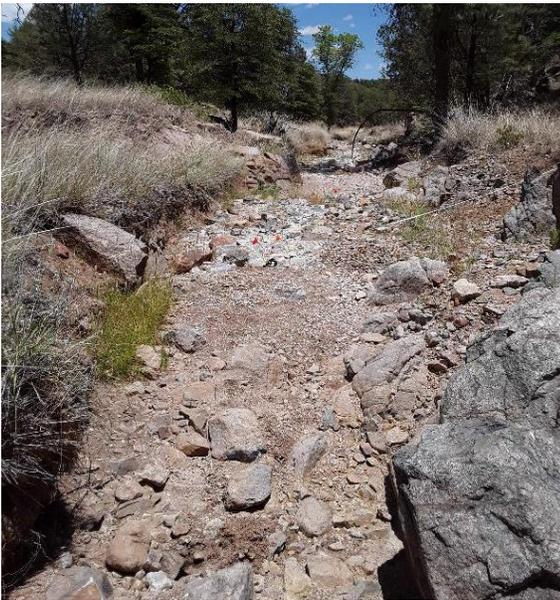
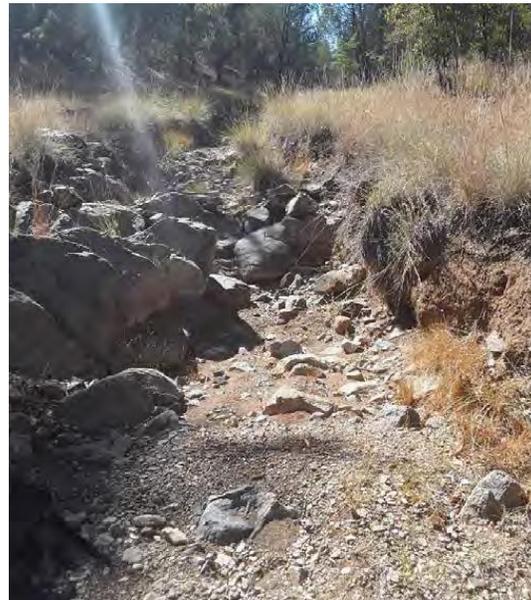
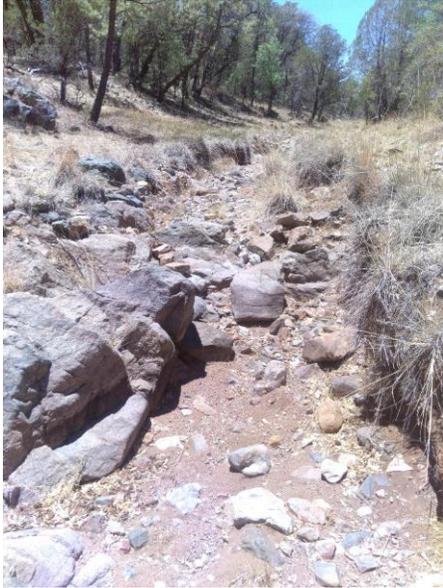
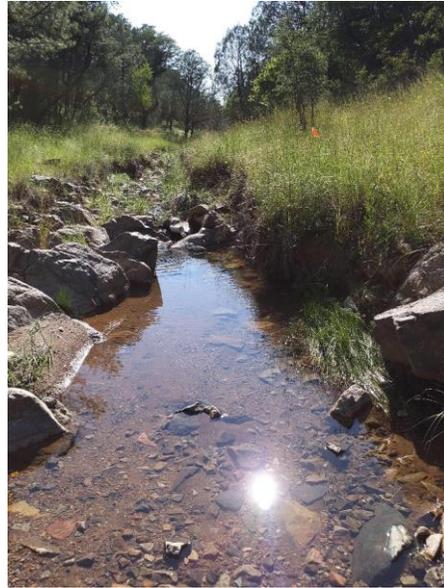
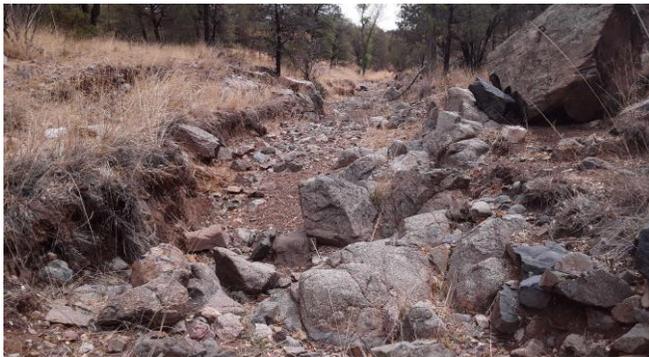
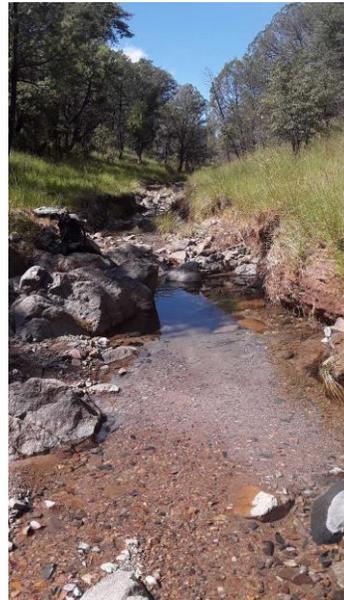
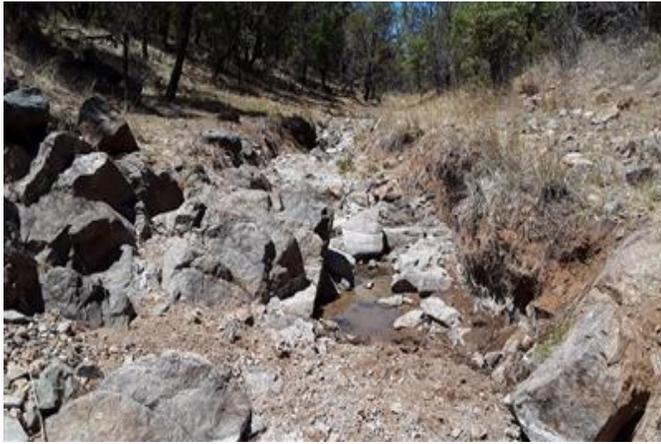
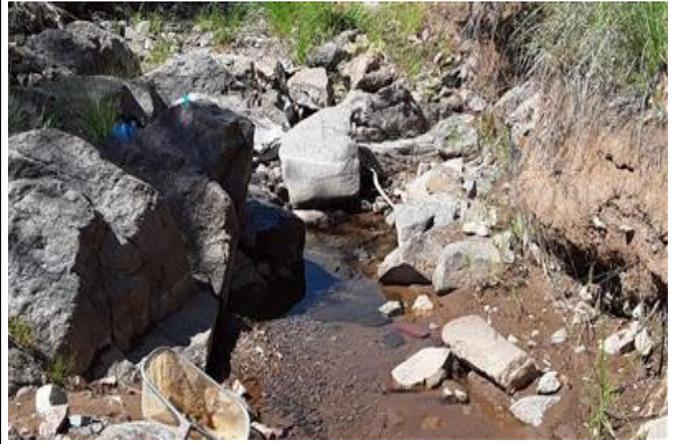
Site ID	MWS2-01	Interpretation of Groundwater Age: Little to no evaporative, modern water during the dry season; little to no evaporative, modern water during the wet season.
Watershed	Mowry Wash South	
Monitoring Period	5/2019 - 11/2023	Potential Impacts/Effects: Site has been dry for a majority visits, but when flowing, the site flowrate has ranged from 1.92 to 128 gpm.
Number of Visits	17

Aquatic and Vegetation Survey Findings: This site is located within rocky/gravelly section of south Mowry Wash with some bedrock outcrop constrictions. Threeawn (*Aristida* sp.) is the dominate perimeter vegetation at this site with deergrass (*Muhlenbergia rigens*), pointleaf manzanita (*Arctostaphylos pungens*), and panicgrass (*Panicum* sp.). Riparian obligates, Mexican rush (*Juncus mexicana*) and spikerush (*Eleocharis* sp.), and seepwillow (*Baccharis salicifolia*) were also noted at the site. This site lacks tree canopy cover, however, overstory vegetation adjacent to the site is dominated by Emory oak (*Quercus emoryi*). Non-native annual rabbitsfoot grass (*Polypogon monspeliensis*) and invasive plants, Lehmann lovegrass (*Eragrostis lehmanniana*) and weeping lovegrass (*Eragrostis curvula*) have been observed. Aquatic invertebrates observed along this drainage include beetles, waterstriders, and backswimmers. Canyon tree frogs (*Hyla arenicolor*) have been observed at this site.

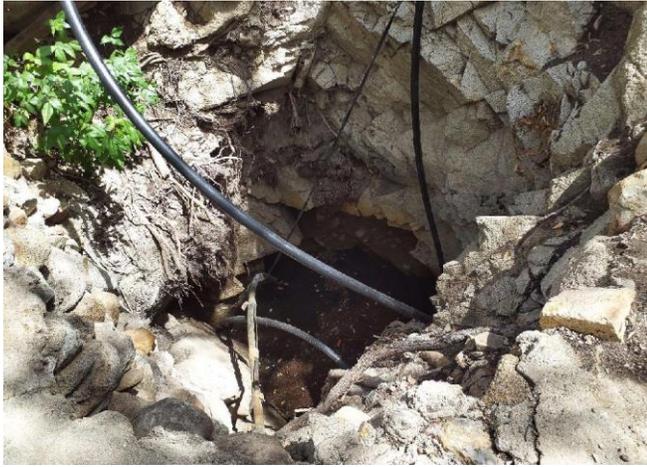
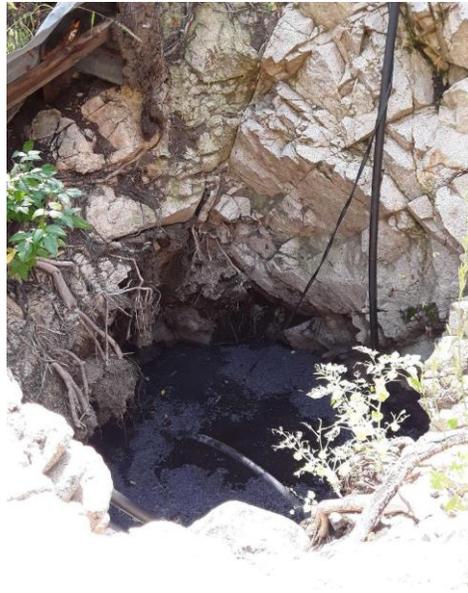
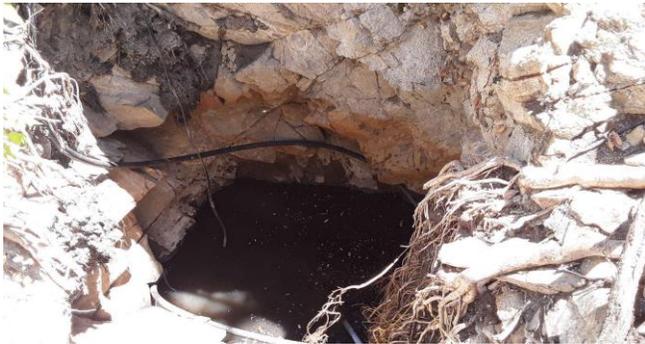
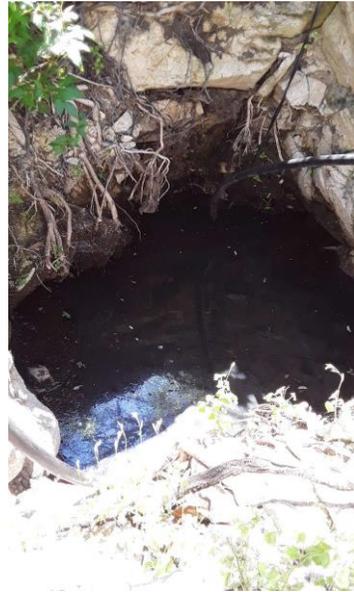
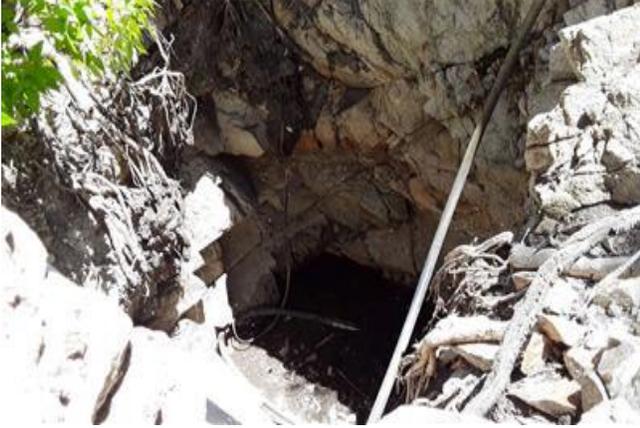
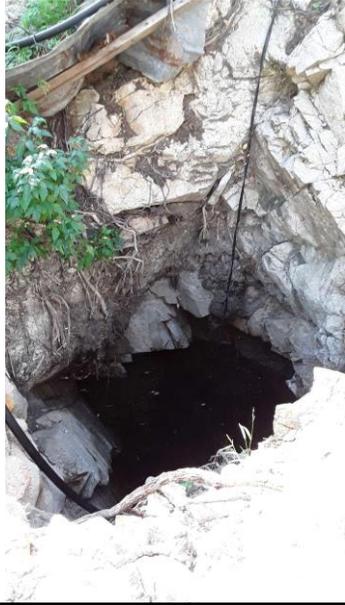
Site ID	PC-SP-01	Interpretation of Groundwater Age: Little to no evaporative, mixed water during the wet season.
Watershed	Providencia Canyon	
Monitoring Period	06/2021 - 11/2023	Potential Impacts/Effects: No flow has been observed at this site.
Number of Visits	11

Aquatic and Vegetation Survey Findings: Also called Shannon Spring, water pools in the shaft on the southern side of Providencia canyon. A functioning submersible solar pump with polyline tubing in all directions resides at the site. Pumped water runs up the canyon side to a cistern about 500 ft up the hillside. The tubing then runs back down and across the canyon to the cattle drinker. The predominant vegetation is consistent with the Madrean oak woodland, with poison ivy (*Toxicodendron radicans*) and velvet ash (*Fraxinus velutina*) surrounding the cistern. Invasive Bermudagrass (*Cynodon dactylon*) is present. Aquatic beetles have been observed, but no aquatic herpetofauna has been observed.

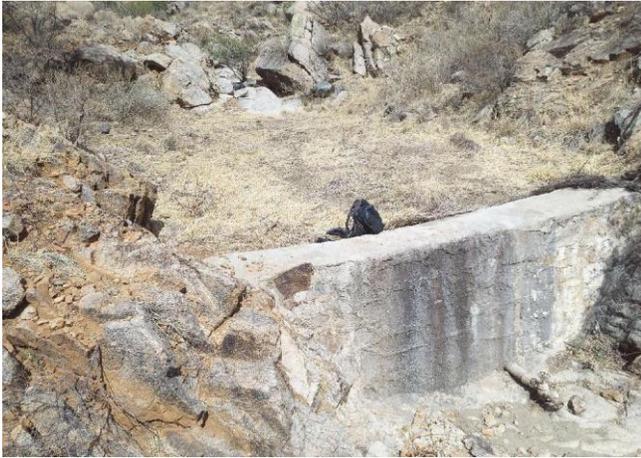
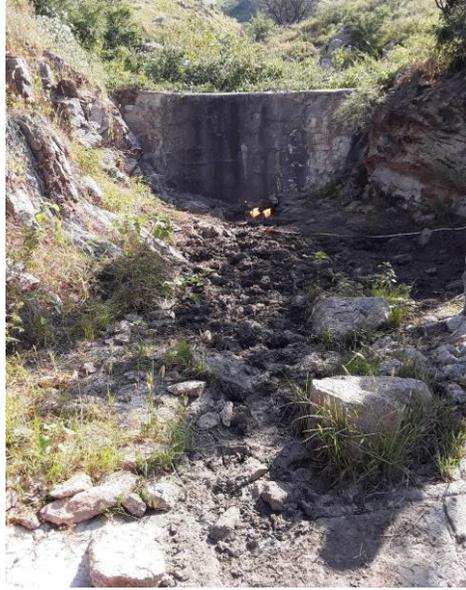
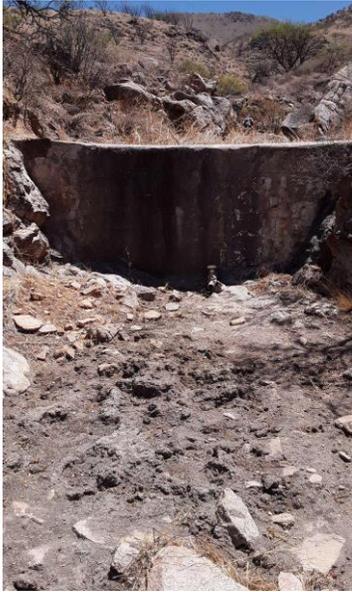
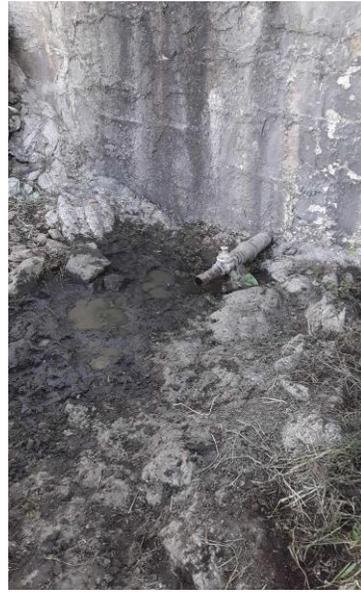
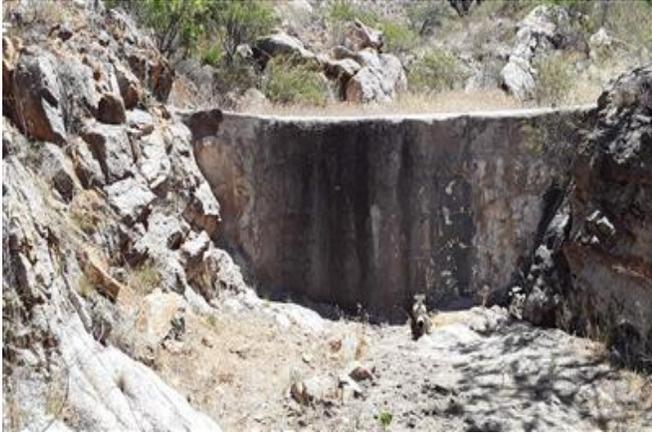
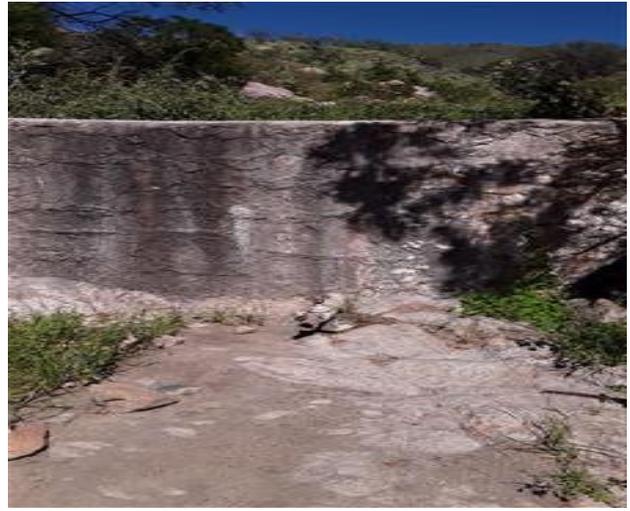
Site ID	PV1-01	Interpretation of Groundwater Age: Inconclusive
Watershed	Paja Verde Wash	
Monitoring Period	06/2021 - 11/2023	Potential Impacts/Effects: The site has been predominantly dry with flow measure twice ranging from 0.02-0.03 gpm.
Number of Visits	11

Aquatic and Vegetation Survey Findings: Dry wash with a masonry dam with a dry valve at the base. No signs of recent water. Stomped mud at site hardened dry. Surrounding vegetation is sparse, dominated by kidneywood (*Eysenhardtia orthocarpa*) and mimosa (*Mimosa dysocarpa*). Invasive cocklebur (*Xanthium strumarium*) Lehmann lovegrass (*Eragrostis lehmanniana*), and natalgrass (*Melinis repens*) occur. No aquatic herpetofauna or invertebrates have been observed.

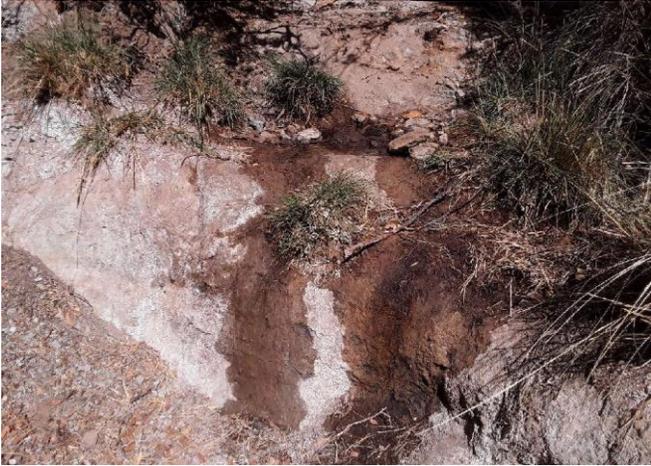
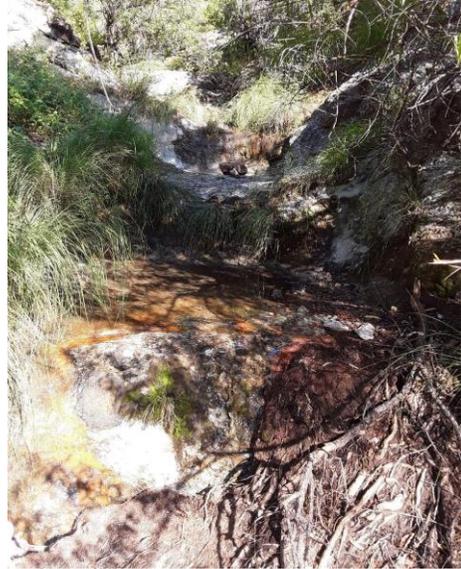
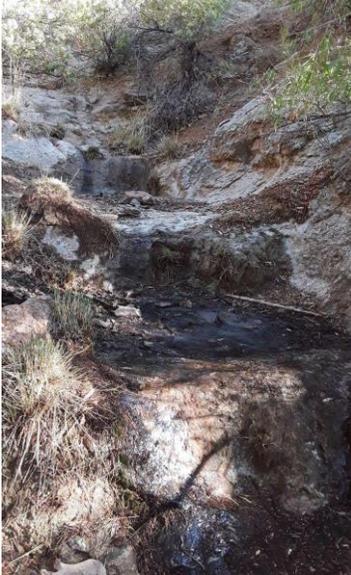
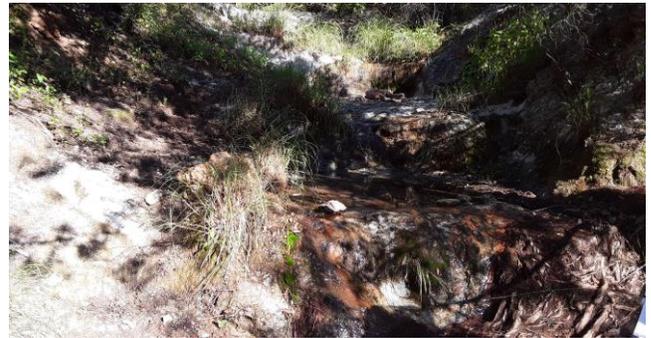
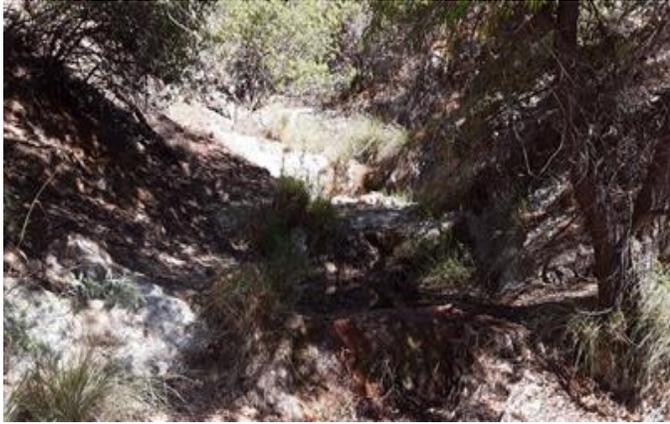
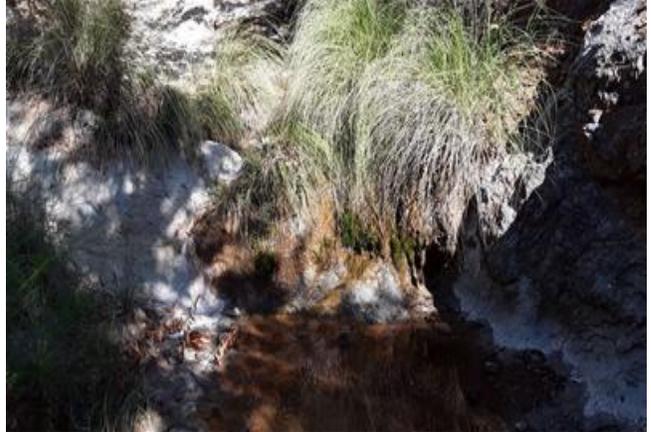
Site ID	RM-SP-01	Interpretation of Groundwater Age: Little to no evaporative, premodern water during the dry season; little to no evaporative, modern water during the wet season.
Watershed	Red Mountain Tributary	
Monitoring Period	06/2021 - 11/2023	Potential Impacts/Effects: Flows measured at this site have ranged from 0 to 3.0 gpm.
Number of Visits	11

Aquatic and Vegetation Survey Findings: Water seeping from bedrock ledges in trachyandesite cascades over shelves into a lower muddy pool. Vegetation is Madrean evergreen woodland with an overstory dominated by Toumey oak (*Quercus toumeyii*). Invasive Lehmann lovegrass (*Eragrostis lehmanniana*) has been observed. Aquatic beetles have been observed. No aquatic herpetofauna has been observed. Cattle scat has been observed below the spring. Javelina tracks have been observed.
