Hermosa Spring and Seep Catalog

Hermosa Project Area

SPRING AND SEEP CATALOG Hermosa Project Area

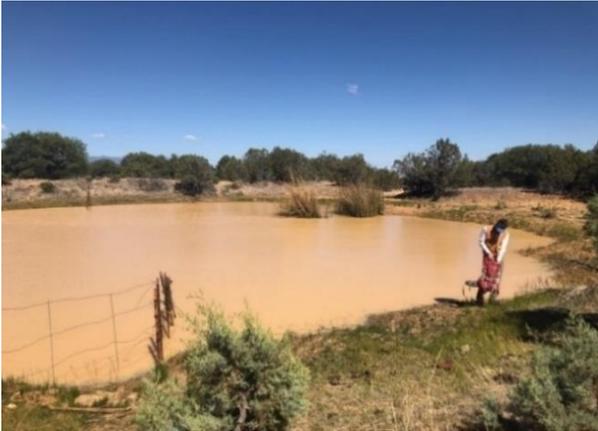
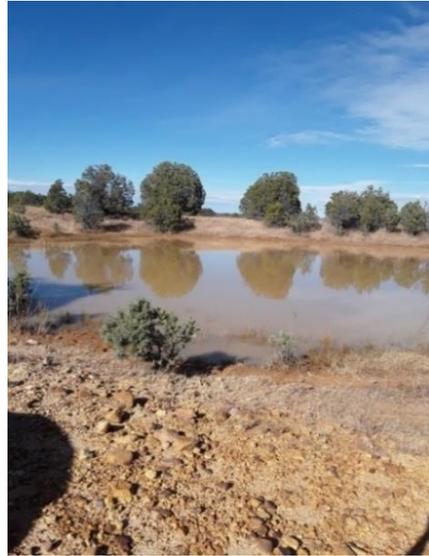
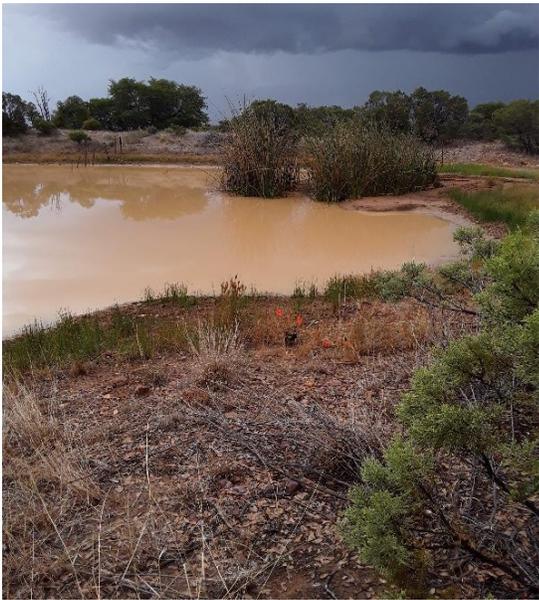
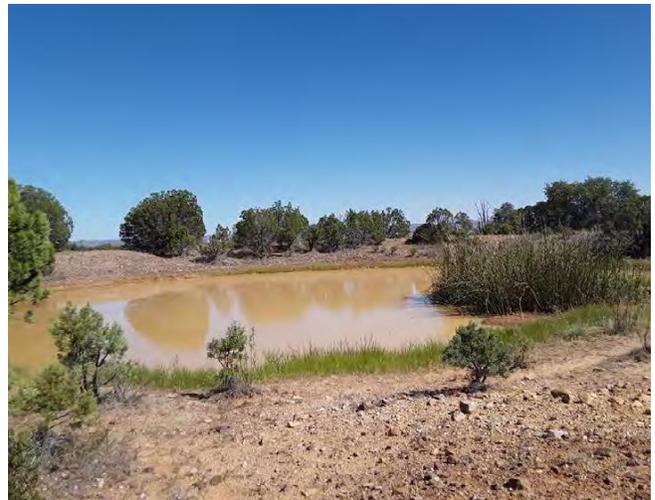
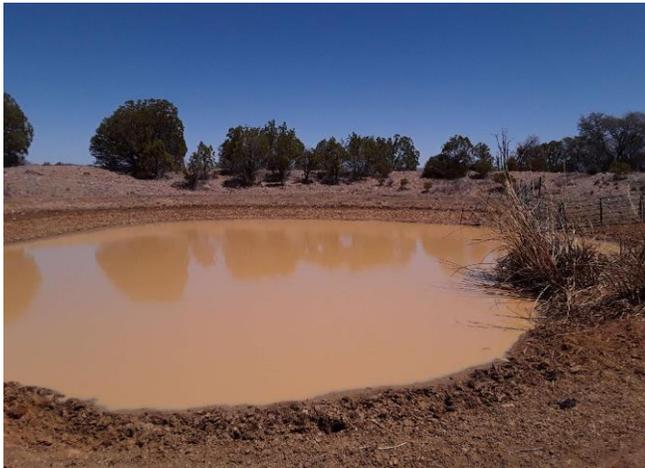
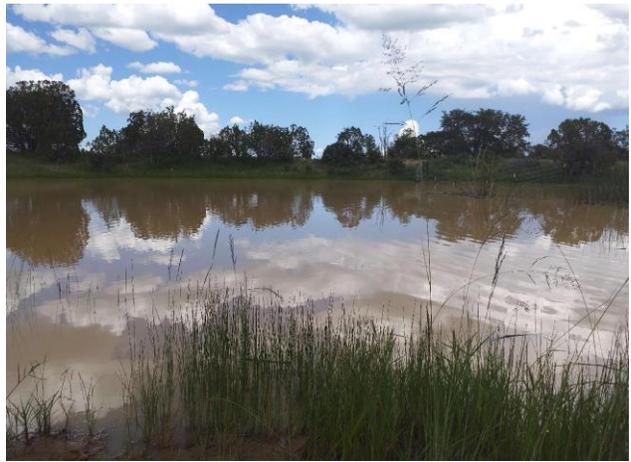
Site ID	RT-01	Interpretation of Groundwater Age: Light to moderate evaporative, modern water during the dry season; little to no evaporative, mixed water during the wet season.
Watershed	Ridge Tank	
Monitoring Period	5/2019 - 11/2023	Potential Impacts/Effects: No flow has been measured at this site. This site sits atop a ridge and is a dirt tank (excavated depression) that holds precipitation and some surface runoff. Groundwater does not contribute to this site. No changes are predicted at this site.
Number of Visits	17

Aquatic and Vegetation Survey Findings: Ridge Tank, a large earthen tank, is located on the ridgetop divide between Adams Canyon and Chino Draw. California bulrush (*Schoenoplectus californicus*), a wetland associated species, is present as emergent vegetation. Hairy watercress (*Marsilea vestita*), a wetland associated species is present as floating vegetation and algae as submerged vegetation. Riparian obligates, spikerush (*Eleocharis* sp.) and Baltic rush (*Juncus balticus*), dominate the perimeter of the tank. Upland overstory vegetation surrounding the tank is dominated by juniper (*Juniperus* spp.) and pointleaf manzanita (*Arctostaphylos pungens*). Invasive plants observed at this site include Lehmann lovegrass (*Eragrostis lehmanniana*), giant reed (*Arundo donax*), and Bermudagrass (*Cynodon dactylon*). Aquatic invertebrates including beetles, waterstriders, damselflies, dragonflies, water scorpions, backswimmers, and snails have been observed. Aquatic vertebrates observed include the black-necked gartersnake (*Thamnophis cyrtopsis*). Non-native sunfish (*Centrarchidae* family) and the invasive American bullfrog (*Lithobates catesbeianus*) have also been noted at this site.

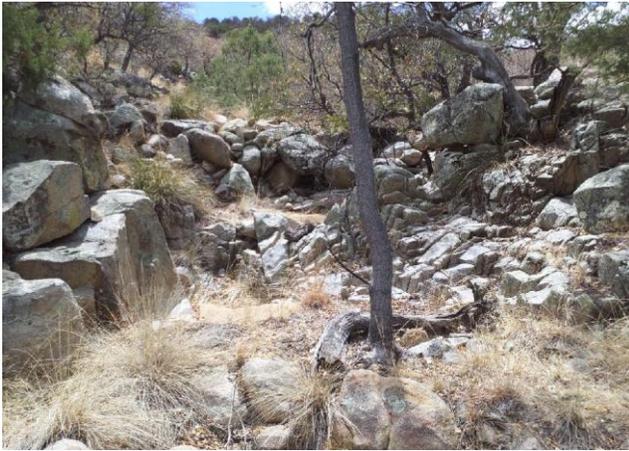
Dry Season Photo (06/2/2021)

Aquatic and Vegetation Survey Findings: Colluvial dam, followed by series of terraces with alluvial deposition. A cobble and concrete container was built into the eastern hillside. Vegetation is Madrean evergreen woodland with a riparian overstory dominated by Fremont cottonwood (*Populus fremontii*). Invasive Lehmann lovegrass (*Eragrostis lehmanniana*) was present. Aquatic beetles were observed. No aquatic herpetofauna have been observed.

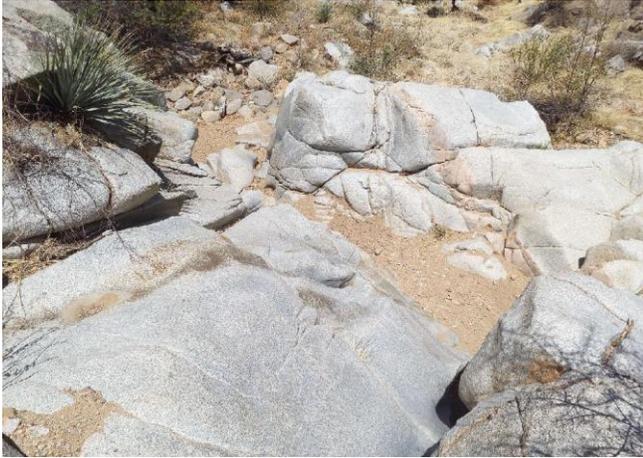
Dry Season Photo (06/2/2021)

Aquatic and Vegetation Survey Findings: Granitic bedrock outcrop in channel near road crossing with seeping trace flow atop outcrop. Vegetation is Madrean evergreen woodland with woody vegetation dominated by beargrass (*Nolina microcarpa*), coyote willow (*Salix exigua*), and mimosa (*Mimosa aculeaticarpa* var. *biuncifera*). Invasive Bermudagrass (*Cynodon dactylon*) and Lehmann lovegrass (*Eragrostis lehmanniana*) are present. Aquatic beetles and one red-spotted toad tadpole (*Anaxyrus punctatus*) were observed. Deer tracks were noted.

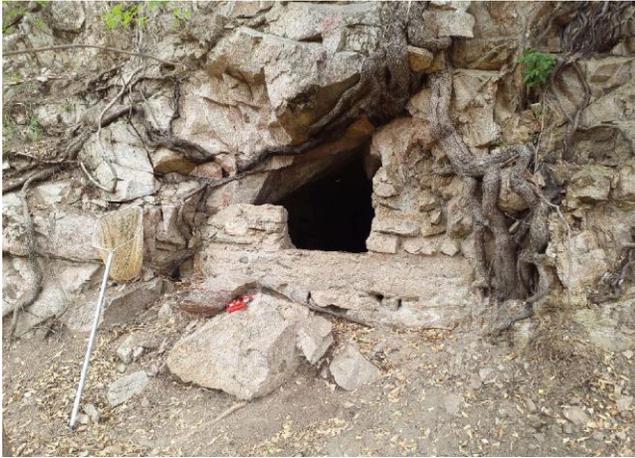
Dry Season Photo (06/2/2021)

Aquatic and Vegetation Survey Findings: Old qanat dug 20 feet back into granodiorite bedrock wall with trace flow. Vegetation is Madrean evergreen woodland with a tree overstory dominated by velvet ash (*Fraxinus velutina*) and Arizona white oak (*Quercus arizonica*). No aquatic invertebrates or herpetofauna were observed. Goldfish were observed in a nearby cistern. Unknown mammal tracks were present in the mud.

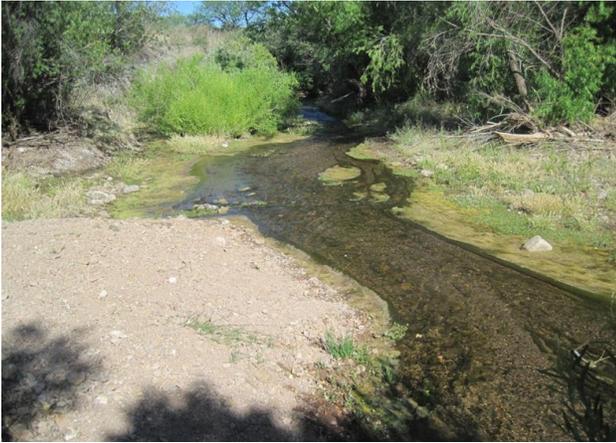
Dry Season Photo (6/4/2018)

Aquatic and Vegetation Survey Findings: This site located along a section of Sonoita Creek upstream of the Alum Gulch confluence. Water is present in shallow riffles and runs. Riparian tree species present include Bonpland willow (*Salix bonplandiana*) and Fremont cottonwood (*Populus fremontii*). Emergent and perimeter vegetation is dominated by invasive plants including Bermudagrass (*Cynodon dactylon*), yellow sweet clover (*Melilotus officinalis*), and Johnson grass (*Sorghum halepense*). Fish have been observed at this site and include speckled dace (*Rhinichthys osculus*) and longfin dace (*Agosia chrysogaster*). Invasive crayfish have been observed. Aquatic invertebrates observed include beetles, waterstriders, belostomatids and damselfly.

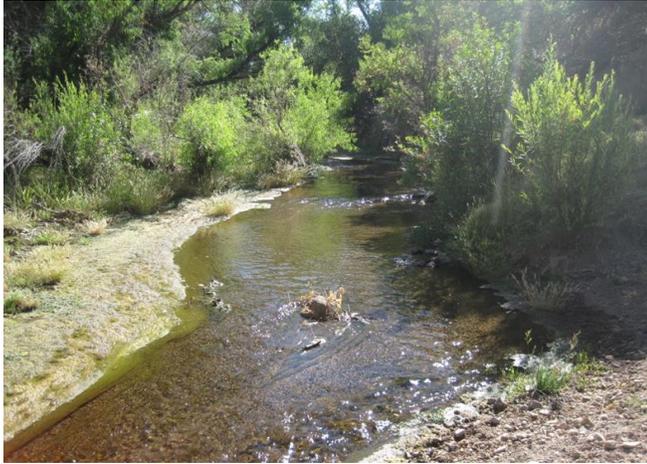
Dry Season Photo (6/4/2018)

Aquatic and Vegetation Survey Findings: This site located along a section of Sonoita Creek downstream of the Alum Gulch confluence. Water is present in shallow riffles and runs. Riparian tree species present include Bonpland willow (*Salix bonplandiana*), narrowleaf willow (*Salix exguia*), Fremont cottonwood (*Populus fremontii*), and velvet ash (*Fraxinus velutina*). Emergent and perimeter vegetation is dominated by invasive yellow sweet clover (*Melilotus officinalis*) and native seepwillow (*Baccharis salicifolia*). Non-native annual rabbitsfoot grass (*Polypogon monspeliensis*) and other invasive plants, water cress (*Nasturtium officinale*) and Johnson grass (*Sorghum halepense*) have been observed. Fish have been observed at this site and include speckled dace (*Rhinichthys osculus*) and longfin dace (*Agosia chrysogaster*). Invasive crayfish have been observed. Aquatic invertebrates observed include belostomatids, boatmen, beetles, waterstriders, damselflies, water scorpions, and snails.

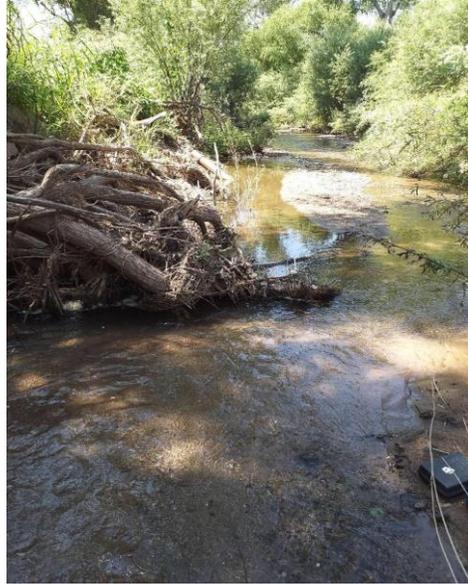
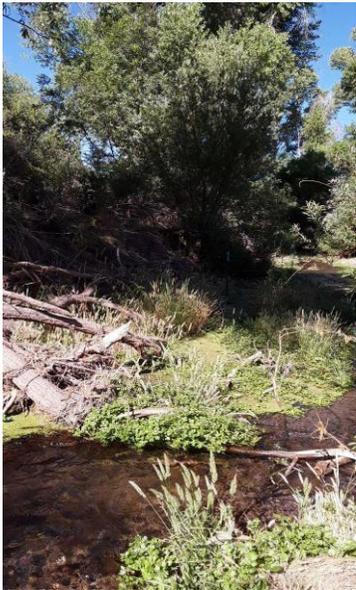
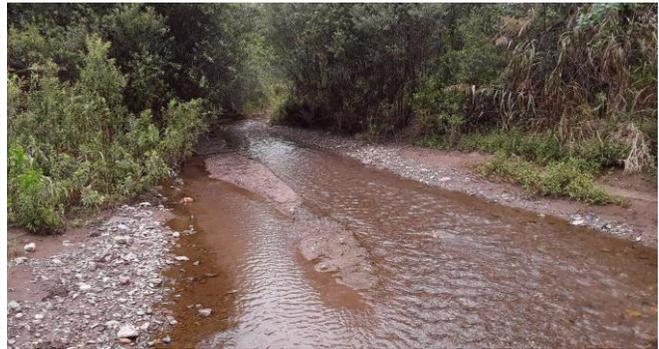
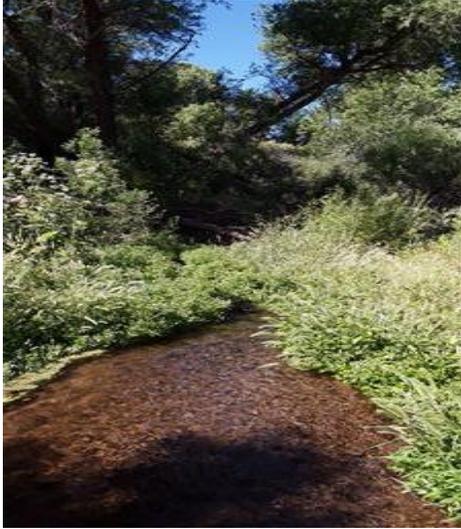
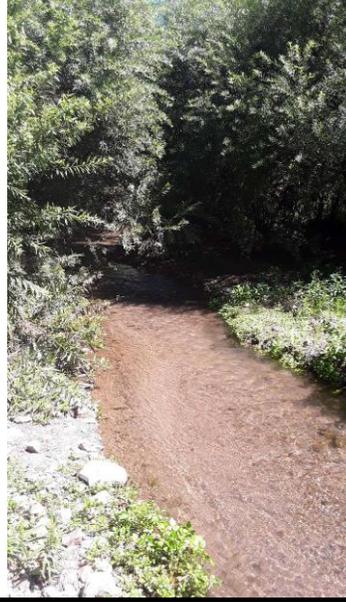
Aquatic and Vegetation Survey Findings: Water flows in a meandering stream channel. Alluvial sediment with sandy, gravelly substrate and cobbles. Vegetation is riparian scrub dominated by coyote willow (*Salix exigua*) with an overstory of Fremont cottonwood (*Populus fremontii*). Invasive Johnsongrass (*Sorghum halepense*) and Lehmann lovegrass (*Eragrostis lehmanniana*) was observed. Fish that have been observed at this site include speckled dace (*Rhinichthys osculus*) and longfin dace (*Agosia chrysogaster*). Aquatic invertebrates observed include beetles, waterstriders, and damselflies.

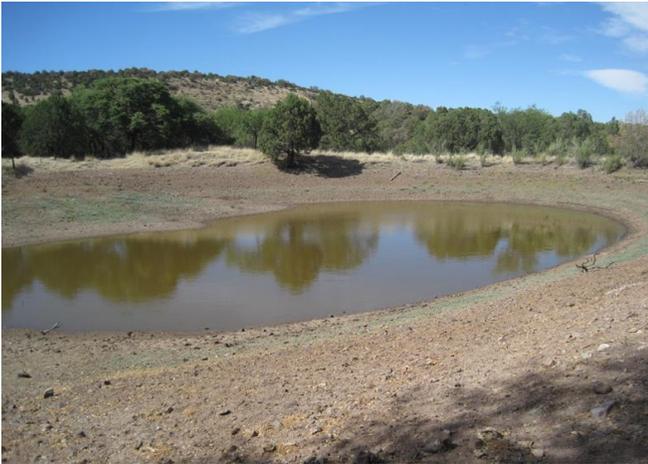
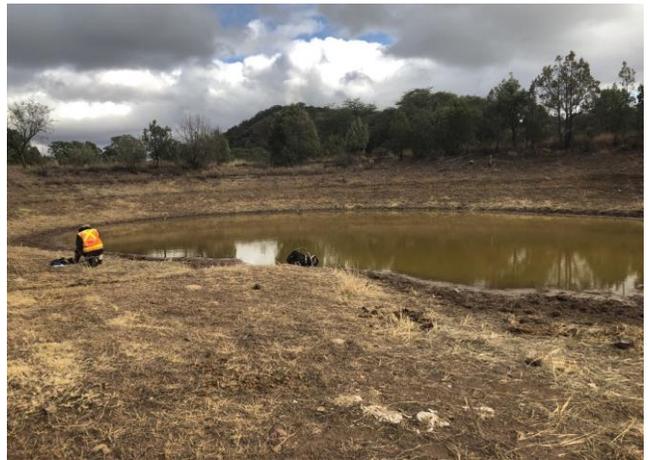
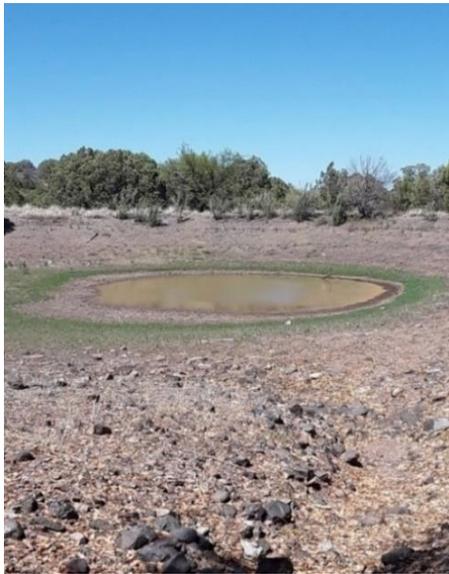
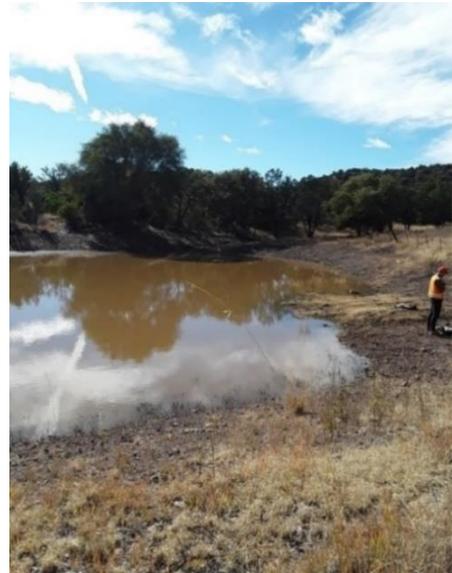
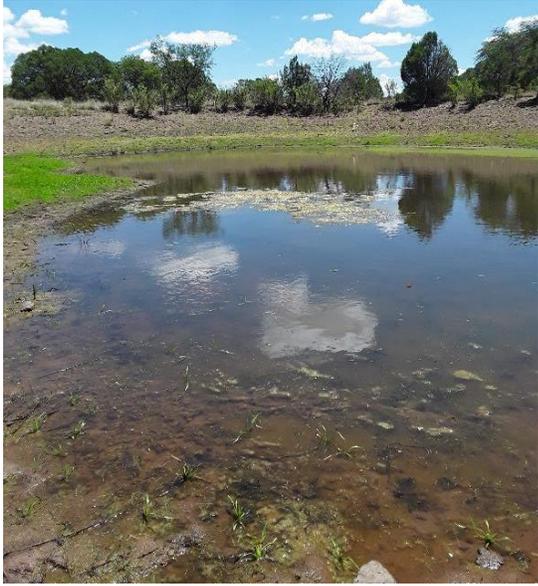
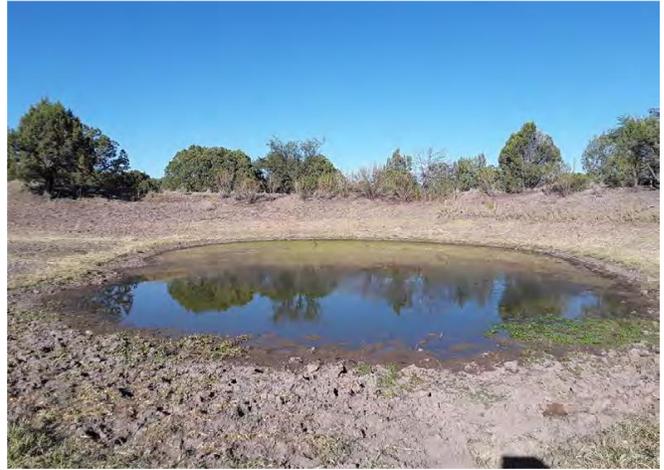
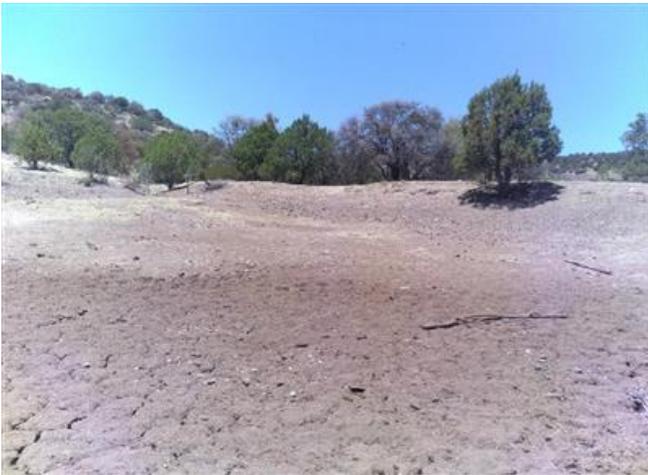
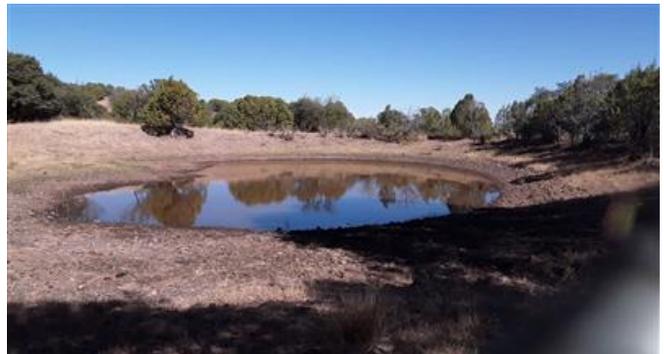
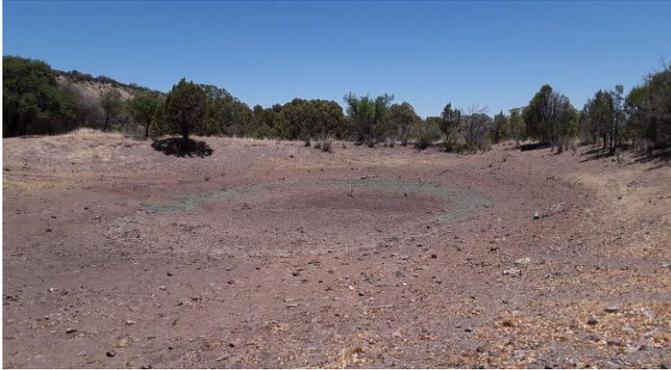
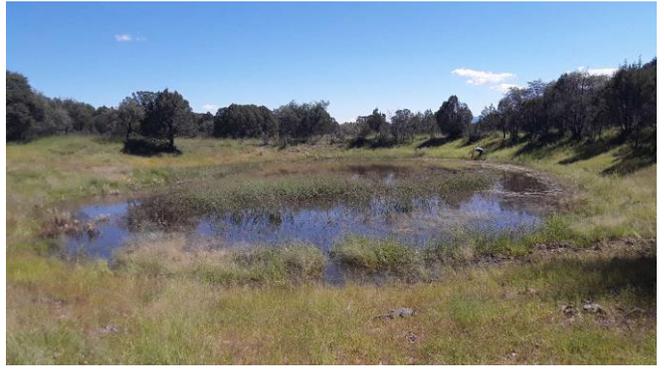
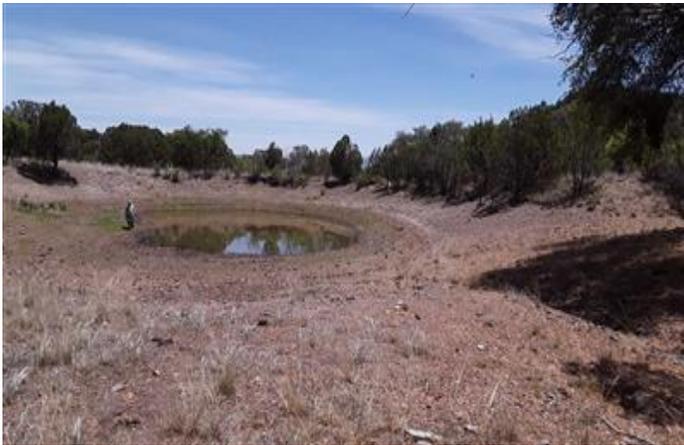
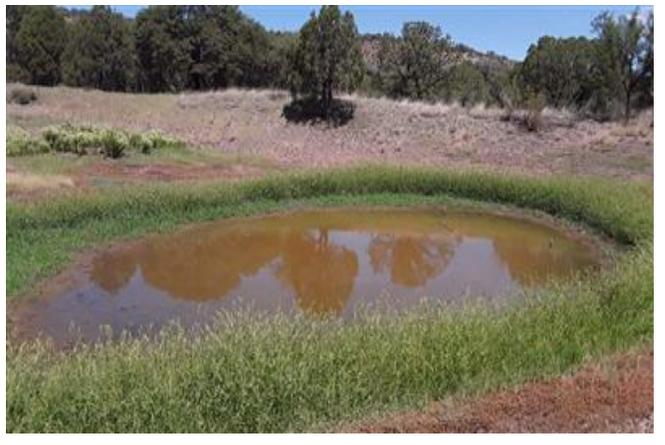
Aquatic and Vegetation Survey Findings: Site is an earthen stock tank located within a tributary to Corral Canyon. The tank typically supports some floating vegetation, Chihuahuan watercress (*Marsilea mollis*), as well as perimeter vegetation dominated by non-native jungle rice (*Echinochloa colona*). Invasive plants observed include Bermudagrass (*Cynodon dactylon*), barnyardgrass (*Echinochloa crus-galli*), weeping lovegrass (*Eragrostis curvula*), and Lehmann lovegrass (*Eragrostis lehmanniana*). Aquatic invertebrates observed include beetles, belostomatid, backswimmers, boatmen, dragonfly, leeches, water scorpions, and snails. Invasive mosquitofish (*Gambusia affinis*) and American bullfrogs (*Lithobates catesbeianus*) have been observed.

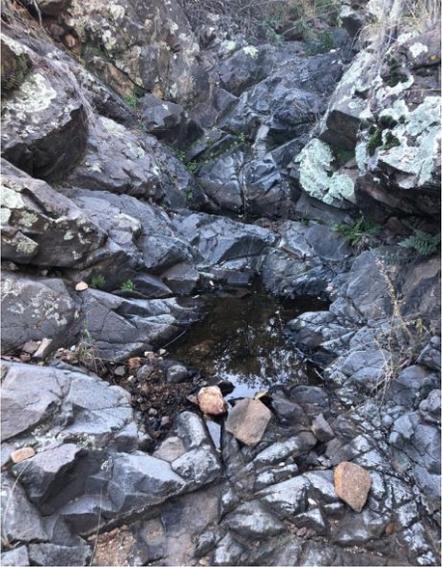
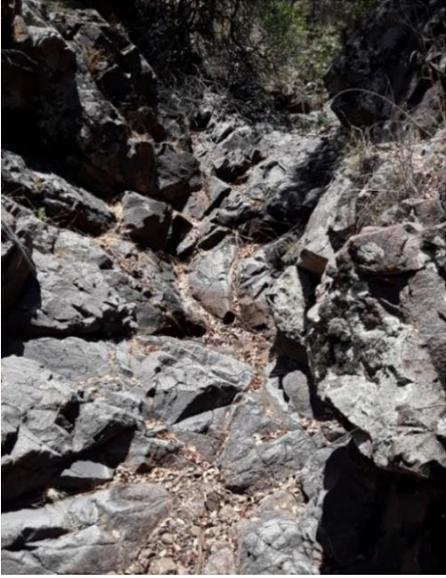
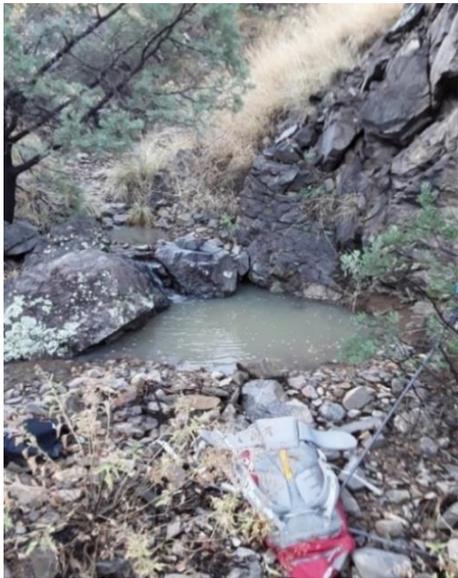
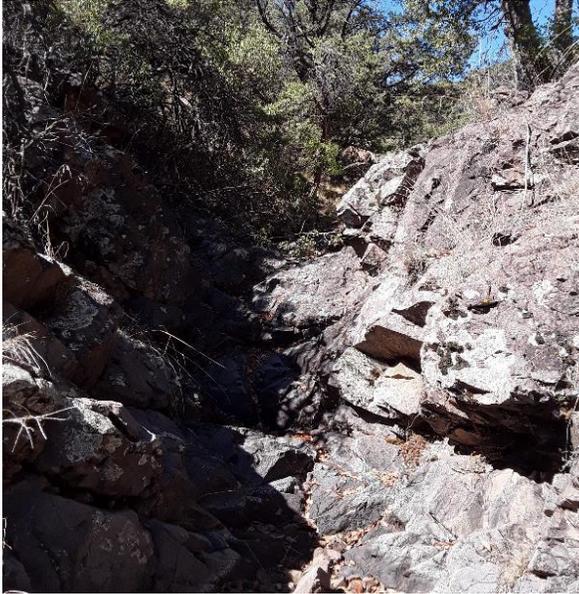
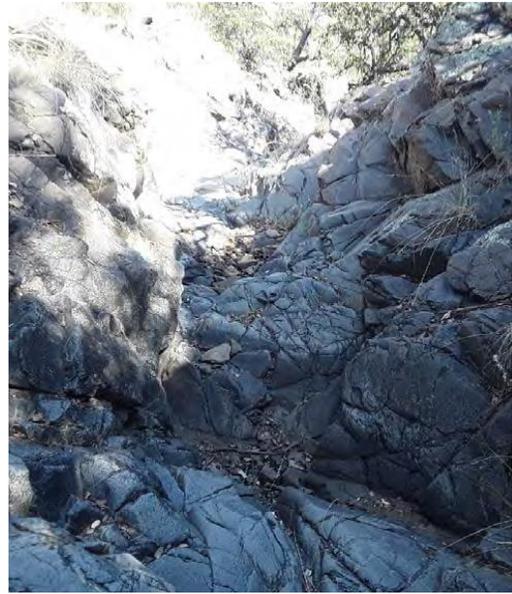
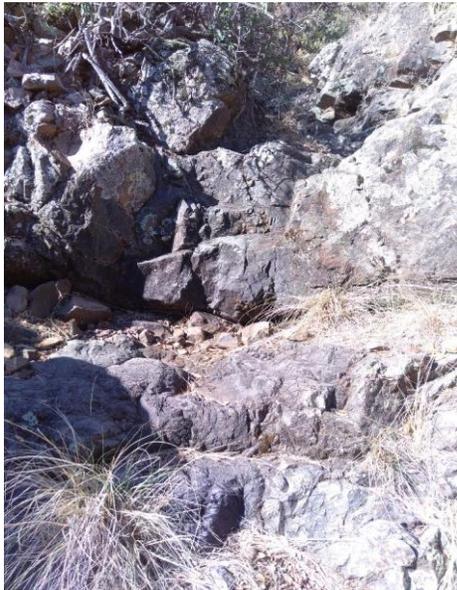
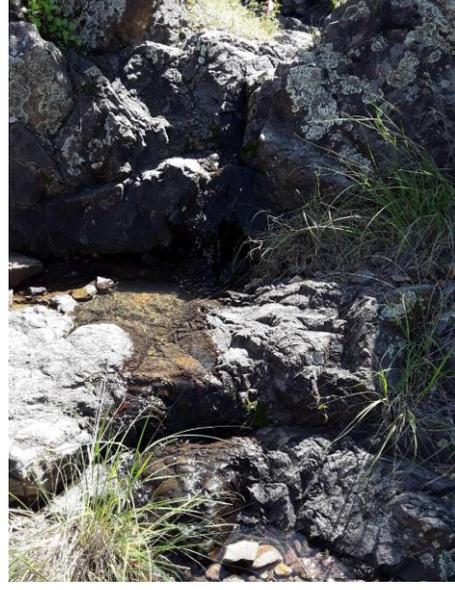
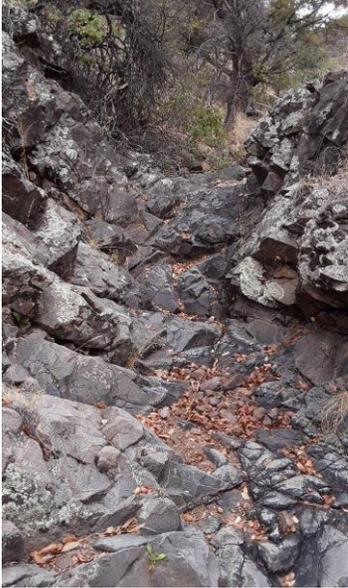
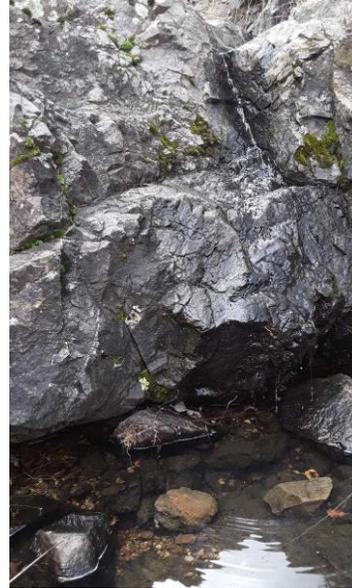
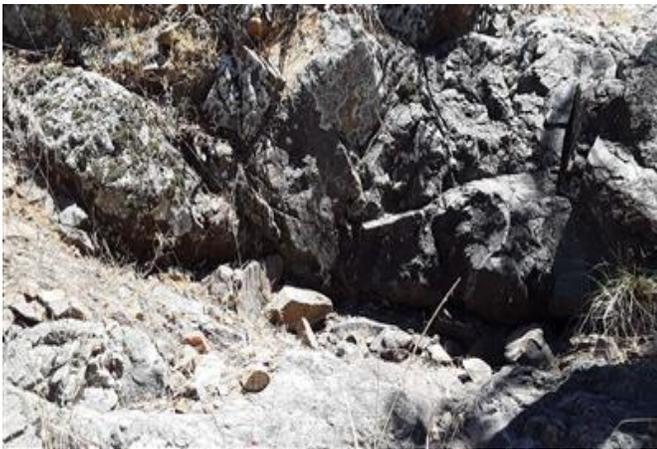
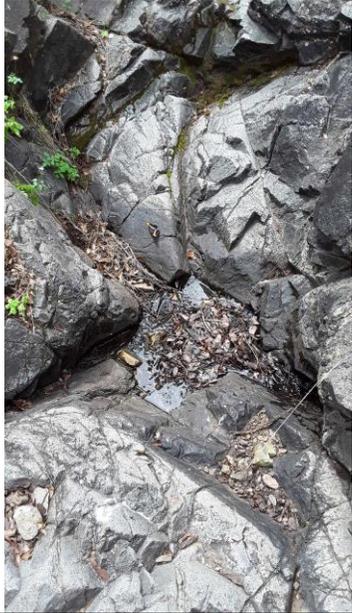
Aquatic and Vegetation Survey Findings: This site located within a bedrock section of a tributary to Harshaw Creek. Understory vegetation at the site is limited to upland species predominated by perennial grasses (*Poaceae* family), rockloving spikemoss (*Selaginella rupincola*), and sugar sumac (*Rhus ovata*). Overstory vegetation is dominated by Arizona white oak (*Quercus arizonica*) and alligator juniper (*Juniperus deppeana*). Invasive Johnsongrass (*Sorghum halepense*) and natalgrass (*Melinis repens*) occur. Aquatic invertebrates observed include beetles and boatmen. No aquatic invertebrates and no aquatic vertebrates have been observed.

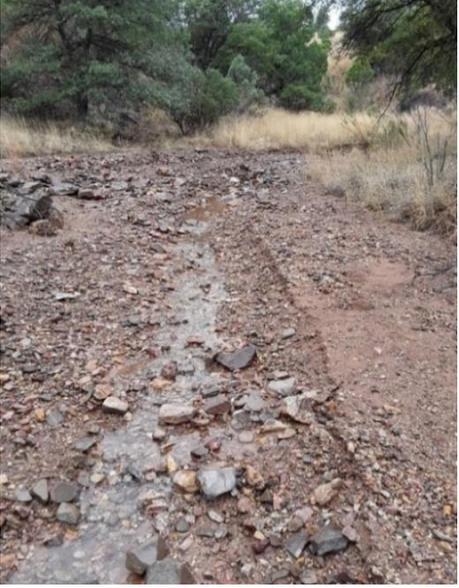
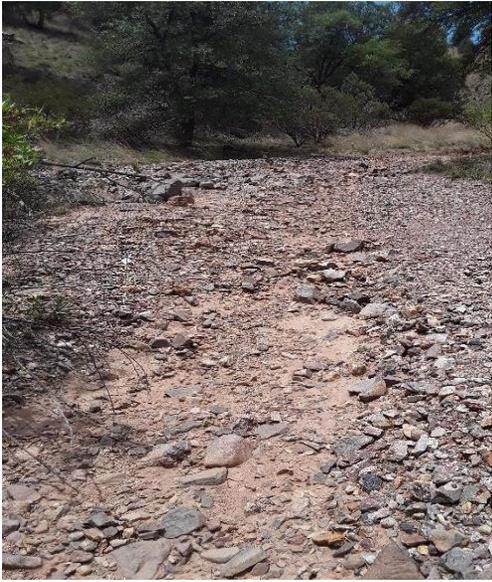
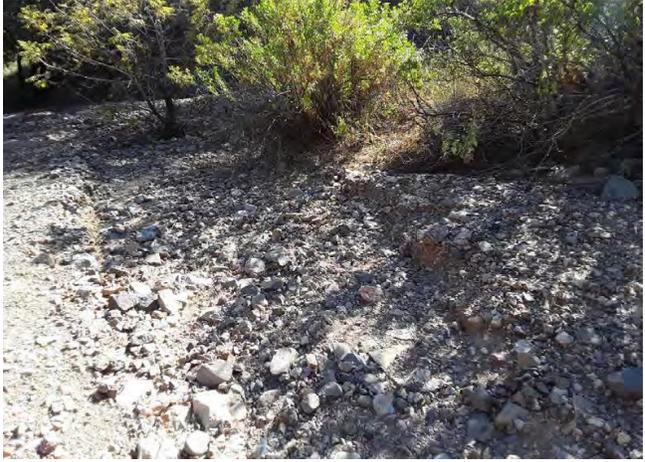
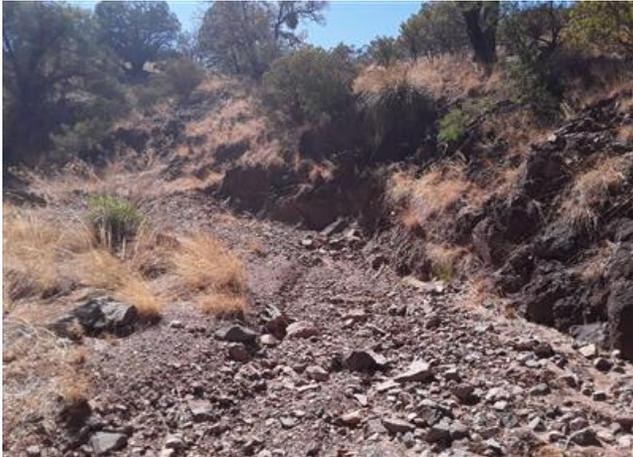
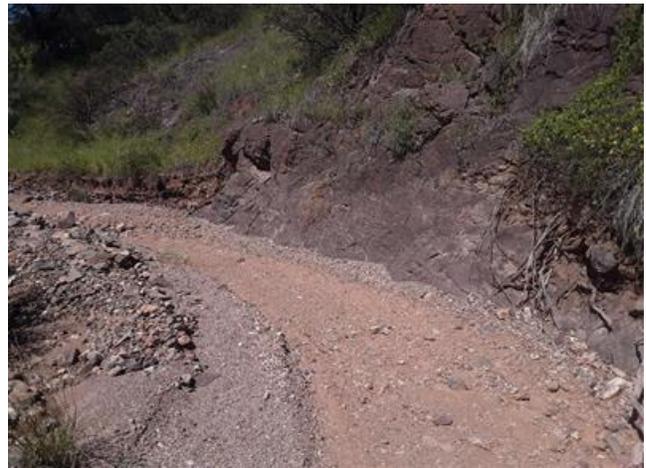
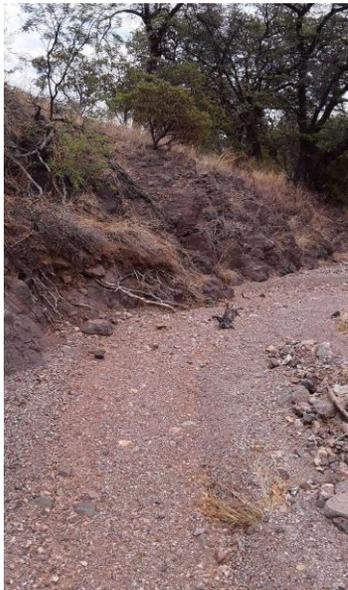
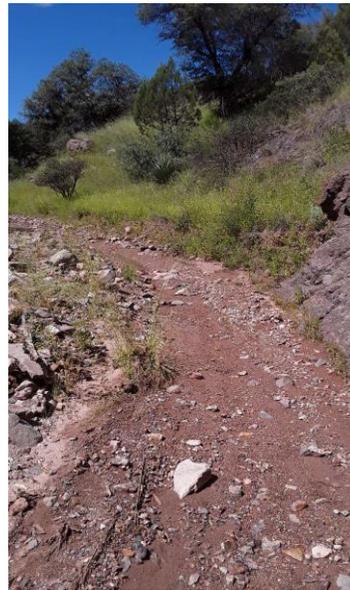
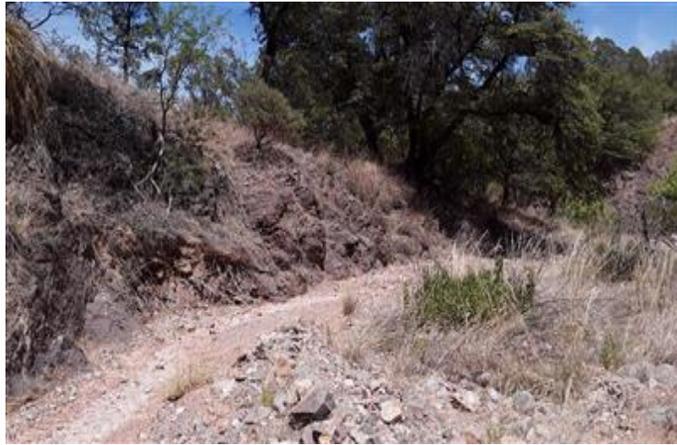
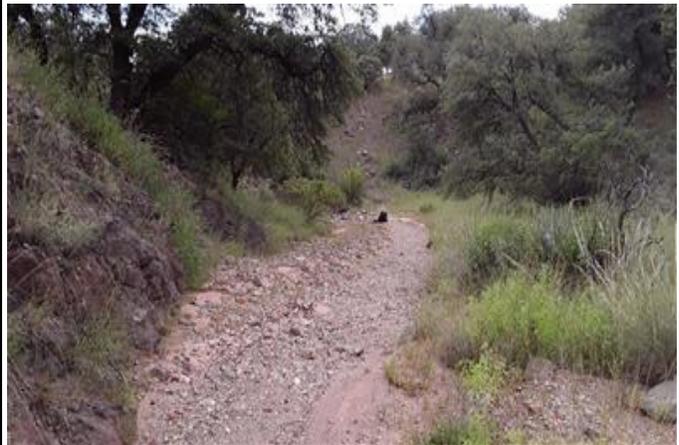
Aquatic and Vegetation Survey Findings: This site located within a gravelly and cobbly section of a tributary to Harshaw Creek. This portion of the creek has little vegetation cover within the drainage. Understory vegetation lining the channel includes grasses and seepwillow (*Baccharis salicifolia*). Overstory cover is dominated by Arizona walnut (*Juglans major*), oak (*Quercus* spp.), and velvet mesquite (*Prosopis velutina*). Invasive plant species observed include common mullein (*Verbascum thapsus*) and Lehmann lovegrass (*Eragrostis lehmanniana*). Aquatic invertebrates observed are beetles. No aquatic vertebrates have been observed.

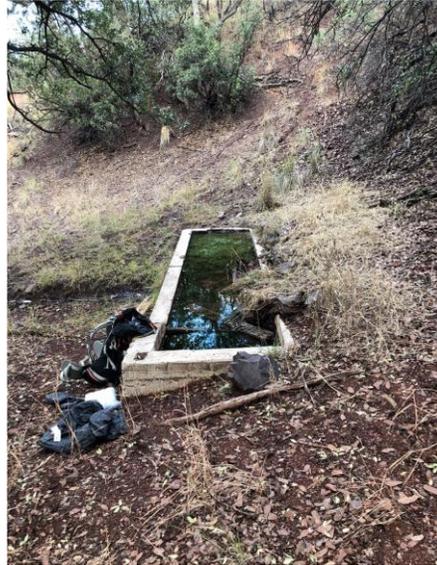
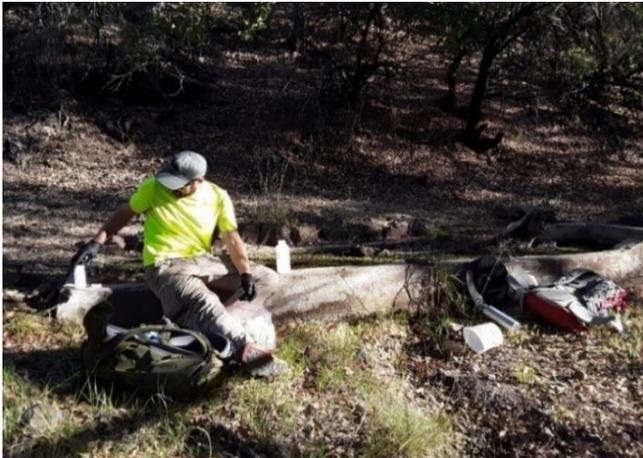
Aquatic and Vegetation Survey Findings: This concrete drinker is located in the upstream extent of an unnamed tributary to Harshaw Creek. Understory vegetation is dominated by sumac (*Rhus* spp.), Wright's silktassel (*Garrya wrightii*), pinyon ricegrass (*Piptochaetium fimbriatum*), and bull grass (*Muhlenbergia emersley*). Overstory vegetation is dominated by Arizona white oak (*Quercus arizonica*) and alligator juniper (*Juniperus deppeana*). Invasive plant species observed include Lehmann lovegrass (*Eragrostis lehmanniana*) and Bermudagrass (*Cynodon dactylon*). Aquatic beetles and waterstriders have been observed.

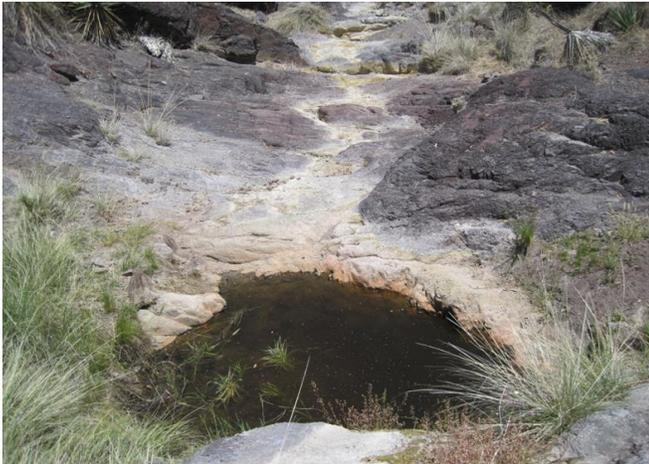
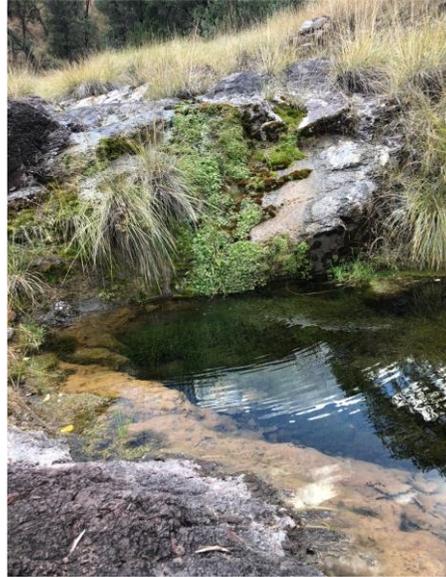
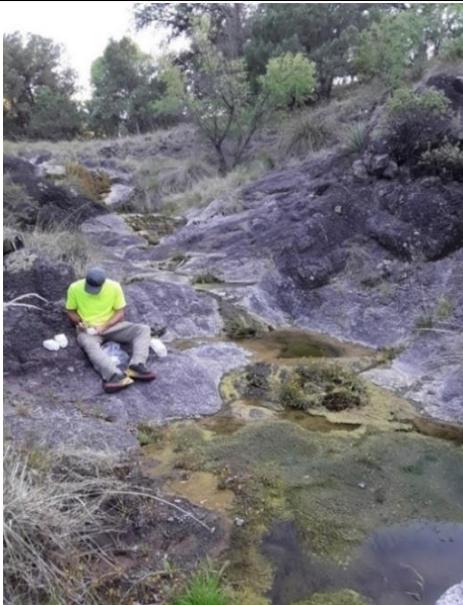
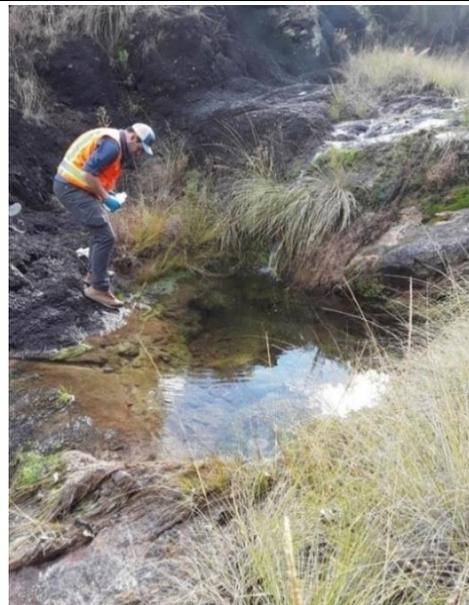
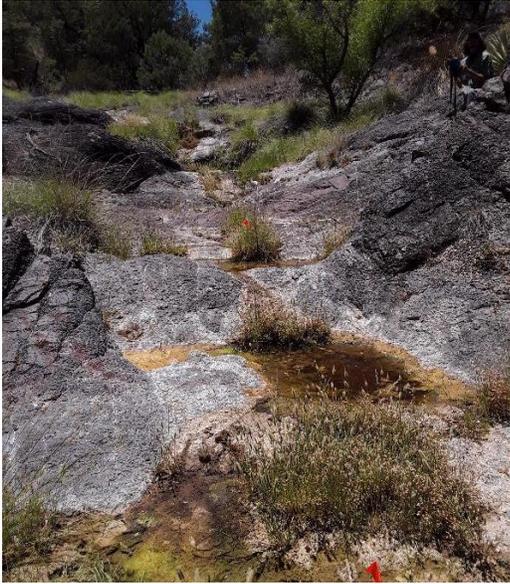
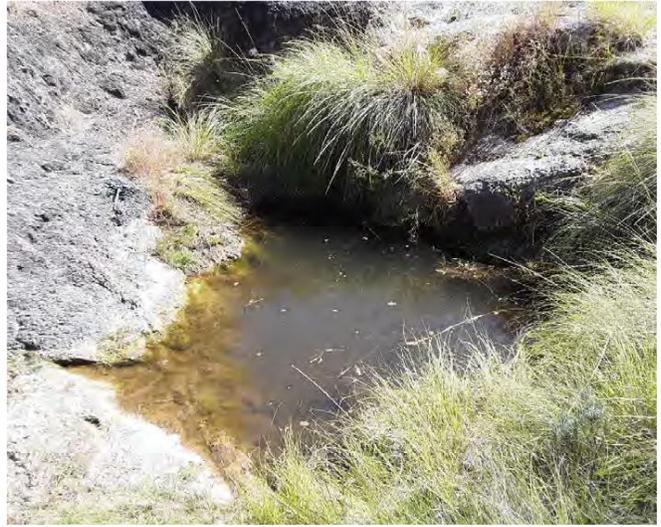
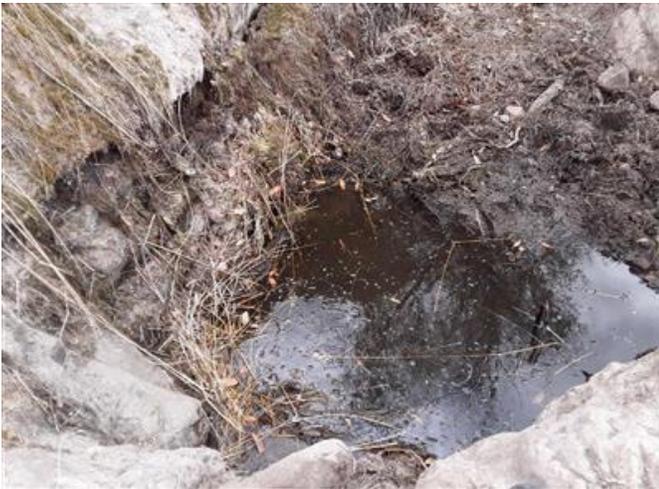
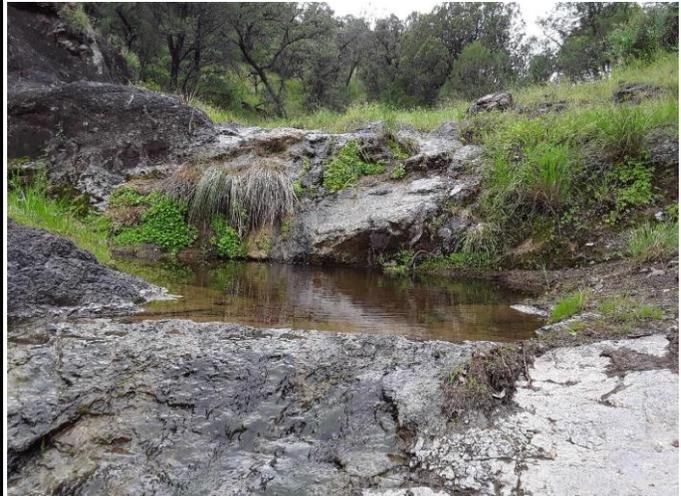
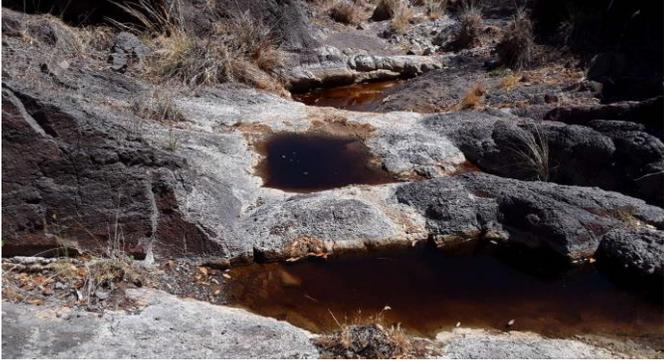
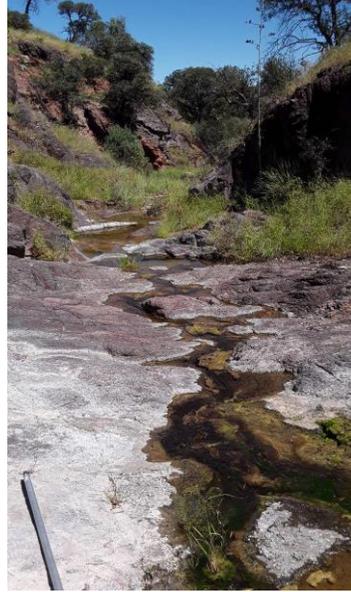
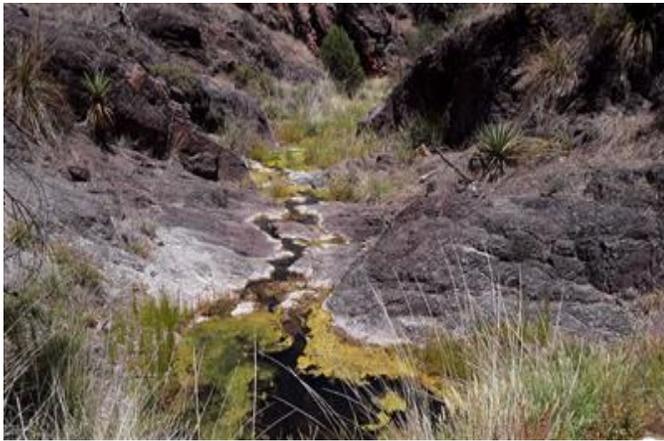
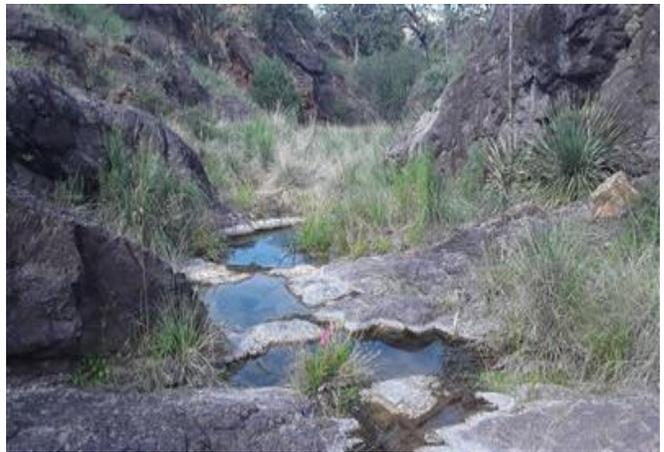
Aquatic and Vegetation Survey Findings: This seep is located in section of unnamed tributary to Harshaw Creek with exposed bedrock. Generally, water is present in shallow pools. The site supports a number of herbaceous riparian obligate or wetland associated species including seep monkeyflower (*Mimulus guttatus*) and Mexican rush (*Juncus mexicanus*) as well as a variety of other herbaceous and shrub cover including bullgrass (*Muhlenbergia emersley*), catclaw mimosa (*Mimosa aculeaticarpa* var. *biuncifera*), sotol (*Dasyliion wheeleri*), green sprangletop (*Leptochloa dubia*), and Gentry yucca (*Yucca madrensis*). Non-native rabbitsfoot grass (*Polypogon monspeliensis*) and invasive Lehmann lovegrass (*Eragrostis lehmanniana*) and barnyardgrass (*Echinochloa crus-galli*) have been observed. Aquatic beetles, boatmen, snails, water scorpions, damselflies, backswimmers, and dragonflies have been observed along this portion of the drainage. Canyon treefrogs (*Hyla arenicolor*) have been observed.
