Hermosa Spring and Seep Catalog

Hermosa Project Area

SPRING AND SEEP CATALOG Hermosa Project Area

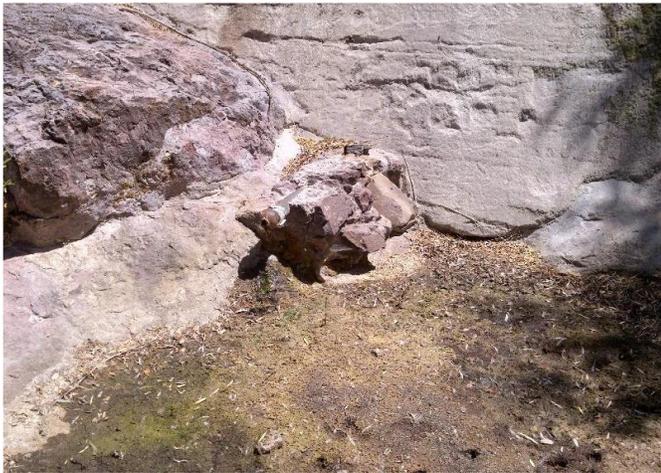
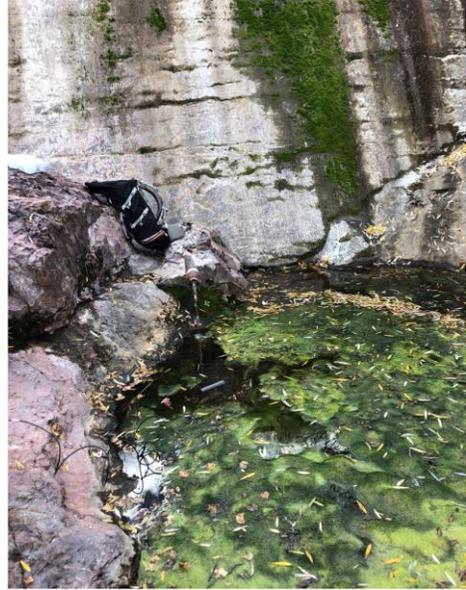
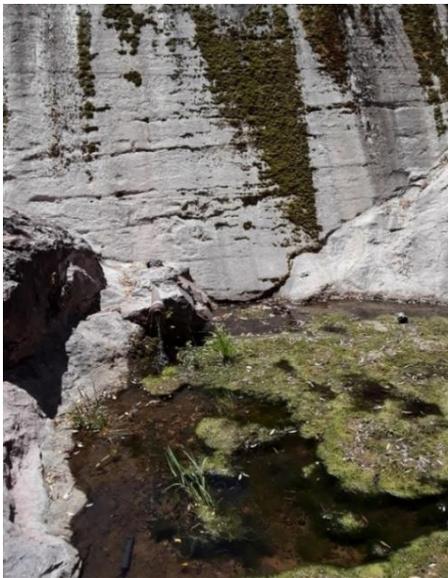
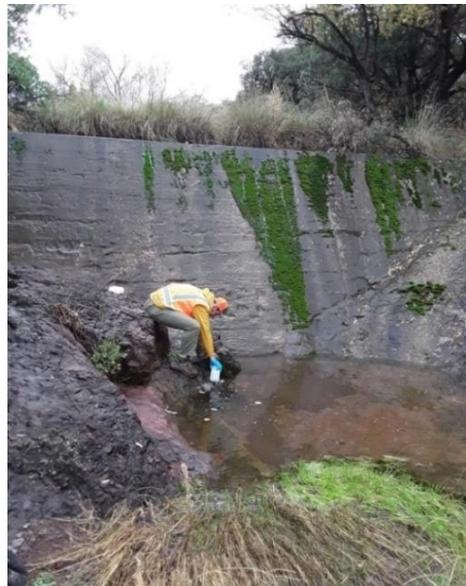
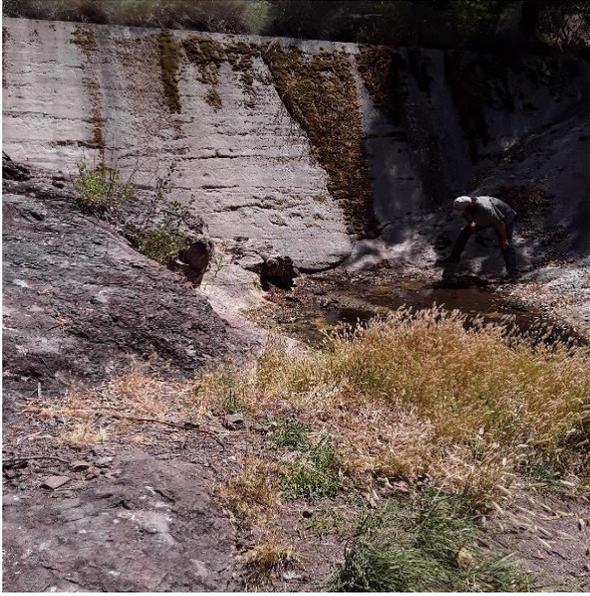
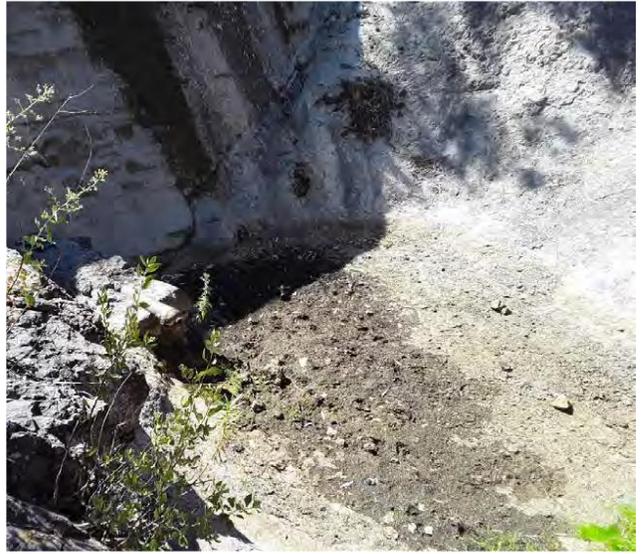
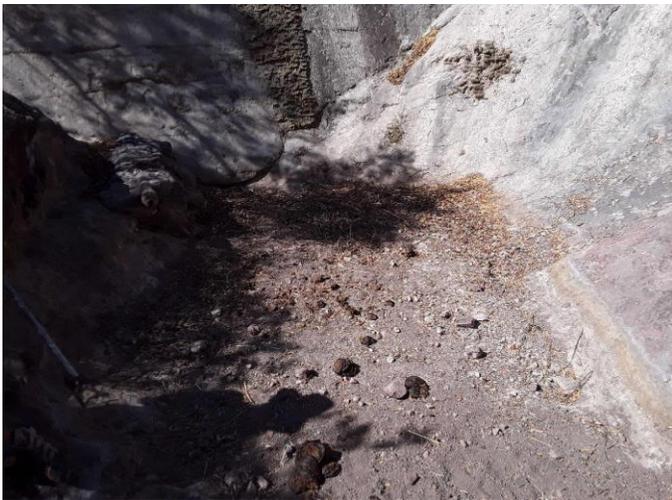
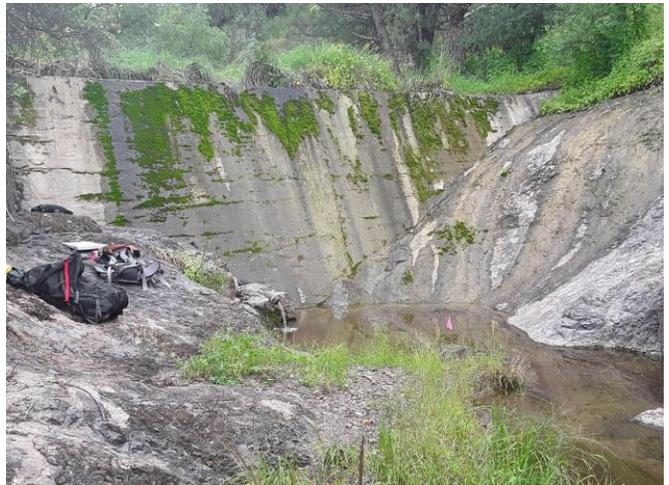
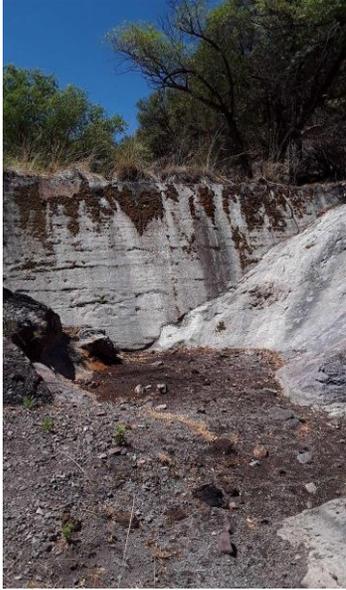
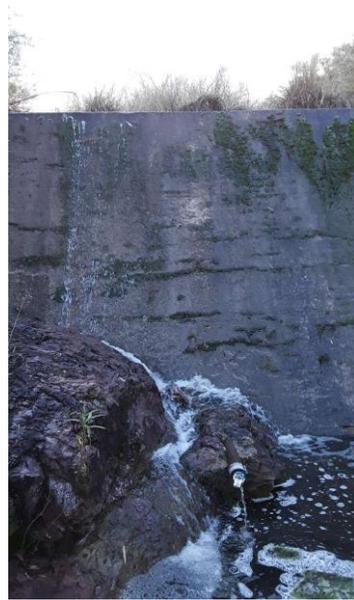
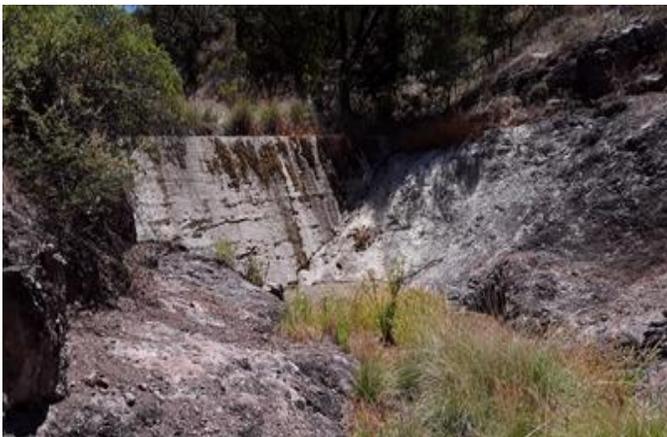
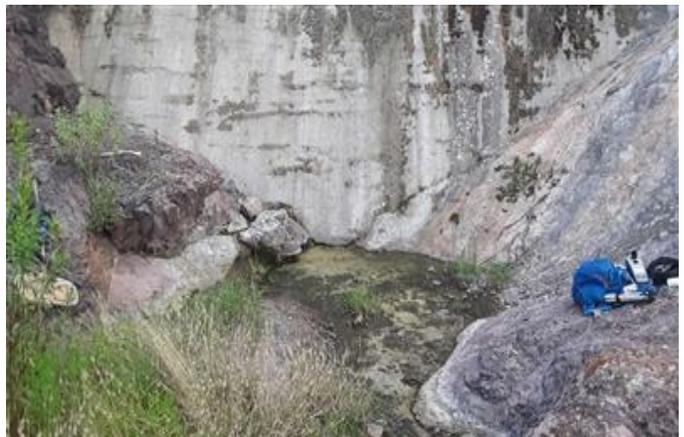
Aquatic and Vegetation Survey Findings: A relic concrete dam that has silted in within an unnamed tributary to Harshaw Creek, downstream of Great Silver Mine supports water at the base of the dam in form of pools and flowing runs during the wet season. Algae is typically present as floating substrate. Understory vegetation is dominated by deergrass (*Muhlenbergia rigens*) and seepwillow (*Baccharis salicifolia*) with seep monkeyflower (*Mimulus guttatus*), a wetland associated plant, also present. Non-native annual rabbitsfoot grass (*Polypogon monspeliensis*) has been noted. Aquatic invertebrates that have been observed include boatmen, backswimmers, dragonflies, belostomatids, and beetles. Canyon treefrog (*Hyla arenicolor*) tadpoles, toad (*Bufo* sp.) tadpoles, and black-necked gartersnakes (*Thamnophis cyrtopsis*) have been observed at this site.

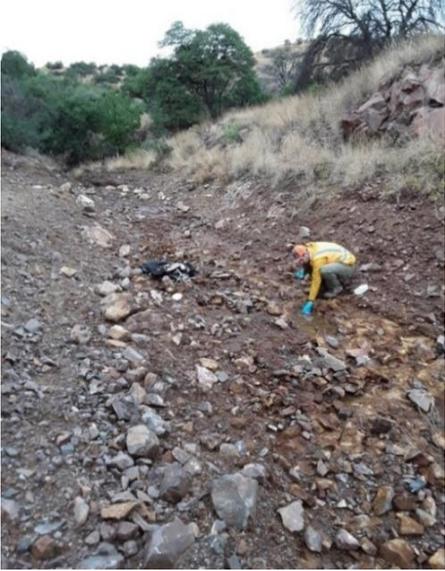
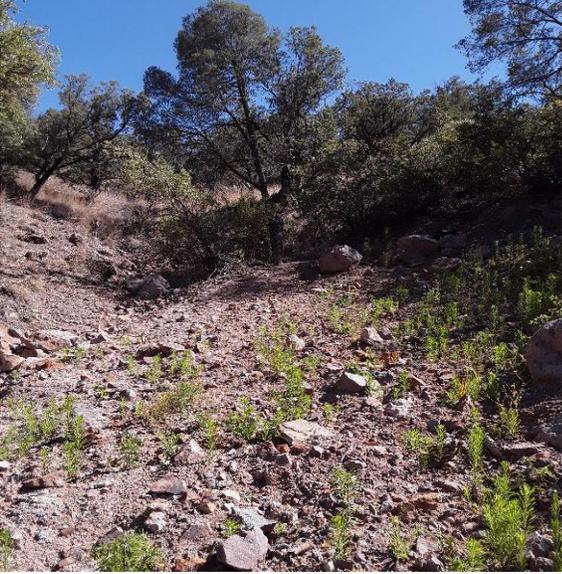
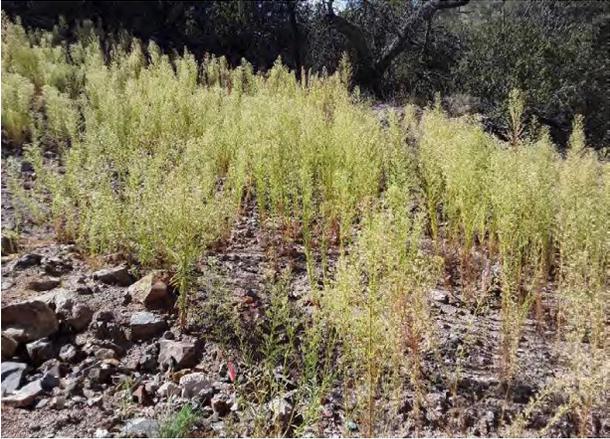
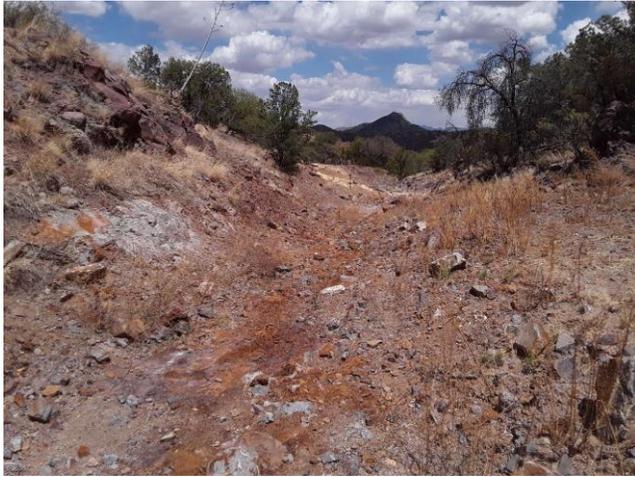
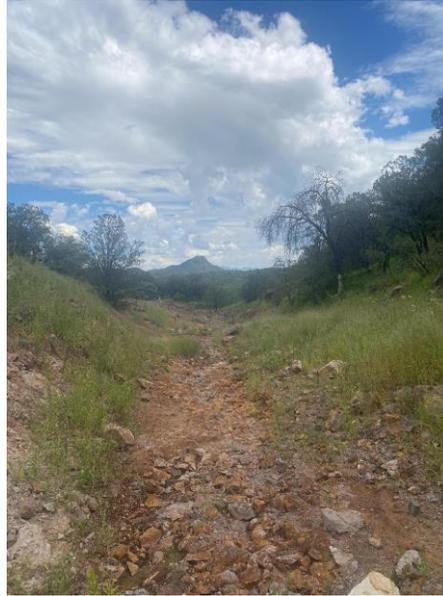
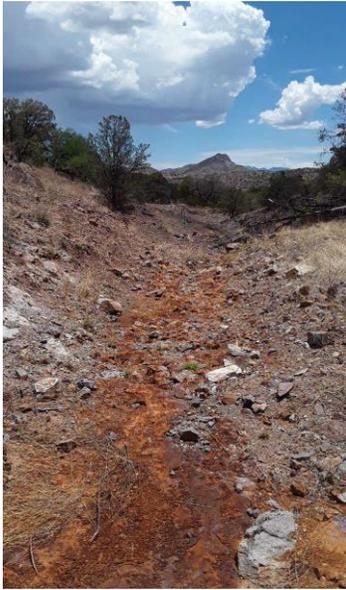
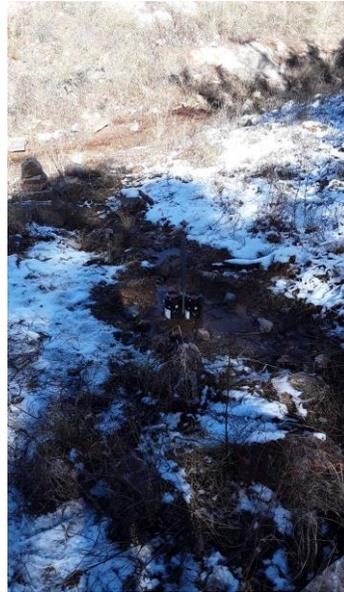
Aquatic and Vegetation Survey Findings: This adit is located in a sandy, gravelly portion of an unnamed tributary to Harshaw Creek; the site was completely filled in and the area around it reclaimed in 2019. There is no remaining aquatic resource thus, no aquatic invertebrates or vertebrates are present. Upland vegetation includes mesquite (*Prosopis* sp.), oak (*Quercus* sp.), juniper (*Juniperus* sp.) and sumac (*Rhus* sp.). The reclaimed area is covered primarily by Canadian horsetweed (*Conyza canadensis*) and non-native Mexican tulip poppy (*Hunnemannia fumariifolia*).

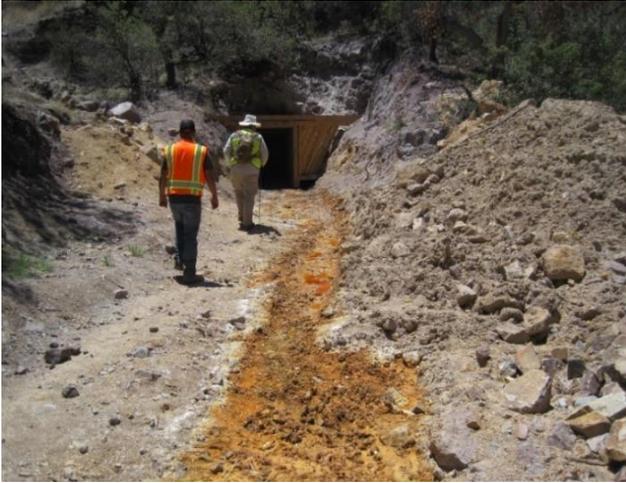
Dry Season Photo (5/21/2018)

Aquatic and Vegetation Survey Findings: This adit is located in a sandy, gravelly portion of an unnamed tributary to Harshaw Creek; the site was completely filled in and the area around it reclaimed in 2019. There is no remaining aquatic resource thus, no aquatic invertebrates or vertebrates are present. Upland vegetation includes mesquite (*Prosopis* sp.), oak (*Quercus* sp.), juniper (*Juniperus* sp.) and sumac (*Rhus* sp.). The reclaimed area is covered primarily by Canadian horseweed (*Conyza canadensis*) and non-native Mexican tulip poppy (*Hunnemannia fumariifolia*).

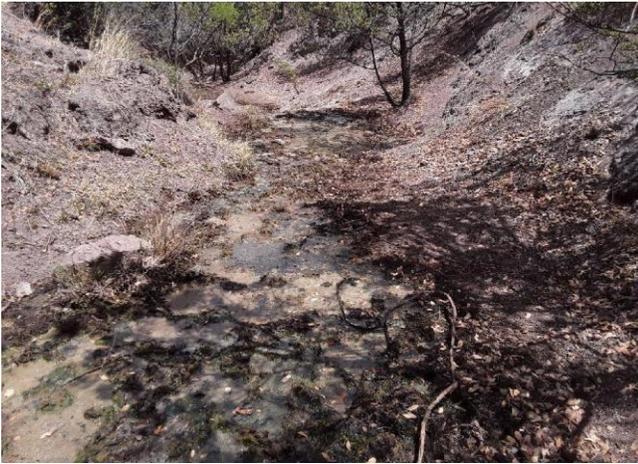
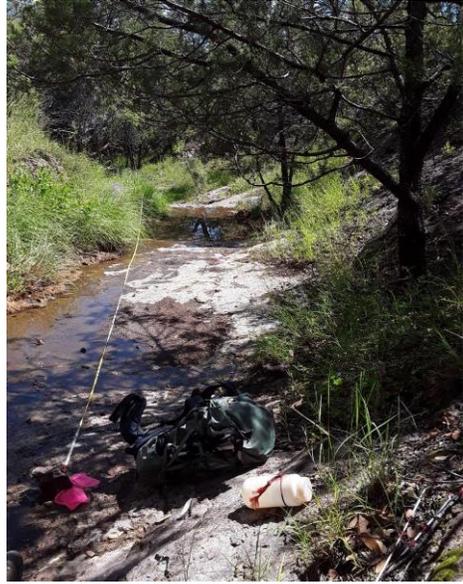
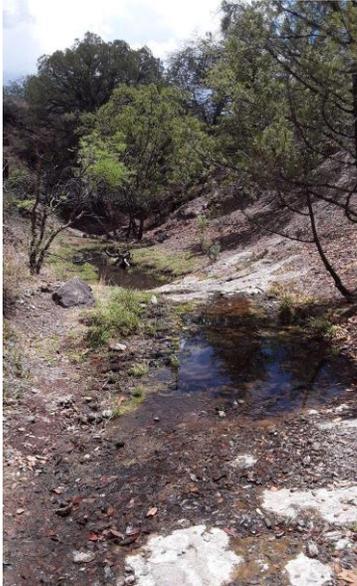
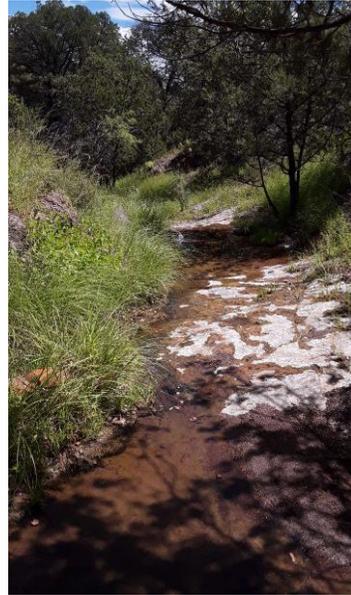
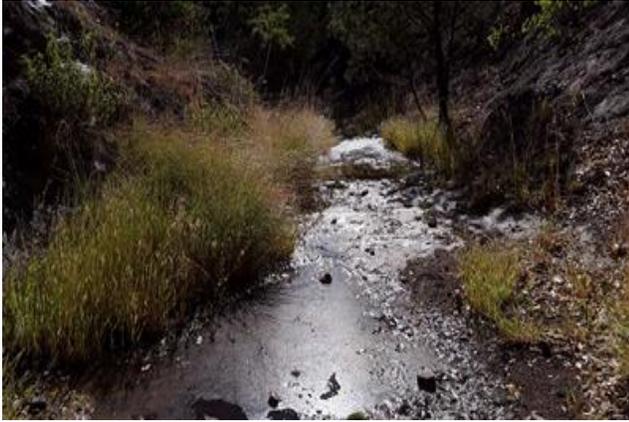
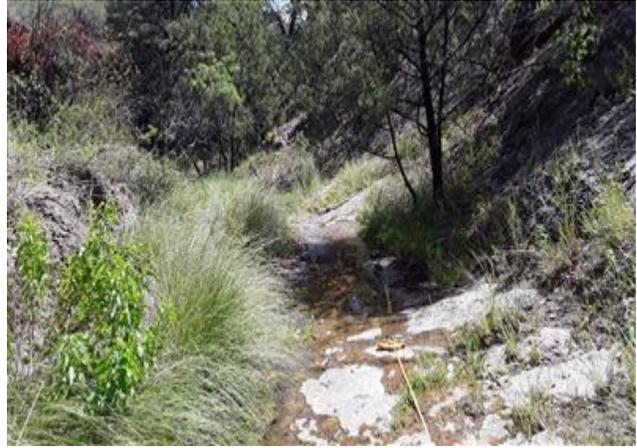
Aquatic and Vegetation Survey Findings: Water seeps from the cutout on the northwest bank. Flows atop bedrock and shallow, alluvial veneer. Vegetation is described as Madrean evergreen woodland. This site is dominated by a woody overstory of Arizona white oak (*Quercus arizonica*) and alligator juniper (*Juniperus deppeana*) and a woody understory that includes Wright's silk tassel (*Garrya wrightii*) and evergreen sumac (*Rhus virens var. choriophylla*). Ground cover is dominated by tick-trefoil (*Desmodium rosei*) and deergrass (*Muhlenbergia rigens*) with Rocky Mountain rush (*Juncus saximontanus*) and sedges (*Cyperus* sp.) present at the seep periphery. Invasive Bermudagrass (*Cynodon dactylon*) is present. Aquatic beetles, belostomatids, and damselflies have been observed. One red-spotted toad (*Anaxyrus punctatus*) metamorph has been observed. The site and surroundings are subject to cattle grazing, and deer tracks were observed during multiple visits.

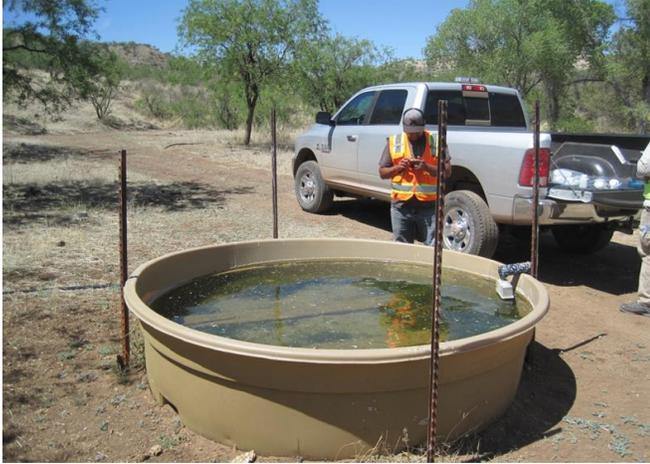
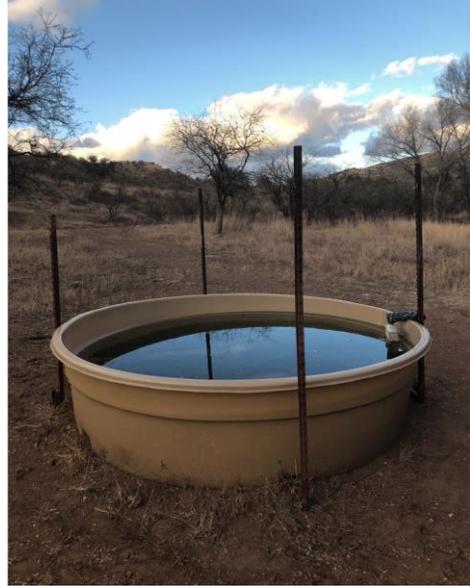
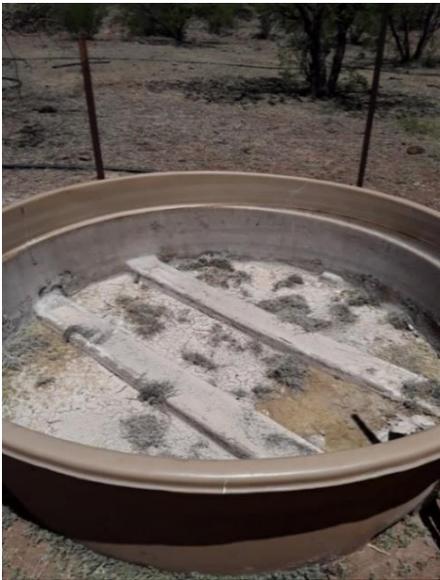
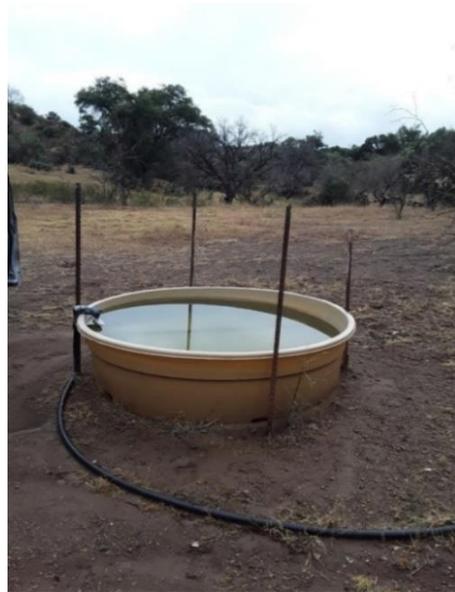
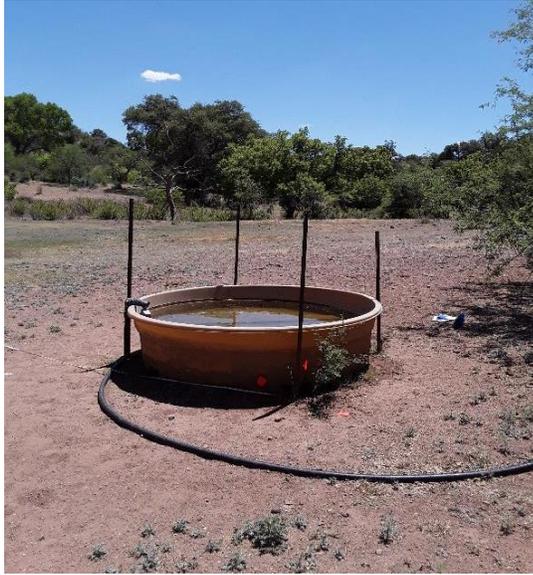
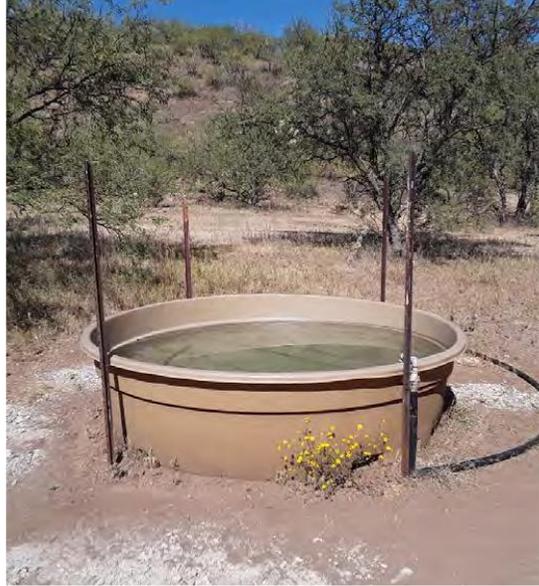
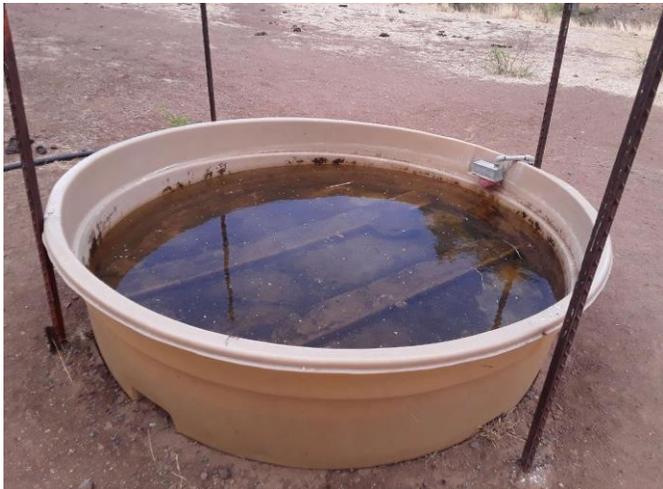
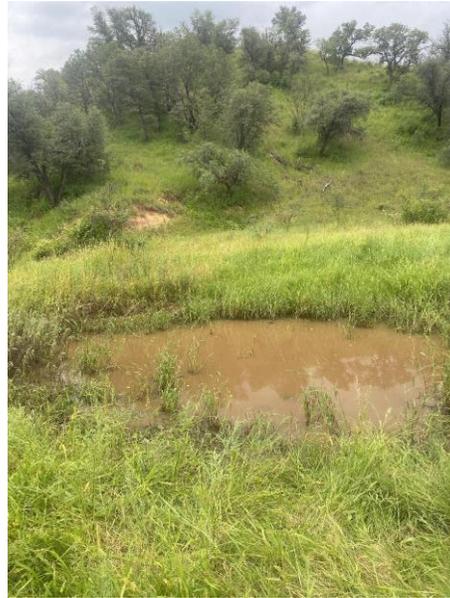
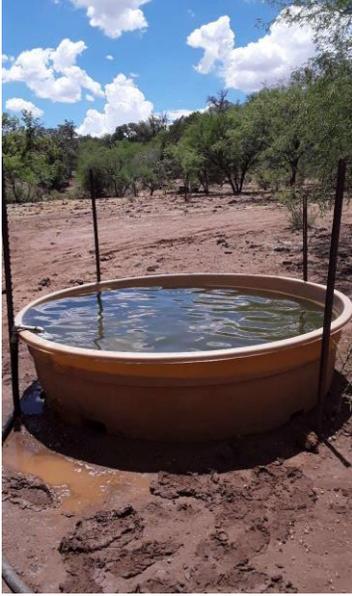
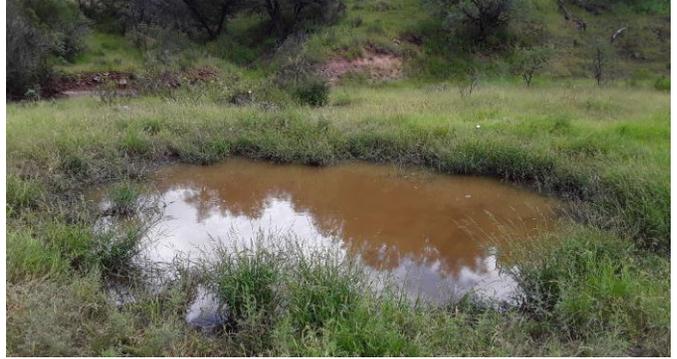
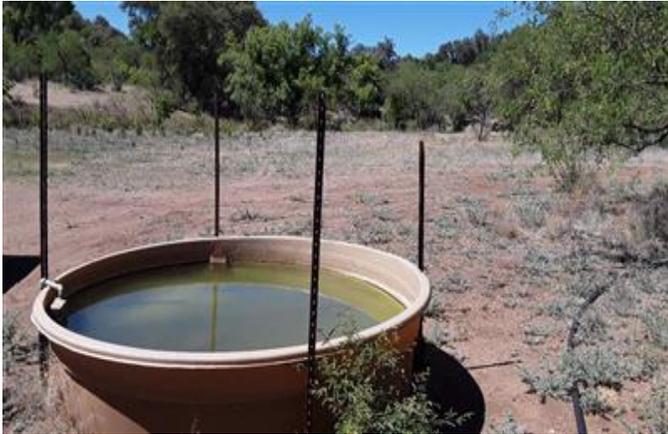
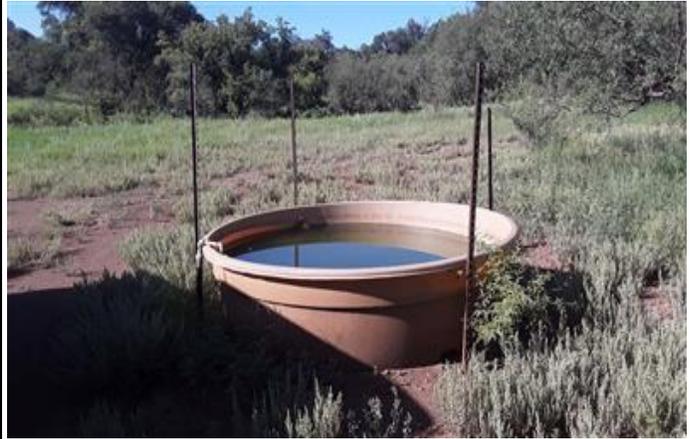
Aquatic and Vegetation Survey Findings: This site is a plastic stock drinker located in an unnamed tributary to Harshaw Creek. Algae has been observed as submerged vegetation at this site. This site does not support emergent or perimeter riparian vegetation. Understory and overstory vegetation at the site includes velvet mesquite (*Prosopis velutina*) and weakleaf bur ragweed (*Ambrosia confertiflora*). Invasive Bermudagrass (*Cynodon dactylon*) has been observed at this site. Aquatic invertebrates observed in this drinker include backswimmers, boatmen, beetles, dragonflies, and belostomatids. There have been no aquatic vertebrates observed.

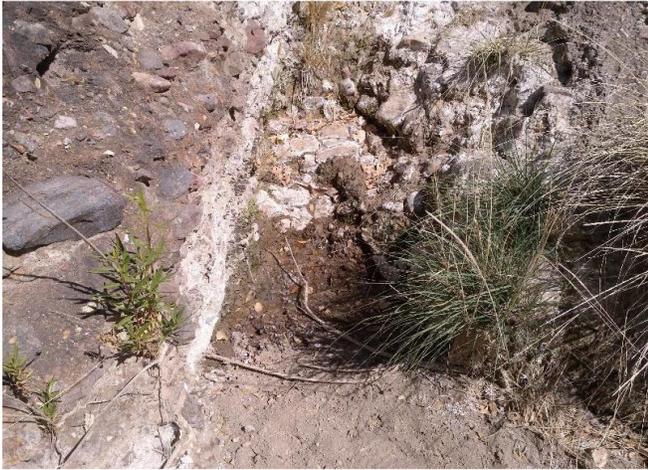
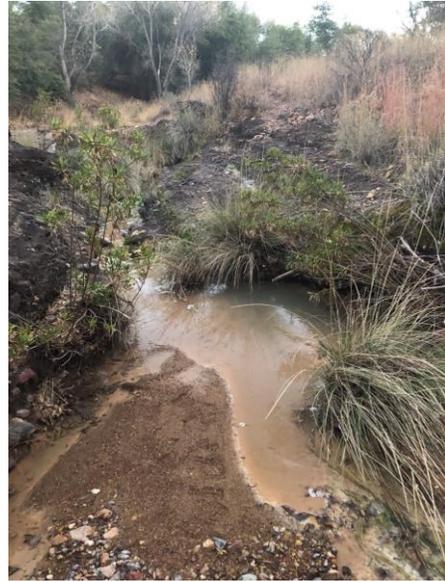
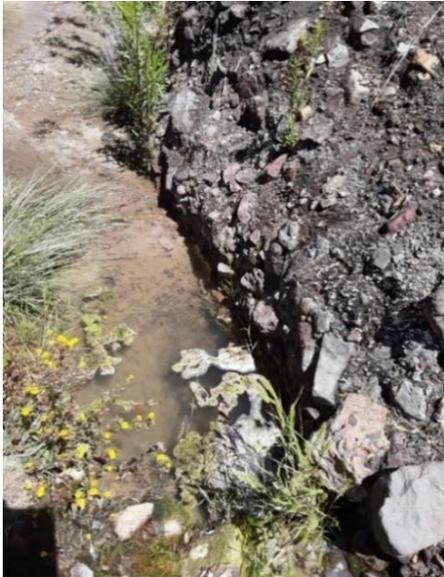
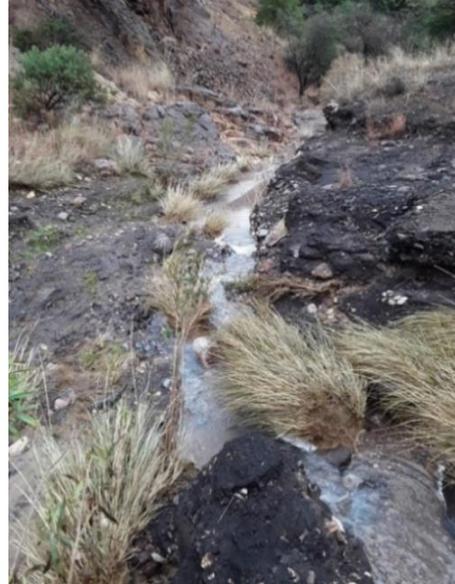
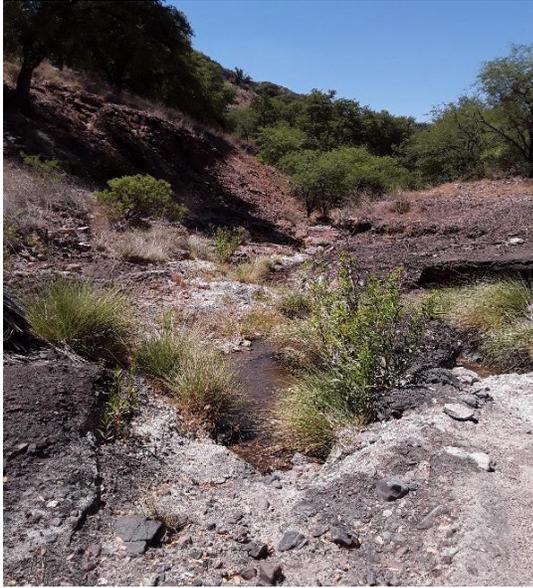
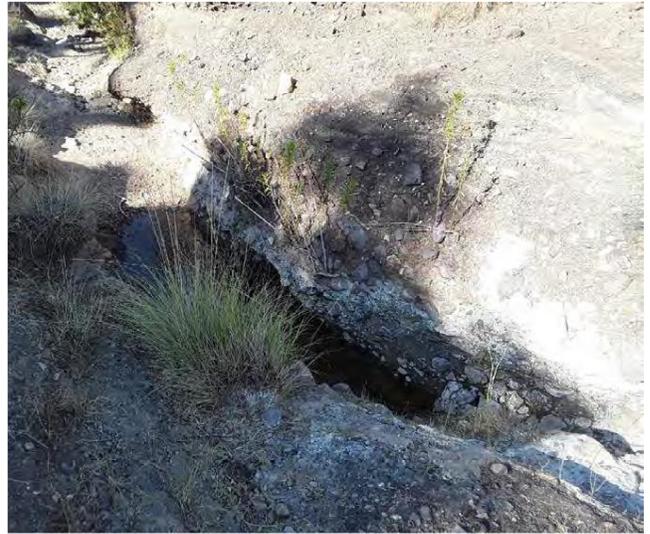
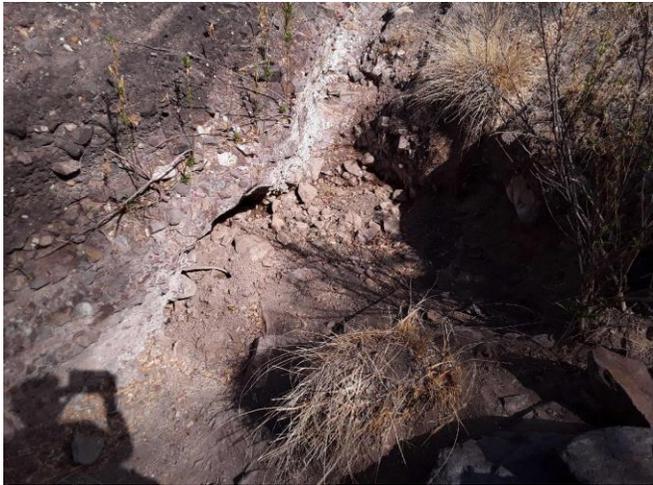
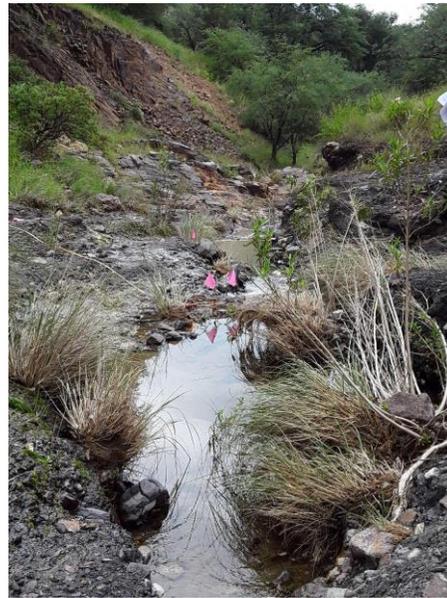
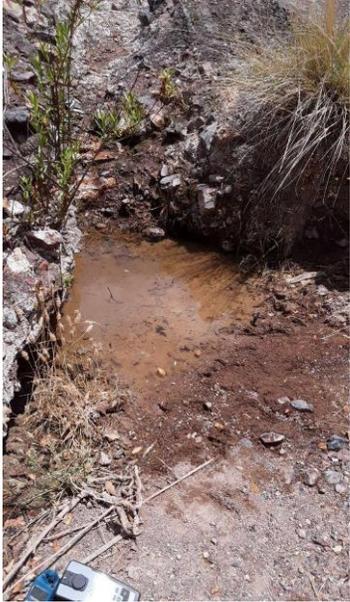
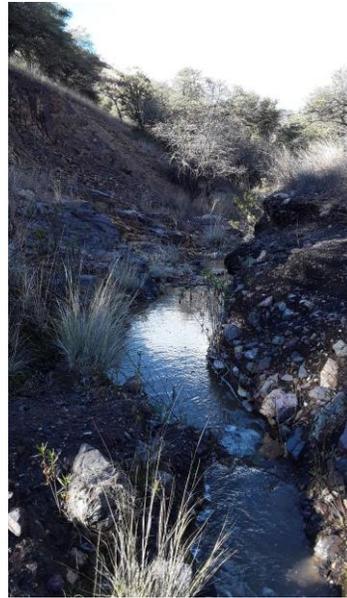
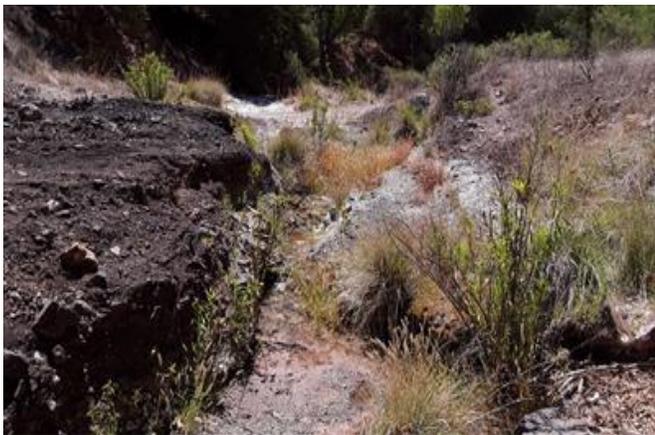
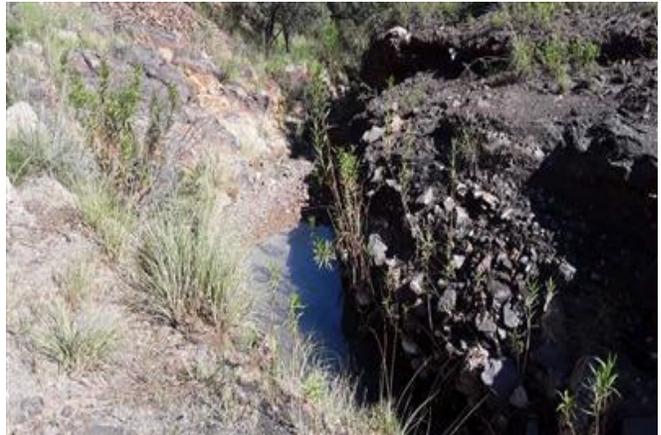
Aquatic and Vegetation Survey Findings: Located in unnamed tributary to Harshaw Creek in portion with bedrock channel. Generally, water is present in shallow pools. Aquatic beetles, boatmen, belostomatids, and dragonflies have been observed. No aquatic vertebrates have been observed along drainage. Riparian overstory is limited to a few individual cottonwood (*Populus fremontii*) trees in the vicinity. Understory vegetation is dominated by seepwillow (*Baccharis salicifolia*), skunkbush sumac (*Rhus trilobata*), and deergrass (*Muhlenbergia rigens*). Riparian obligate forbs, seep monkeyflower (*Mimulus guttatus*) and annual rabbitsfoot grass (*Polypogon monspeliensis*), have been noted. Upland vegetation is characterized as oak woodlands with pointleaf manzanita (*Arctostaphylos pungens*). Aquatic beetles, boatmen, belostomatids, water scorpions, and dragonflies have been observed. No aquatic vertebrates have been observed along drainage.

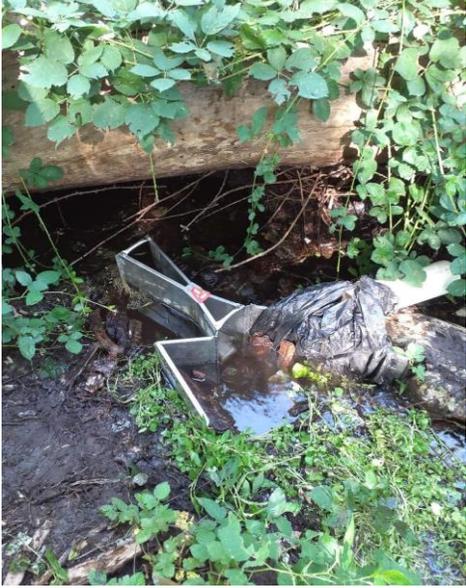
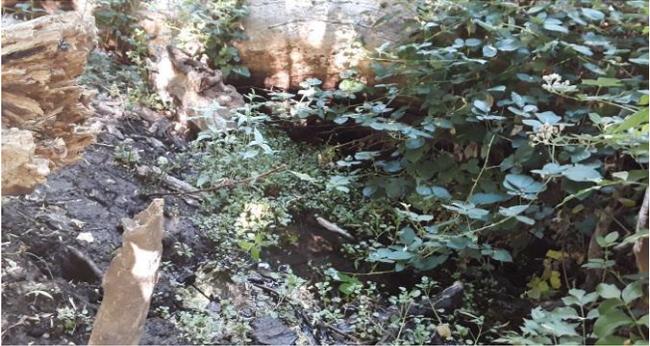
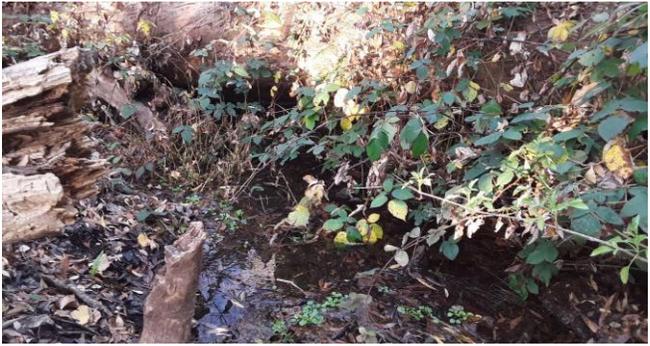
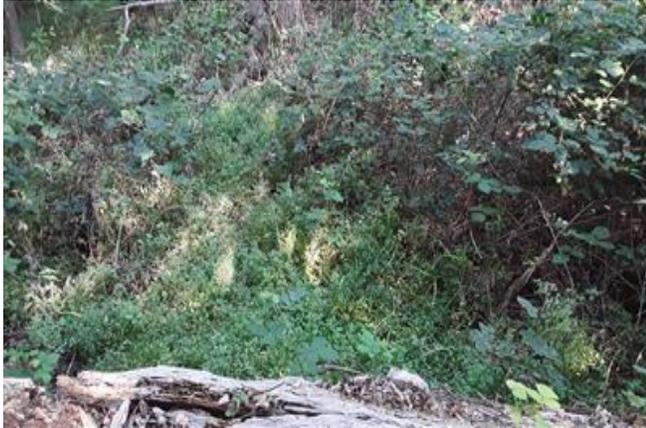
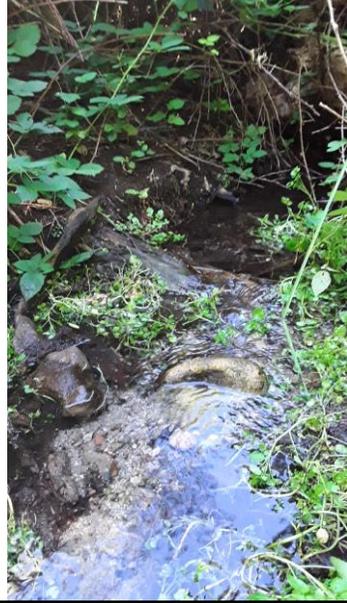
Aquatic and Vegetation Survey Findings: Emergence of spring at the base of small hill flowing out from under log forming large cienega. Predominant floating and emergent vegetation include watercress (*Rorippa nasturtium-aquaticum*), chairmaker's bulrush (*Schoenoplectus americanus*), and whorled pennywort (*Hydrocotyle verticillata*). Perimeter vegetation consists of Himalayan blackberry (*Rubus discolor*), velvet ash (*Fraxinus velutina*), and Goodding's willow (*Salix gooddingii*). Invasive Johnsongrass (*Sorghum halepense*) occurs. Aquatic beetles have been observed. An adult red-spotted toad (*Anaxyrus punctatus*) has been observed.

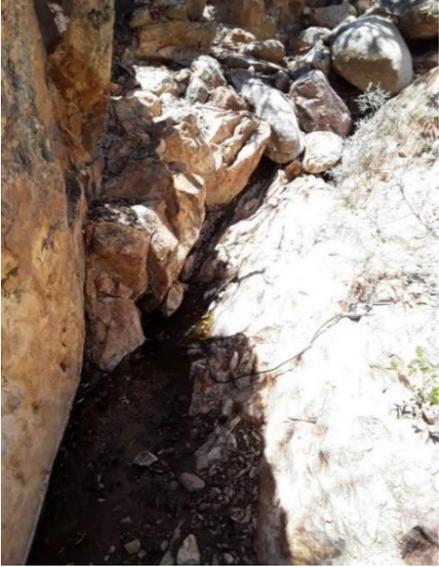
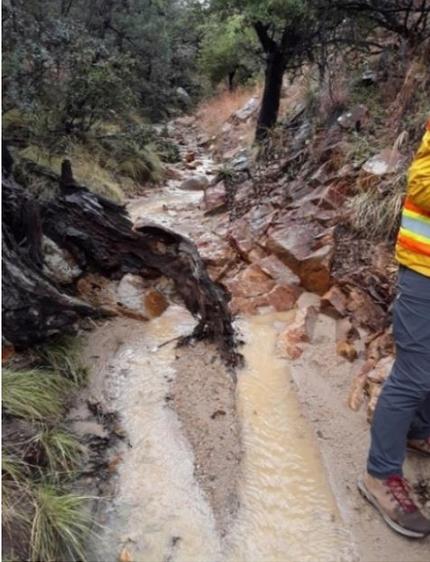
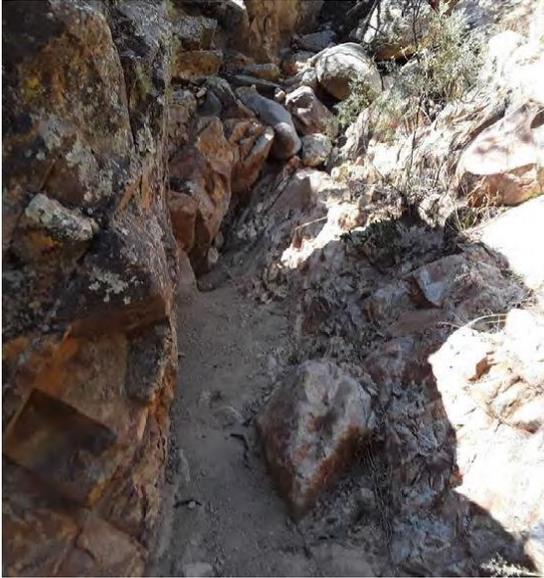
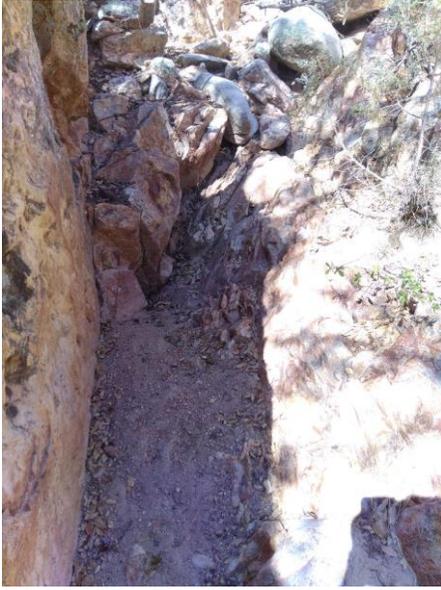
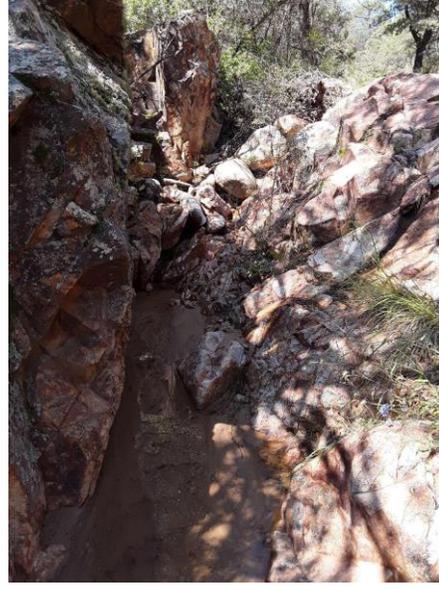
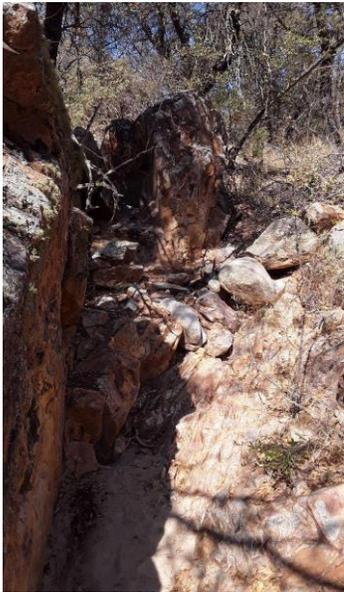
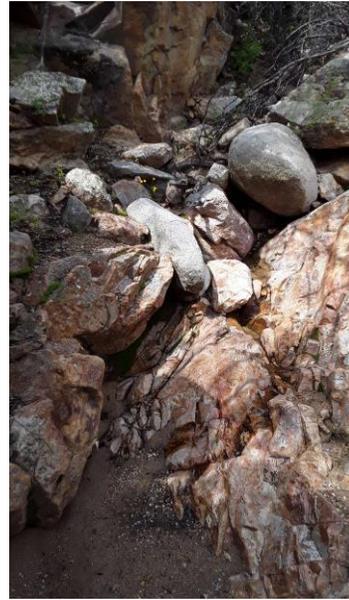
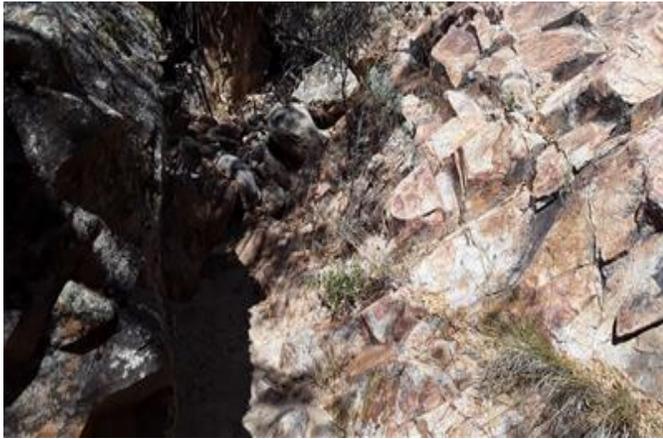
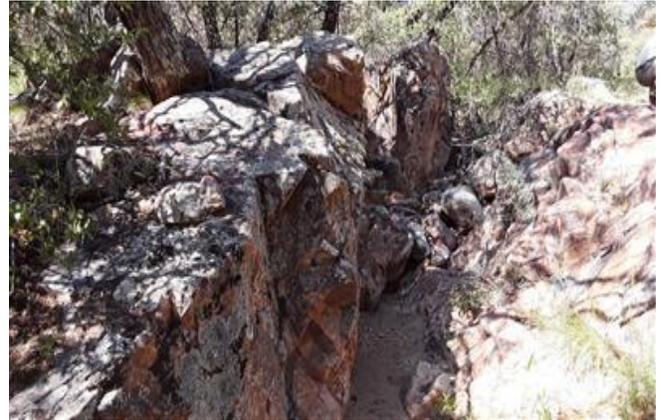
Aquatic and Vegetation Survey Findings: This seep is located at an exposed bedrock constriction in the upper Finley and Adams Canyon. Grasses and shrubs occur in sparse distributions, mostly dominated by little bluestem (*Schizachyrium* sp.), pinyon ricegrass (*Piptochaetium fimbriatum*), and skunkbush sumac (*Rhus trilobata*). Riparian obligate rushes (*Juncus* spp.) are also present at the site. Overstory vegetation cover is dominated by Mexican pinyon (*Pinus cembroides*) and oak (*Quercus* spp.). Invasive plants observed include Lehmann lovegrass (*Eragrostis lehmanniana*). No aquatic invertebrates or vertebrates have been observed at this site.

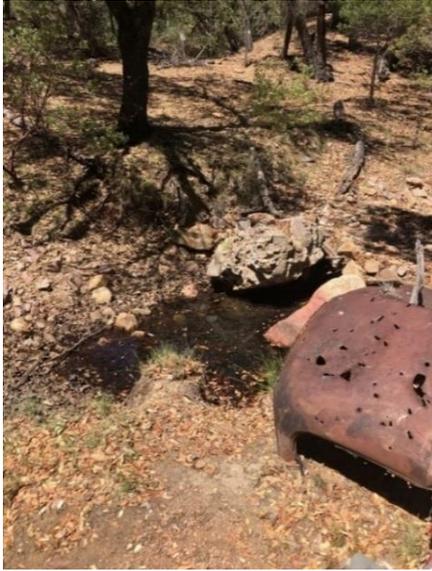
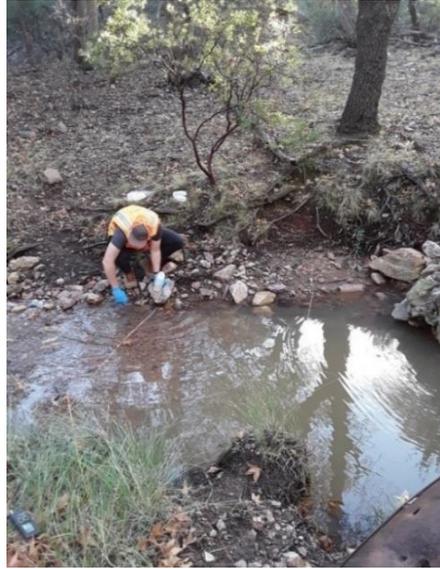
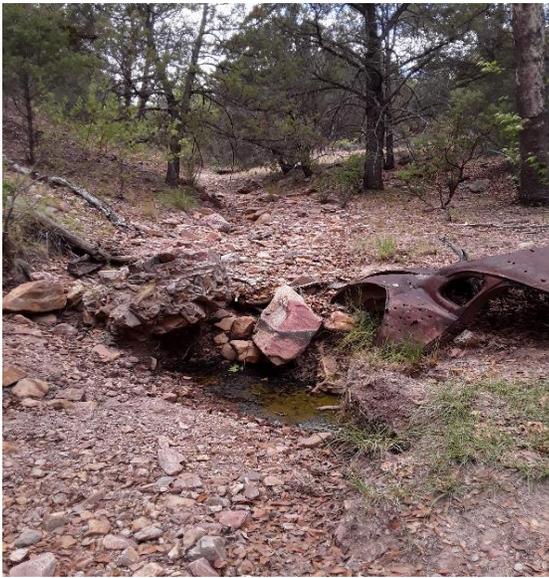
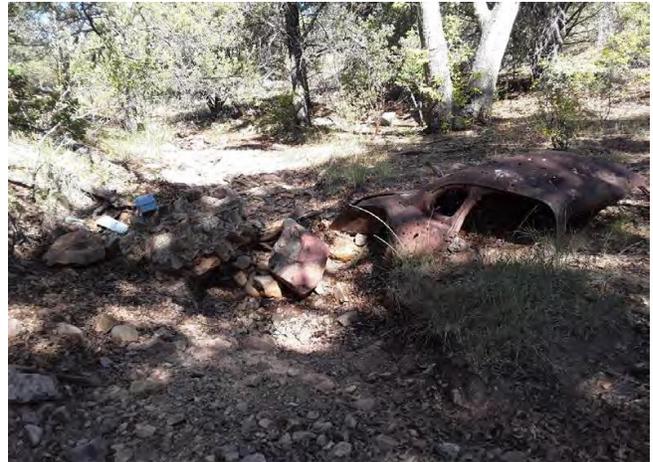
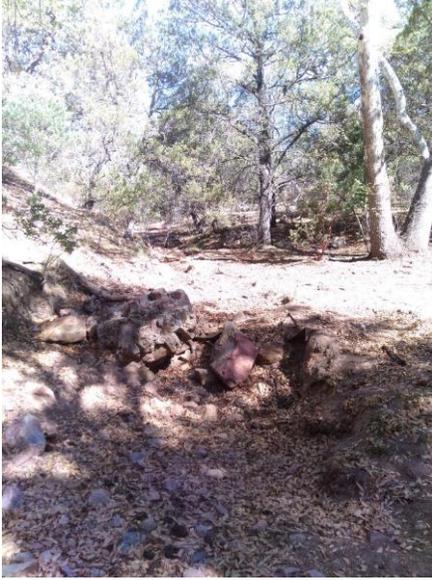
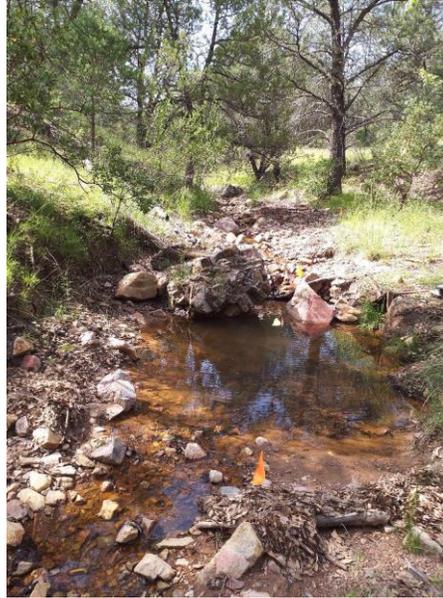
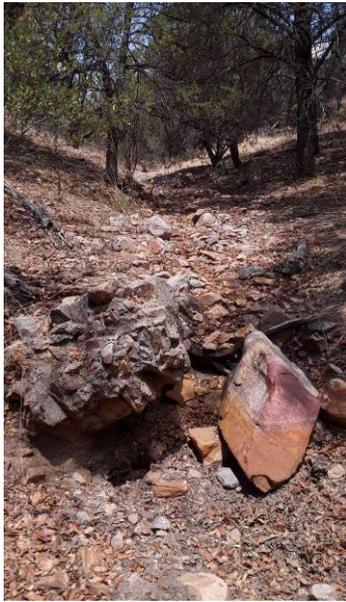
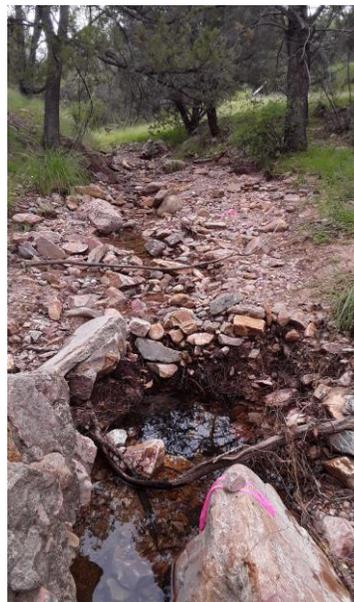
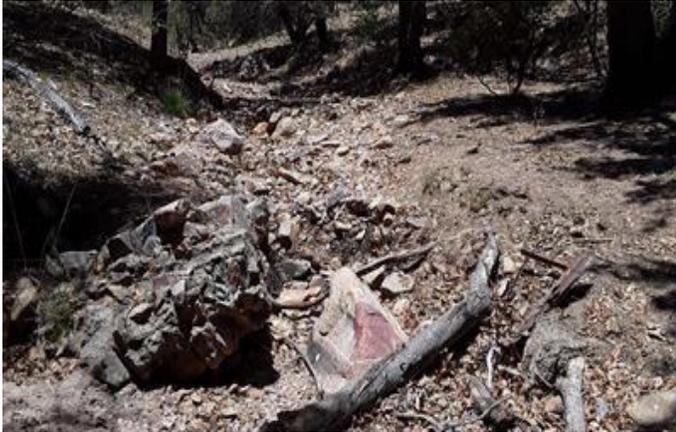
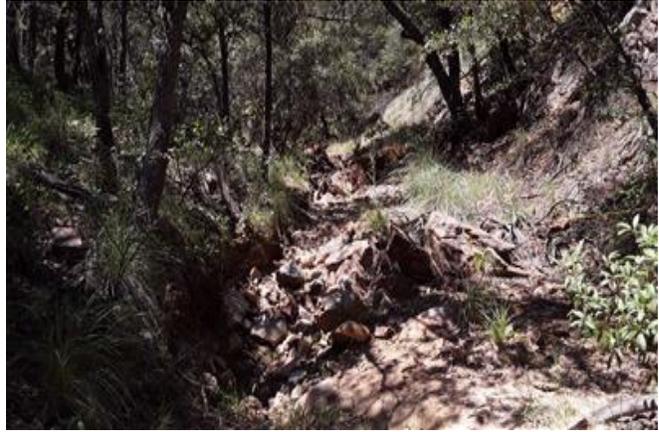
Aquatic and Vegetation Survey Findings: This seep is located in a rocky/gravelly section of Finley and Adams Canyon. Water is typically present in a small, shallow pool. Limited herbaceous cover is dominated by deergrass (*Muhlenbergia rigens*) and riparian obligate Rocky Mountain rush (*Juncus saximontanus*). Understory shrub cover is dominated by pointleaf manzanita (*Arctostaphylos pungens*), skunkbush sumac (*Rhus trilobata*), and Wright's siltkassel (*Garrya wrightii*). Overstory vegetation is dominated by Arizona sycamore (*Platanus wrightii*), a preferential riparian tree species, and oak (*Quercus* spp.). Invasive Bermudagrass (*Cynodon dactylon*) occurs. Aquatic invertebrates observed along the Finley and Adams drainage include backswimmers and beetles. No aquatic vertebrates have been observed at this site.
