Hermosa Spring and Seep Catalog

Hermosa Project Area

SPRING AND SEEP CATALOG Hermosa Project Area

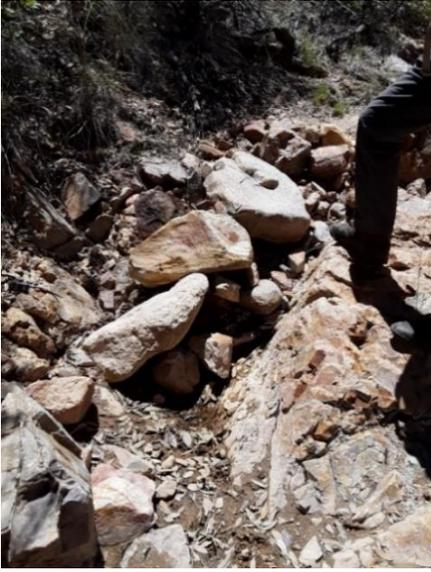
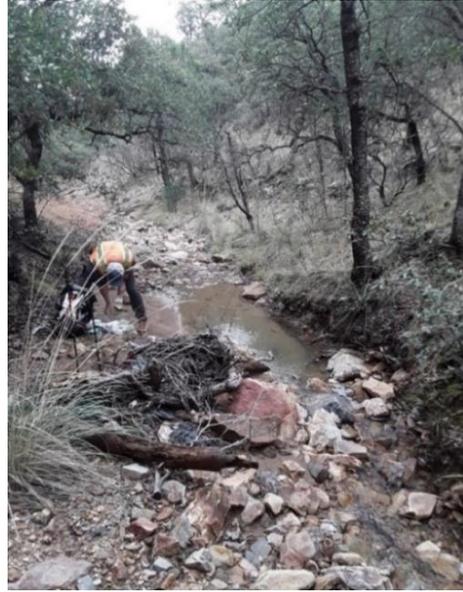
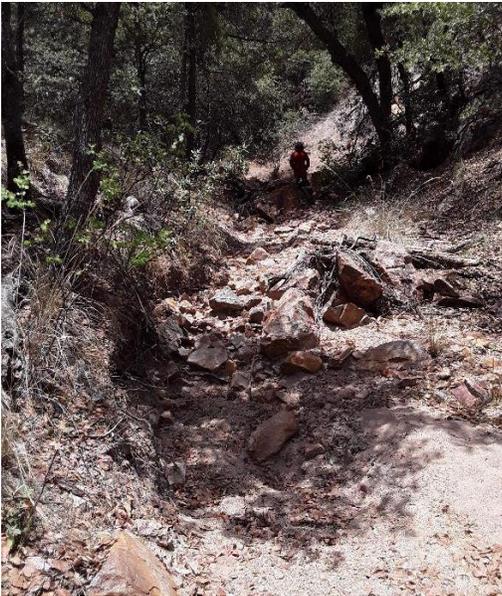
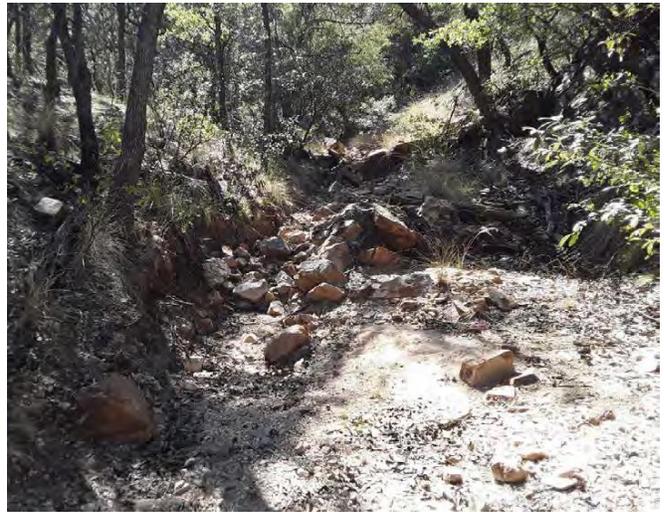
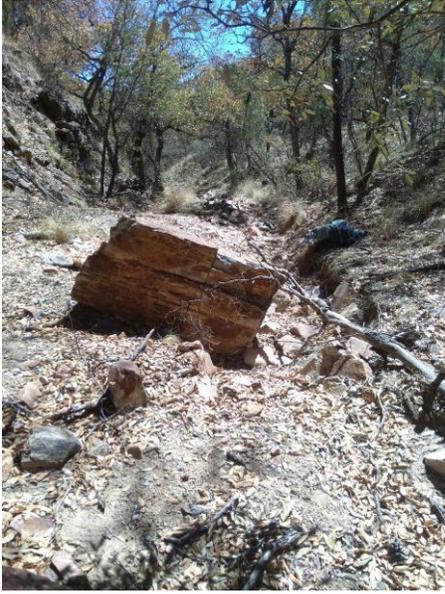
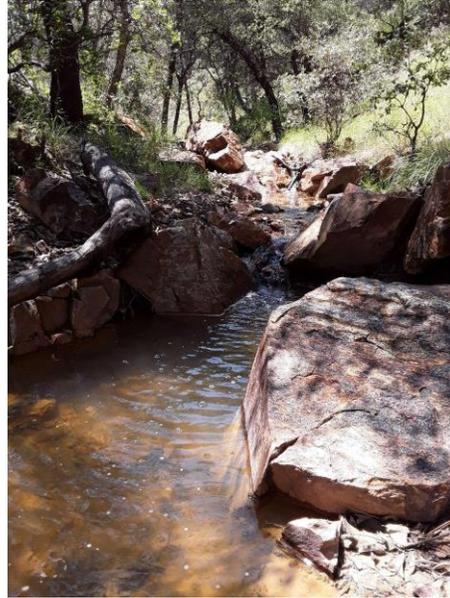
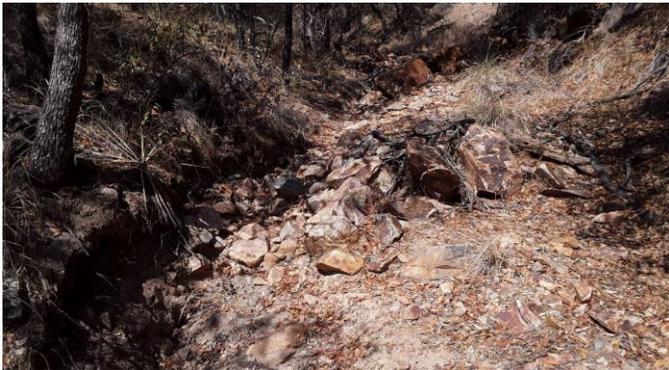
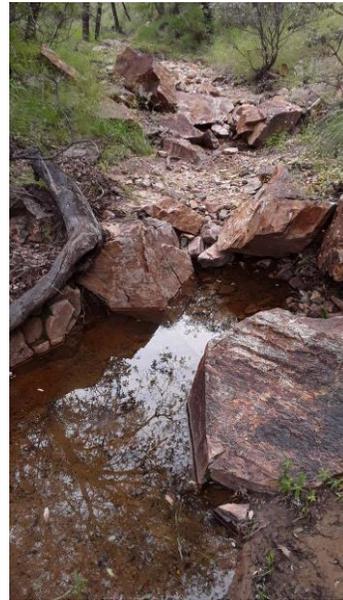
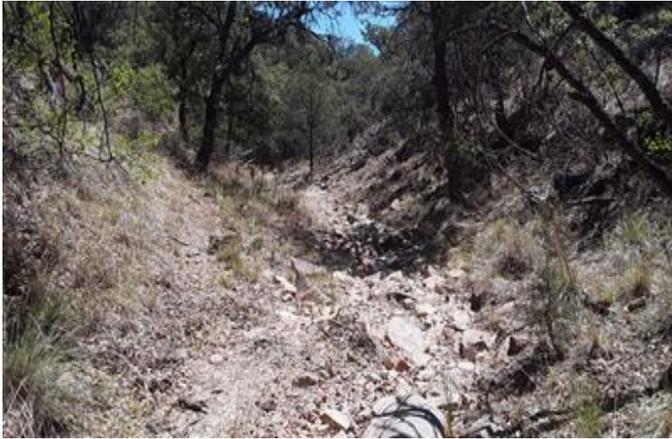
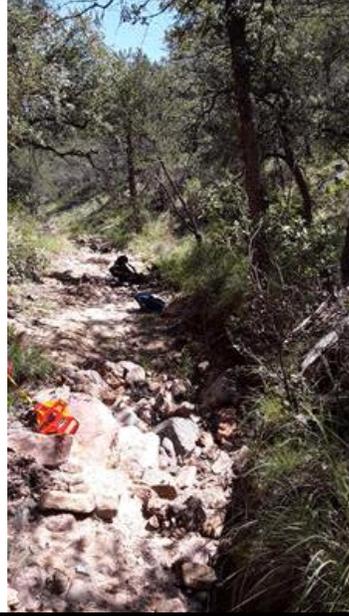
Aquatic and Vegetation Survey Findings: This site is located in rocky/bouldery section of Finley and Adams Canyon. Herbaceous cover is sparsely distributed, dominated by bullgrass (*Muhlenbergia emersleyi*) and pinyon ricegrass (*Piptochaetium fimbriatum*). Riparian obligate Rocky Mountain rush (*Juncus saximontanus*) is also present. Overstory vegetation is dominated by oak (*Quercus* spp.) and pine (*Pinus* spp.) trees. Invasive Lehmann lovegrass (*Eragrostis lehmanniana*), barnyardgrass (*Echinochloa crus-galli*), and natalgrass (*Melinis repens*) have been observed. Aquatic invertebrates observed are backswimmers. Aquatic vertebrates observed are tadpoles of an unidentified species.

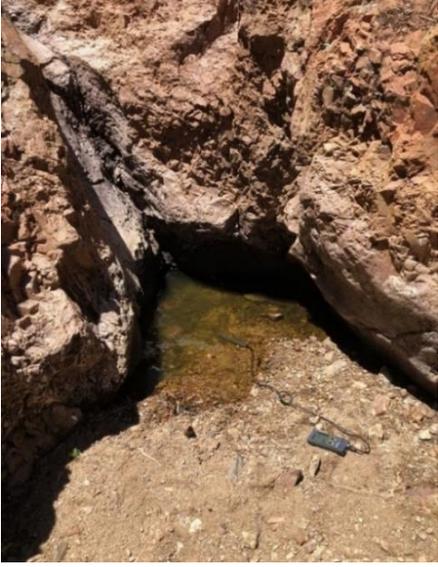
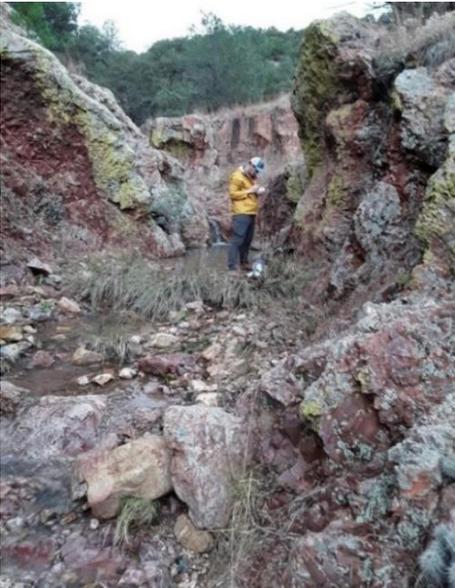
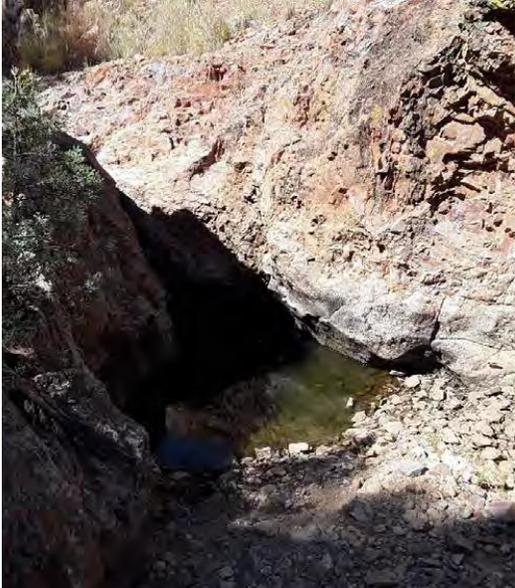
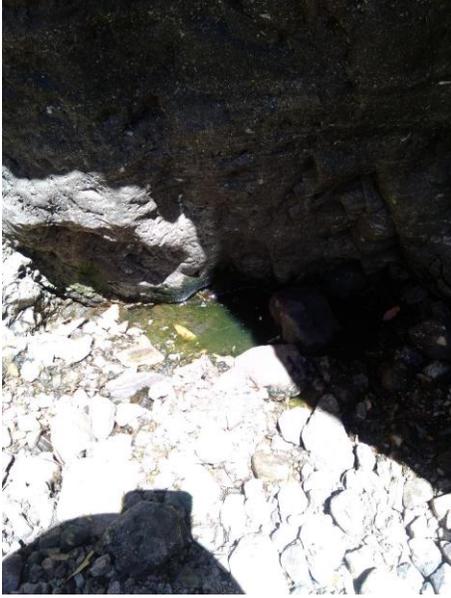
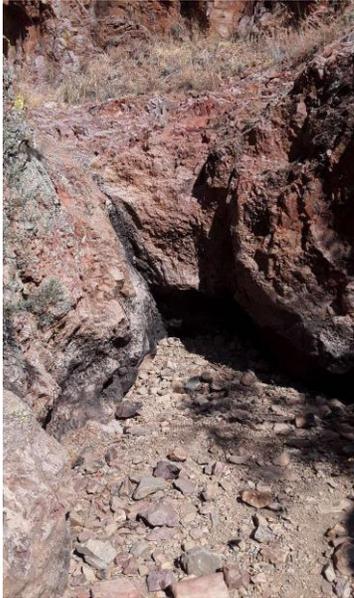
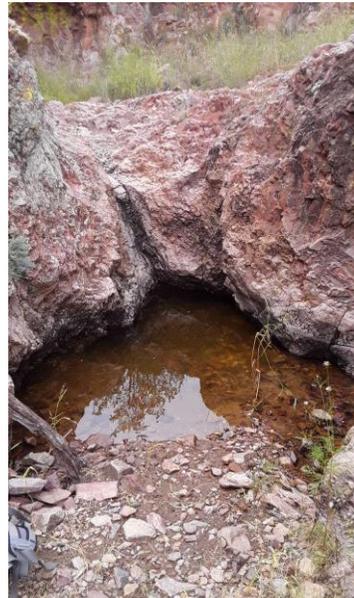
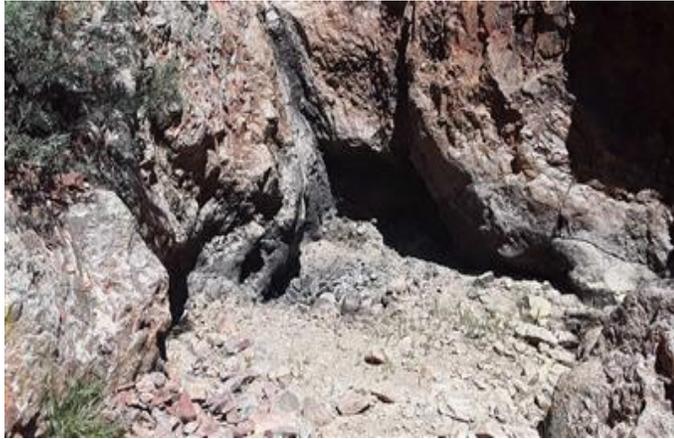
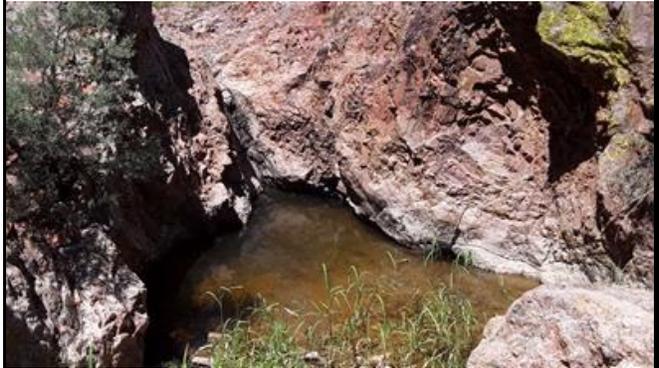
Aquatic and Vegetation Survey Findings: Seep is located at a bedrock constriction in Finley and Adams Canyon where a plunge pool is present at the base of the bedrock. The plunge pool does not support emergent or perimeter vegetation. Within the drainage, understory vegetation is sparse, dominated by deergrass (*Muhlenbergia rigens*) and hummingbird trumpet (*Epilobium canum*). Other perennial grasses (*Poaceae* family) and riparian obligate Baltic rush (*Juncus balticus*) are present. Alligator juniper (*Juniperus deppeana*) and Mexican pinyon (*Pinus cembroides*) dominate the overstory vegetation within this section of the drainage. Invasive plant species observed include Johnson grass (*Sorghum halepense*), barnyardgrass (*Echinochloa crus-galli*), and natalgrass (*Melinis repens*). Aquatic invertebrates observed include beetles, boatmen, backswimmers, and waterstriders. Aquatic vertebrates observed are tadpoles and metamorphs of an unidentified species. Deer tracks have been noted during some visits.

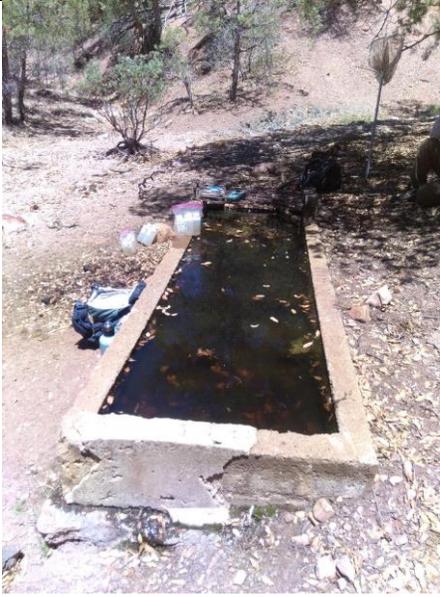
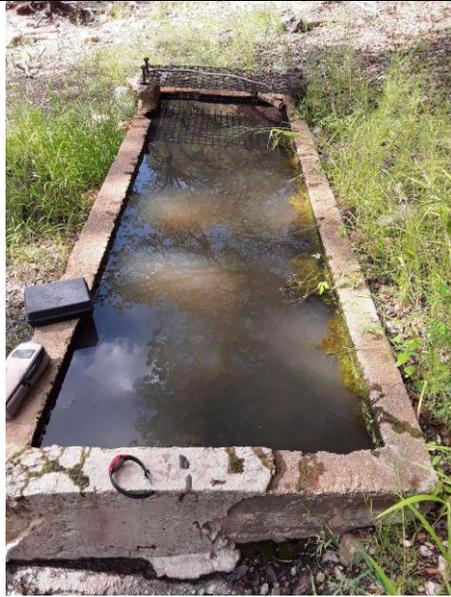
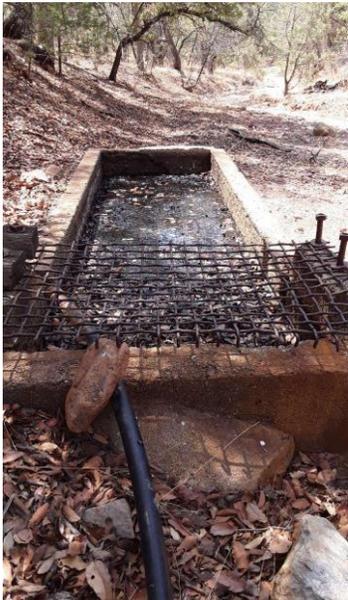
Aquatic and Vegetation Survey Findings: Hillslope spring emergence is captured in the springbox and plumbed to the downstream concrete drinker. The ground is saturated downstream of the spring box in the wash for a slight reach. Concrete, rectangular stock drinker (approx. 4m x 2m) is fed from a pipe sunk into the adjacent hillside. The line may collect water from a subsurface source or the adjacent concrete stock drinker. Upland vegetation is Madrean evergreen woodland. Invasive Bermudagrass (*Cynodon dactylon*) and barnyardgrass (*Echinochloa crus galli*) occur. Aquatic beetles, backswimmers, and boatmen have been observed. An elegant trogon (*Trogon elegans*) and grey fox (*Urocyon cinereoargenteus*) have been observed at the site.

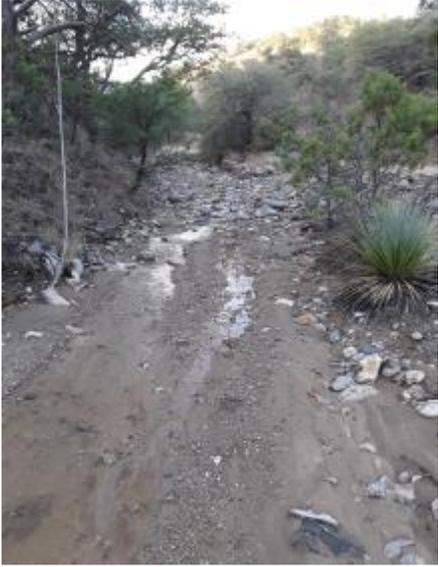
<p align="center">Dry Season Photo</p>	<p align="center">Wet Season Photo (12/6/2019)</p>
<p align="center">Photo not taken</p>

Aquatic and Vegetation Survey Findings: Site is located in silty and cobbly section of Washington Gulch. Herbaceous vegetation is sparse, dominated by hairy grama (*Bouteloua hirsuta*), Wright's buckwheat (*Eriogonum wrightii*), and annual muhly (*Muhlenbergia minutissima*). Limited overstory cover is provided by oak (*Quercus* spp.), and alligator juniper (*Juniperus deppeana*) trees. Invasive natalgrass (*Melinis repens*) occurs. Aquatic beetles have been observed. No aquatic invertebrates or vertebrates have been observed at this site.
